**NS 2 FRESHWATER PEARL MUSSEL SUB-BASIN
MANAGEMENT PLANS**

**REPORT ON MORPHOLOGICAL MONITORING AND
CATCHMENT WALKOVER RISK ASSESSMENTS IN THE
CARAGH CATCHMENT**

September 2009

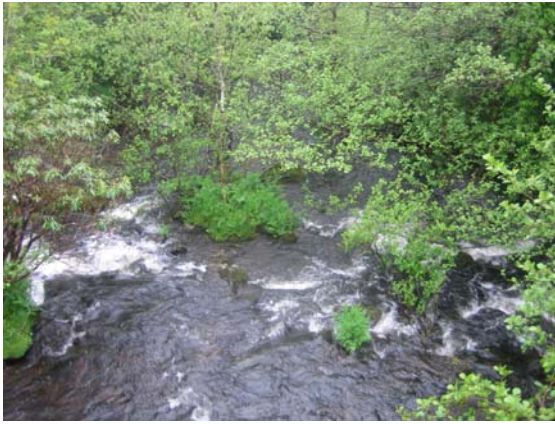
RHAT 2

Eight RHAT surveys were carried out throughout the Caragh catchment. The results of these surveys can be found in the electronic appendix. Three were deemed to be at High status, three at Good status and two at Moderate status. RHAT number 2 scored well on all attributes except for barriers to continuity and riparian land cover. However, the barriers to continuity were based on the natural river typology and overall this stretch was classified as being at high status.

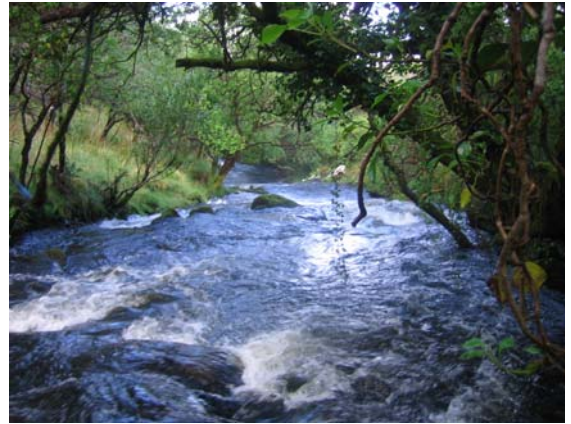
RHAT 3

RHAT number 3 was one of the highest scoring stretches within the catchment with all attributes scoring 4 out of 4 except for the riparian landcover which scored 2 and the floodplain connectivity which scored 3. Both these attributes scored low due to the presence of coniferous plantation along the step banks together with extensive evidence of dumping along the stretch. The river is highly confined within this valley due to its

step sides and therefore the floodplain connectivity was scored 3 out of 4. There is also some evidence to suggest this stretch was possibly reinforced along the toe in the past which has led to an alteration of the bank side vegetation in some areas.

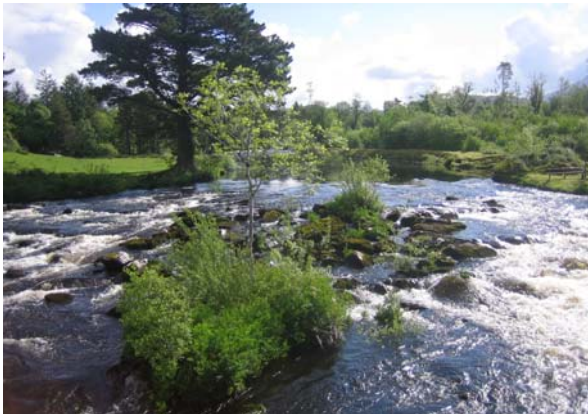
RHAT 4

RHAT number 4 overall was classified as Good however, the channel vegetation, substrate condition, riparian landcover and floodplain connectivity all scored 2 or less. The left bank is maintained for fisheries with much of the bank vegetation cut on the day in which the survey took place. This bank may also have been artificially raised in the past forming an embankment along a significant stretch of the river which can cause problems in relation to the floodplain connectivity.

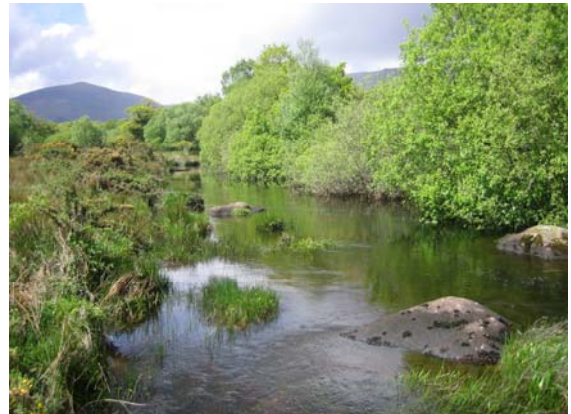
RHAT 5

RHAT number 5 on the Meelagh River was scored 2 on all attributes except channel form and floodplain connectivity which scored 4 and 3 respectively. Overall the substrate condition was poor with above average macrophyte growth for a river of this typology in particular *ranunculus*. This is largely due to the presence of a fine layer of silt on the substrate. The banks have been trampled and are also eroding heavily on the meanders with slumping evident also. Within the survey stretch covered by RHAT number 7 the bank structure & stability, bank vegetation & riparian landcover scored lowest. Along the left bank in particular downstream of the bridge heavy poaching, trampling and siltation is evident. Along the right bank and towards the centre of the channel *ranunculus* is present in large plumes.

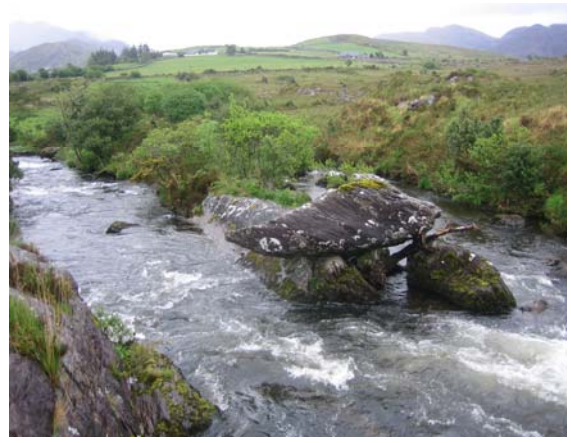
RHAT 8

RHAT number 8 covered a stretch on the main channel of the Owenroe river. This stretch scored high in the classification process and overall scored well on all attributes. It is a fast flowing stretch with small mid channel Islands evident indicating it is a high energy system.

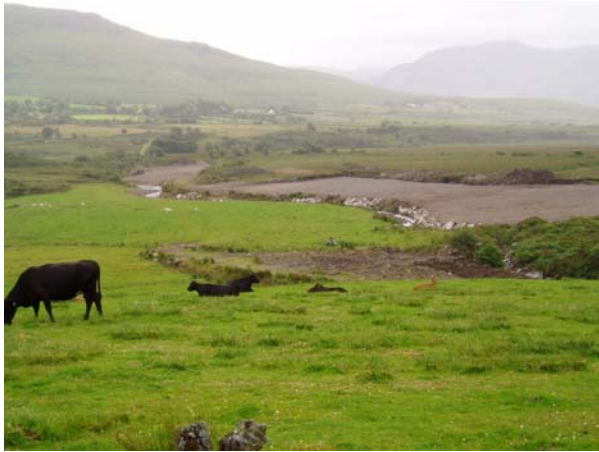
Stopping Point 11 Glashawee River Photo taken in February 2009

The various stopping points which are also indicated in Figure 2 highlighted a number of areas where bank and site clearance works are also a significant pressure throughout the catchment. In particular on the Glashawee River (Site 11) near the recorded population of pearl mussels, significant bank and site clearance works were recorded. These site clearance works are recent with initial bank reinforcement and site clearance works for improved grassland recorded in February 2009 with subsequent photos taken in June 2009 as per the photographs below. Further site clearance (Stopping point 4 & 5), land improvement, small scale sand and gravel abstraction together with tree felling was also recorded at the remaining stopping points.

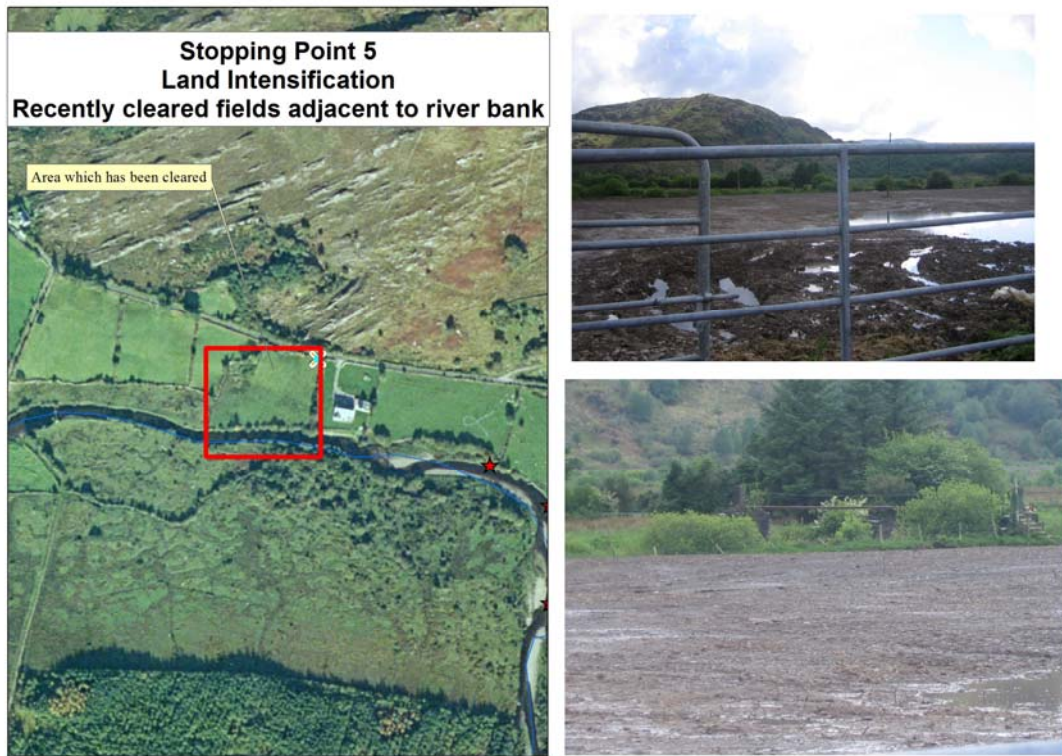
Figure 6 Location of stopping point 5 where significant land clearance has been undertaken adjacent to a river stretch containing pearl mussel records and habitat.
