**NS 2 FRESHWATER PEARL MUSSEL SUB-BASIN  
MANAGEMENT PLANS**

**REPORT ON MORPHOLOGICAL MONITORING AND  
CATCHMENT WALKOVER RISK ASSESSMENTS IN THE  
CLOON CATCHMENT**

**September 2009**

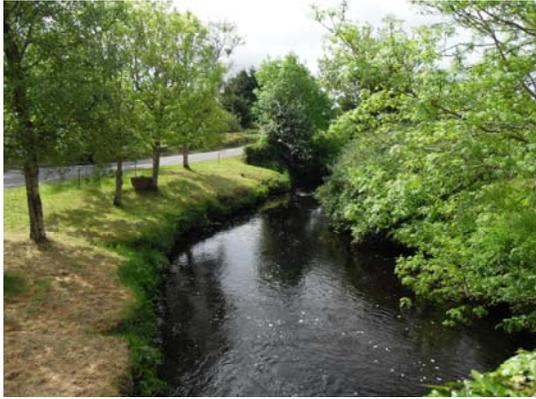
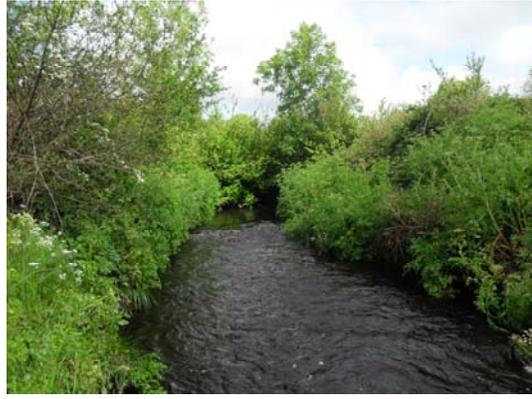
<p><b>RHAT 1</b></p>

Three RHAT surveys were carried out throughout the Cloon catchment within the vicinity of the known pearl mussel records or habitat. The results of these surveys can be found in the electronic appendix. All three survey stretches were deemed to be at “Good” status. RHAT number 1 scored well on all attributes except for bank structure and stability and floodplain connectivity. This was due to the pressure from the small village of Cranny in the vicinity of the survey stretch. The banks are steepened on the lower end of the survey stretch while upstream of the bridge more natural bank instability was found due to cattle poaching and access points. On the left bank an embankment was noted along this stretch of the lowland meandering channel which has the effect of preventing floodplain connectivity.

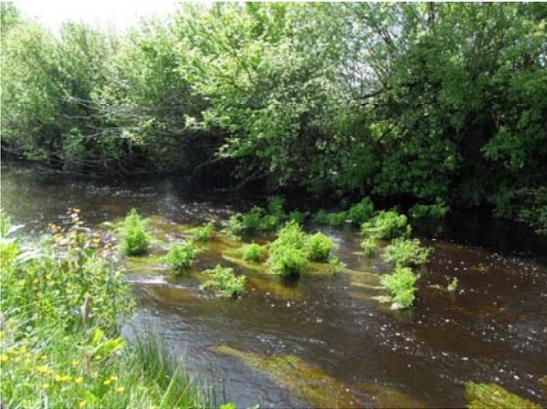
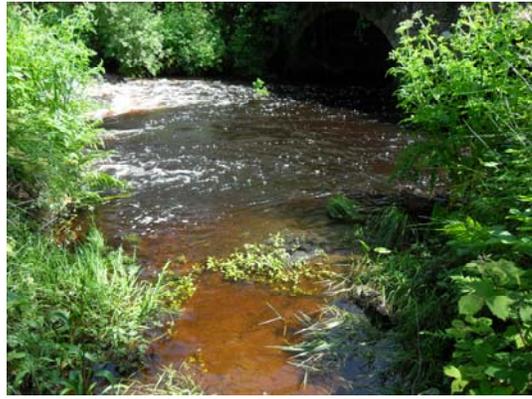
<p><b>RHAT 3</b></p>

RHAT number 3 scored three out of a possible 4 on all attributes except channel vegetation and substrate condition. Both of these attributes scored two out of a possible four. In regards the channel vegetation for this channel type rooted aquatic vegetation may be common at channel margins during the growing season however along this survey stretch excessive *Potamogetans*, and *Apium* species were recorded across the channel. This could indicate high levels of both silt and nutrients are contained within the substrate to allow the macrophytes to take root and flourish. The substrate condition although not visible along all of the stretch was also downgraded as the high levels of macrophyte growth would indicate the substrate has greater than expected levels of siltation. Where the substrate was visible it was found to be in poor condition.

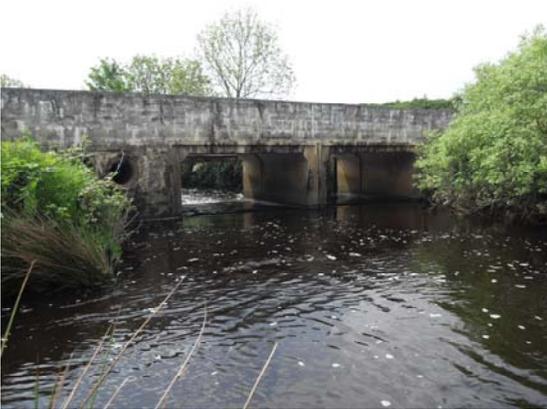
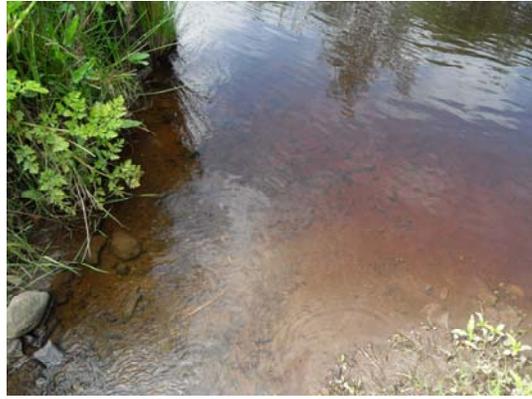
<p><b>RHAT 4</b></p>

RHAT number 4 scored low on channel form and flow types and substrate condition. This is largely due to the presence of one major bridge which has been altered numerous times over the past number of years. The bridge consists of two large box culverts and a number of round culverts which were added in recent years on either side. Underneath the bridge an artificial concrete substrate has also been put in place which is acting as a minor weir. The weir and bridge structure are altering the flow regime of the river. Again, the substrate condition along this stretch is quite poor with a heavy peat stain.

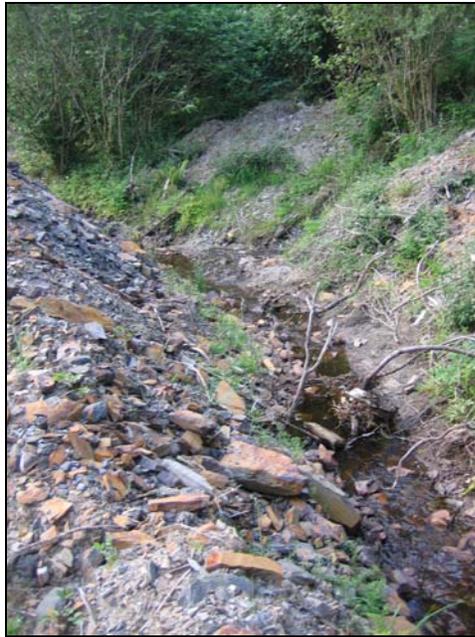
**Site 9 Photo 4**

Site 9 at Breaghva Bridge in the upper Cloon catchment was found to have been significantly altered and damaged. From the road bridge and continuing downstream for approximately 200m the channel has been completely manipulated with the removal of both bank side and in channel vegetation. Large boulders have been dumped it would appear from the road side down into the channel. The river now flows underneath this channel and is acting as a total barrier to migration.

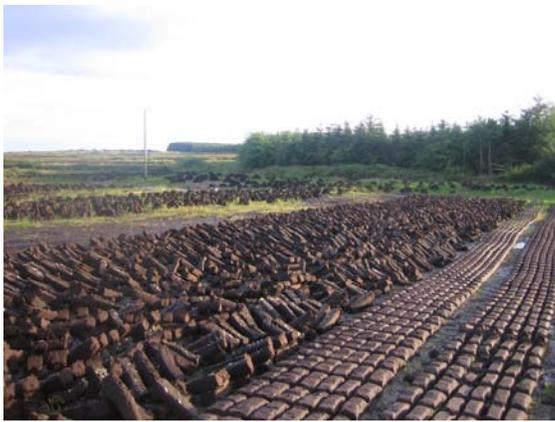
**Site 10 Peat spreading together with Forestry cover adjacent to the river channel**

Both pressures were found in close proximity and adjacent to the river channel with inadequate buffer zones in some instances. In combination these two pressures may lead to a significant source of silt in the river.

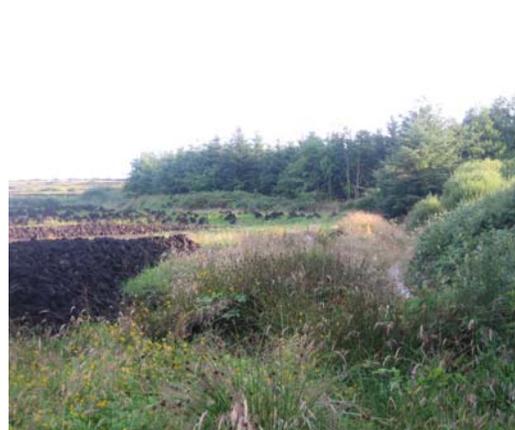
**Site 10 Peat spreading together with Forestry cover adjacent to the river channel**

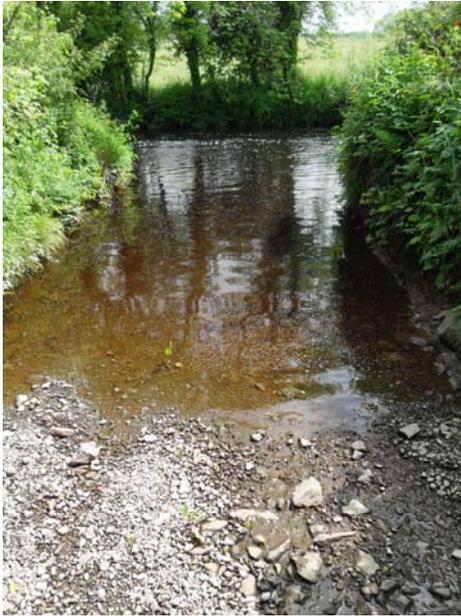
**Site 4 Photo 9**

- Flood protection works in particular at site four is a major pressure, particularly since this is a Freshwater Pearl Mussel site. Presence of new culverts and a bridge that has been continually expanded by the council are having significant impacts.

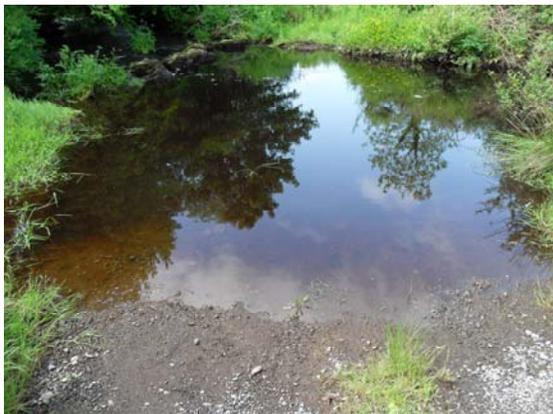
**Stopping point 1 Photo 3**

Two fords were found within the Cloon catchment. The first was located at Stopping Point 1 as indicated in Figure 2. The access point appears to be used by animals and perhaps more infrequently by vehicles. Boulders have been placed down stream of the access point in order to prevent cattle passing down the channel. The second ford is located at Site 4 again as indicated in Figure 2. This is a larger Ford in that the entry and exist points are a considerable distance apart. An access slip road slopes down to the

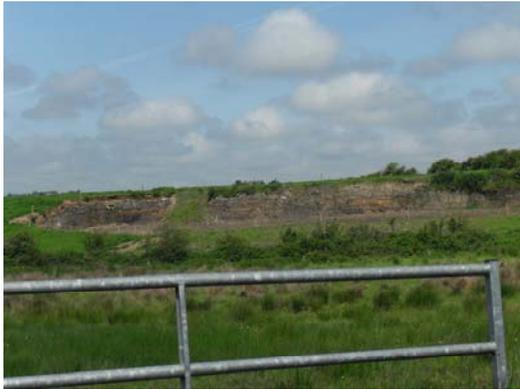
**Stopping point 3 Photo 1**

A series of small scale non-commercial quarries were recorded along the North Cloon Kildysert tributary. While these appeared to be largely inactive or used infrequently on the day in which our surveys took place the landowners who operate the number of private quarries should be made aware of the Freshwater Pearl Mussel requirements and if developed further in the future and used commercially the landowner is aware that planning permission and a licence will be required from Clare CoCo.
