**NS 2 FRESHWATER PEARL MUSSEL SUB-BASIN
MANAGEMENT PLANS**

**REPORT ON MORPHOLOGICAL MONITORING AND
CATCHMENT WALKOVER RISK ASSESSMENTS IN THE
AUGHVAUD CATCHMENT**

September 2009

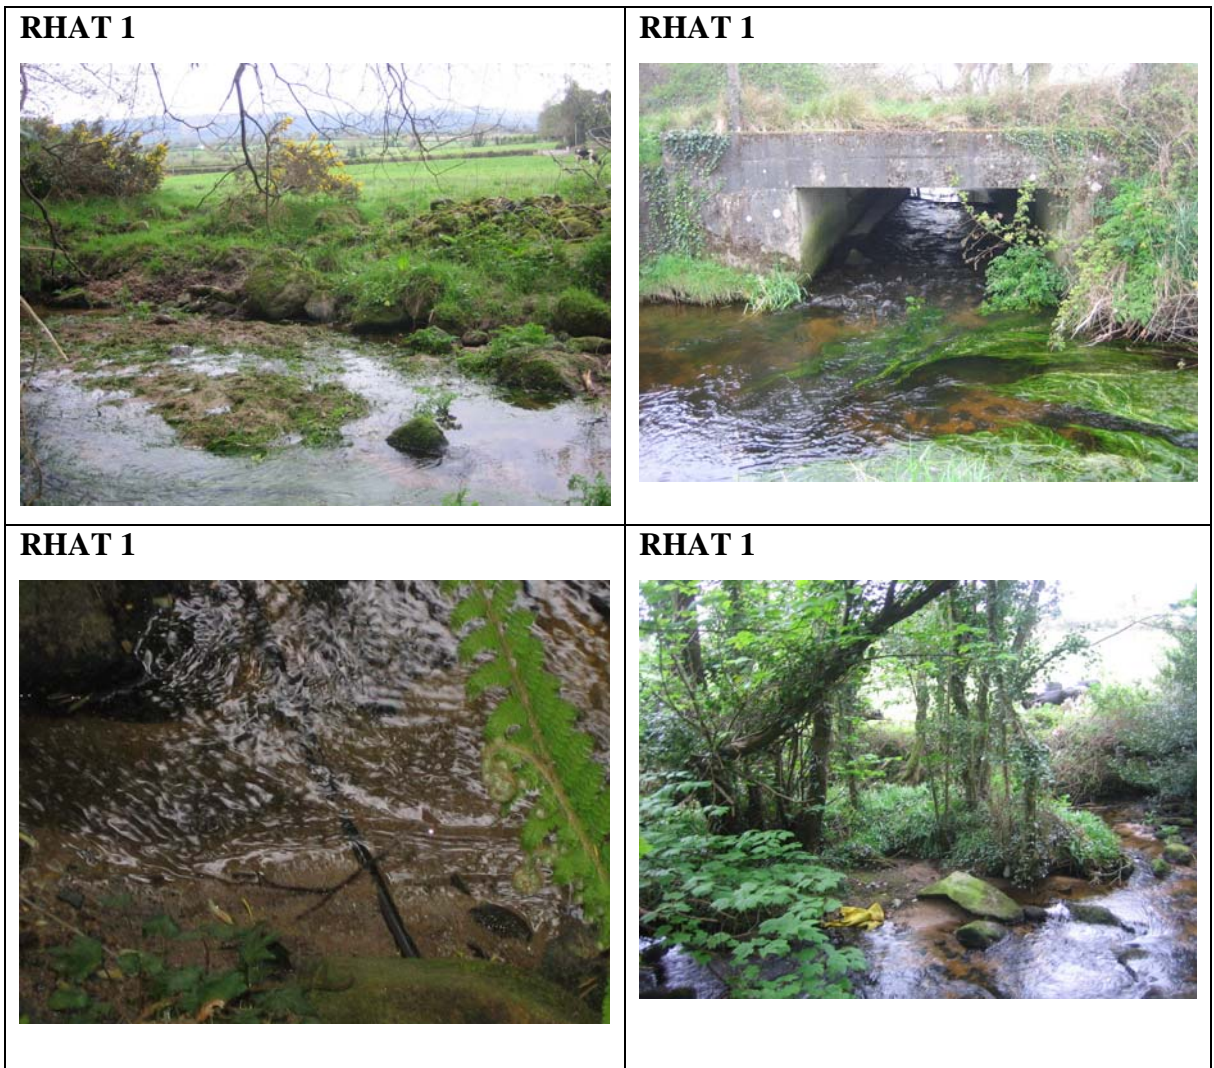
Representative photographs from reach:

One RHAT survey was carried out in the Aughavaud catchment over a 620m survey stretch within the vicinity of the pearl mussel population. The results of these surveys can be found in the electronic appendix. This survey stretch was deemed to be at poor and is located at the lower end of the catchment was at Good status. All attributes scored low with no category scoring more than 2. This was due to the pressure from agriculture on the right bank with cattle access and trampling causing significant pressure. Also, the removal of bankside vegetation and dumping of construction and demolition waste on the left bank has led to siltation within the channel. This is further evident from the macrophyte growth which is found at the bridge (See Site 2 Photo 15 & 16)
