**NS 2 FRESHWATER PEARL MUSSEL SUB-BASIN  
MANAGEMENT PLANS**

**REPORT ON MORPHOLOGICAL MONITORING AND  
CATCHMENT WALKOVER RISK ASSESSMENTS IN THE  
BALLYMURPHY CATCHMENT**

**September 2009**

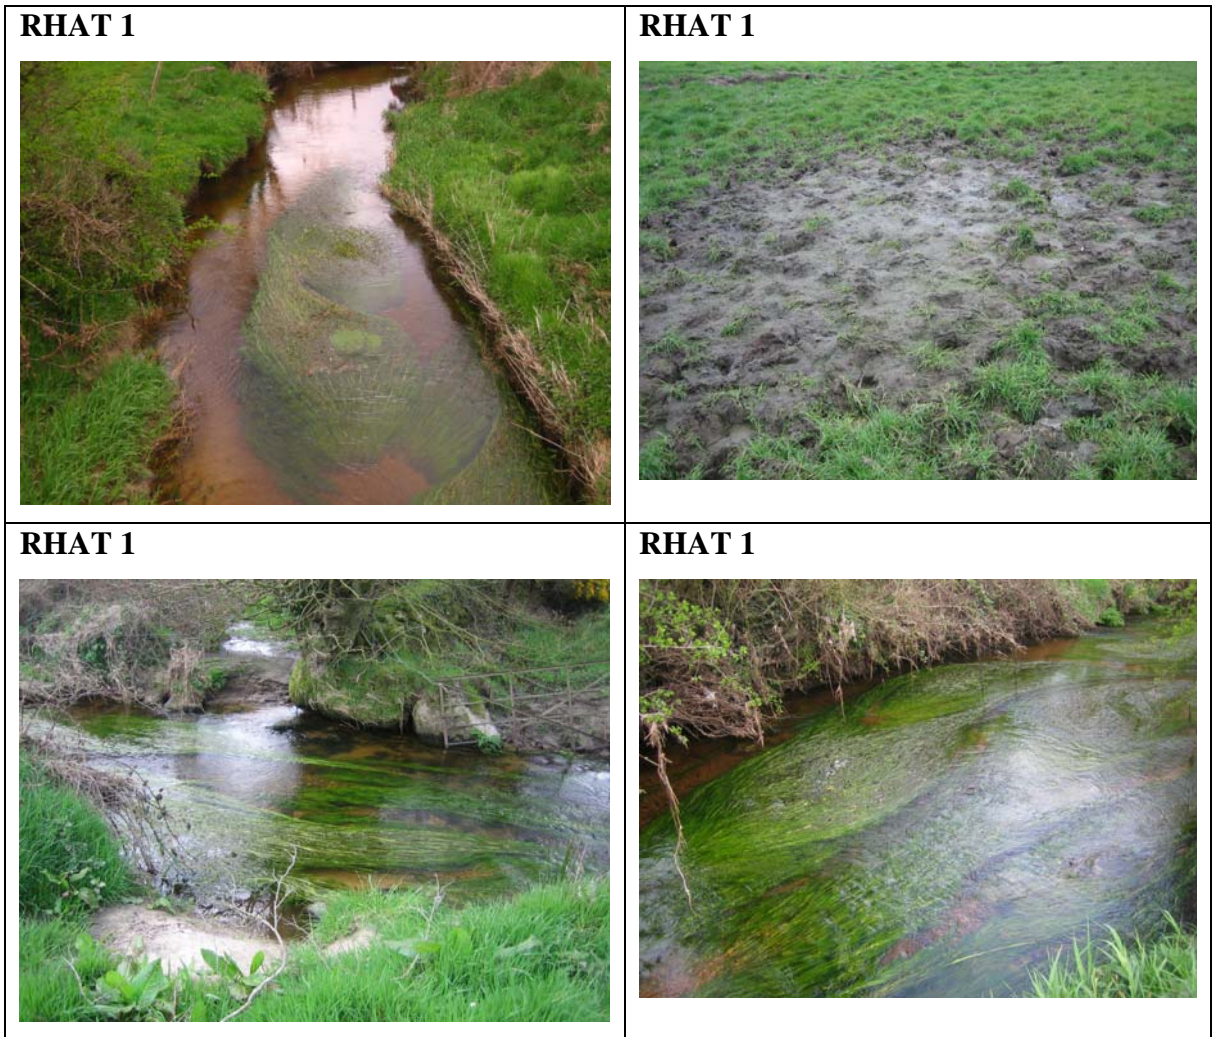
Representative photographs from reach:

One RHAT survey was carried out throughout the Ballymurphy catchment within the vicinity of the pearl mussel populations. The results from this survey can be found in the electronic appendix. This survey stretch of 220m was deemed to be at moderate status. This was due to the very poor substrate condition together with the various pressures from the surrounding landuse which is intensive agriculture. Cattle poaching and trampling was evident along both banks with a poor buffer zone. Siltation levels within the channel greatly exceeded the expected values for this river type; however this is largely due to the underlying soil type rather than from a diffuse source. The heavy

siltation has lead to an increased growth of macrophytes along the stretch again at higher levels than you would expect for a river of this type.
