**NS 2 FRESHWATER PEARL MUSSEL SUB-BASIN
MANAGEMENT PLANS**

**REPORT ON MORPHOLOGICAL MONITORING AND
CATCHMENT WALKOVER RISK ASSESSMENTS IN THE
BANDON CATCHMENT**

September 2009

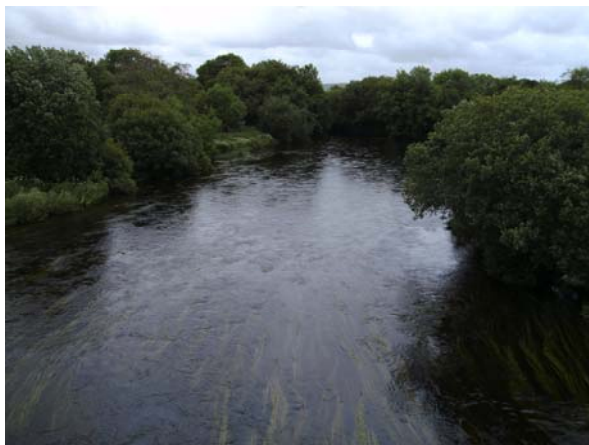
RHAT 1 – Site 1 Photo 10

RHAAT number 1 (Dunmanway) was carried out along the stretch of the Bandon both above and below the main bridge located on the outskirts of Dunmanway. This is a lowland meandering channel where rooted aquatic vegetation may be common at

channel margins during the growing season. Mid-channel islands may also be present and fringing reed beds may be found, but not excessive. Along the survey stretch excessive macrophyte growth was recorded not only along the margins but also across the entire width of the channel from the bridge and continuing down stream. (Site 1, Photo 7, 10 & 12). The levels of macrophyte growth along this stretch would suggest both a nutrient and siltation problem. The flow can be quite fast at this point and therefore the macrophytes would need a strong foot hold in order to maintain their dominance. This would suggest the substrate has become heavily infiltrated with silt.

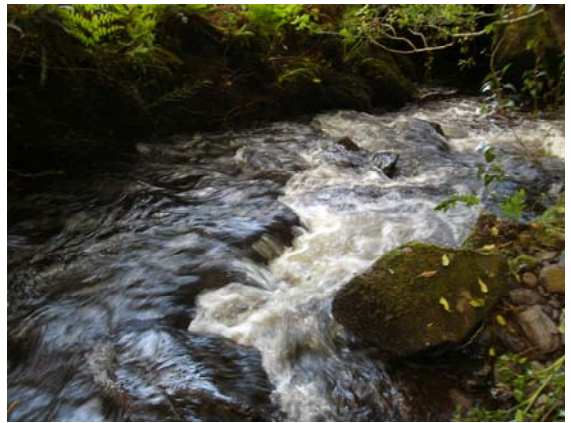
RHAT 6 – Site 2 Photo 5

RHAT Number 6 was surveyed at the top of the Bandon river on a tributary which flows out of Cullenagh Lake. This stretch scored the highest out of all the RHAT surveys carried out throughout the catchment. The hydromorph score was 0.93. The only two attributes which were marked down slightly was the substrate condition and barriers to continuity. This was due to the presence of small pockets of fine silt along the stretch together with the presence of quick large boulders which may act as a barrier to migration. A number of small unmanaged land drains were also recorded along this stretch.

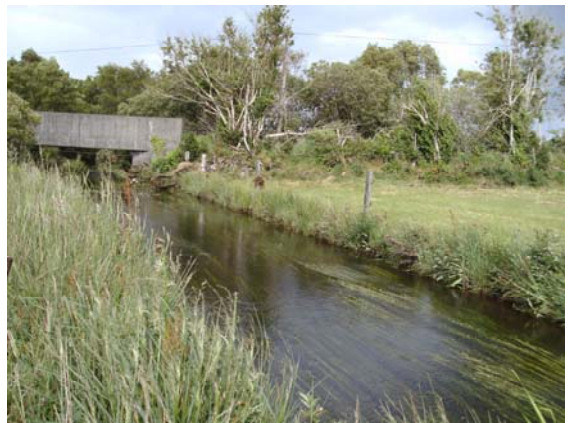
RHAT 7 – Site 7 Photo 2

RHAT Number 7 was carried out at Farnanes bridge. The stretch was generally a glide which appeared to have been straightened at some point in the past. (Site 7, Photo 2). Due to this alteration coupled with the intensification of the land for agricultural purposes the bank side vegetation is of a uniform nature with little to no buffer zone as the fence line is directly on the bank edge. (Site 7, Photo 3). This led to low scores for both the channel form and flow types together with the bank vegetation. The riparian landcover also scored quite low due to the presence of improved grassland coupled with the presence of spreading of manure and cattle access directly to the channel. During April round feeder marks where cattle were obviously out wintered were recorded. The field in which the feeders were located is adjacent to the channel and quite wet. Little to no buffer zone exists along this stretch which may have lead to significant nutrient input to the channel and hence the increased macrophyte growth. While carrying out the

morphology surveys in June, round mounds of manure were recorded in the same location.

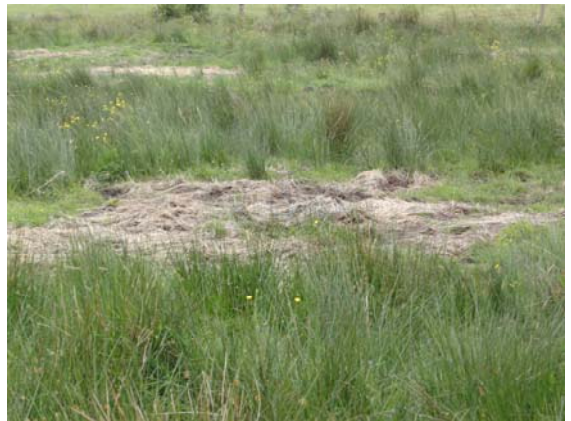
RHAT 7 – Site 7 Photo 13 same area as photo taken in April 09

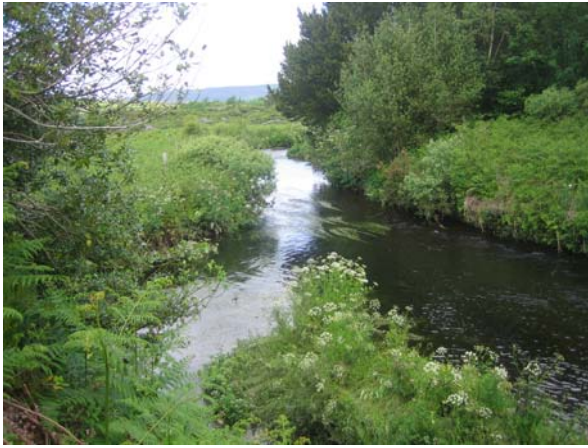
RHAT 16 – Site 16 Photo 11

RHAT Number 16 was carried out on the lower stretch of the Caha river. The lowest scoring attribute within the catchment was the substrate condition as higher than expected levels of silt were recorded. This was further confirmed due to the presence of rooted macrophytes. All other attributes except the channel form and flow types scored three out of four. Some unmanaged drains were also recorded along this stretch.

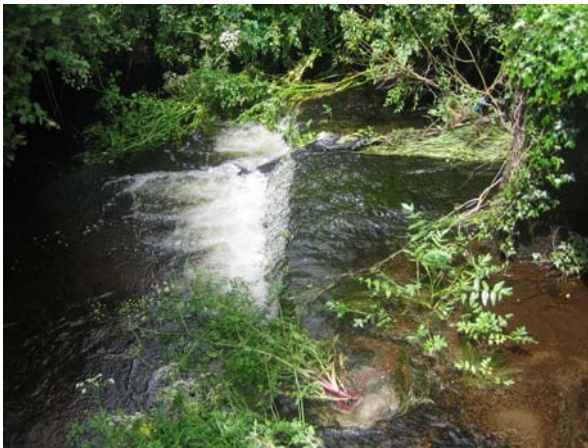
RHAT 17 – Site 17 Photo 7

RHAT Number 17 was also carried out along the lower Caha river just above site 16 in the vicinity of the pearl mussel population. Rooted macrophytes in particular *Ranunculus* was recorded along the margins of the river channel together with *Apium sp.* however, such growth along the margins is expected during the growing season. The channel vegetation attribute was slightly marked down but this was largely due to the presence of filamentous green algae at the confluence of the tributaries. The substrate condition was also quite poor along this stretch with fine silts recorded along the centre of the channel.

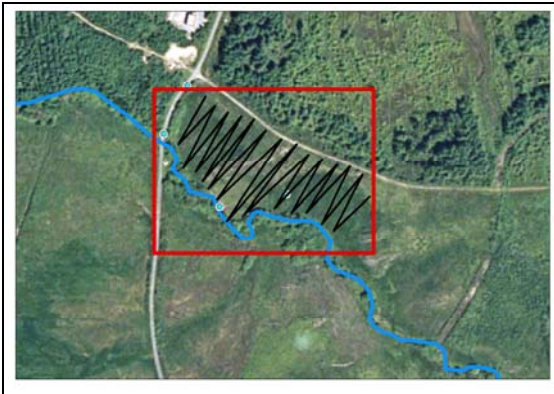
The most common source of diffuse silt is forestry which is evident throughout the catchment at five high risk sites, often within close proximity to the river channel. This coupled with a poor riparian buffer significantly intensifies the potential effects of diffuse silt on Freshwater Pearl Mussel Populations, each individual source of diffuse silt is illustrated below in Figure 5. Site 11 contained one of the most significant sources of this diffuse silt associated with land improvement works from what our field investigations and consultation with local NPWS staff could identify. A large area of the riparian zone along a tributary of the Bandon – Shanacrane East was recently cleared together with the removal of the top layer of vegetation for the construction of a road. This large area was cleared down to the river bank where the bank side vegetation was also removed. The substrate condition was very poor along this stretch with

siltation recorded in the gravels. The area is to the North East of the catchment near Tooreen. The Eastings and Northings are 117859 59321. Photos indicating the extent of these works are located below.

Site 11 Cleared riparian zone and bank side vegetation

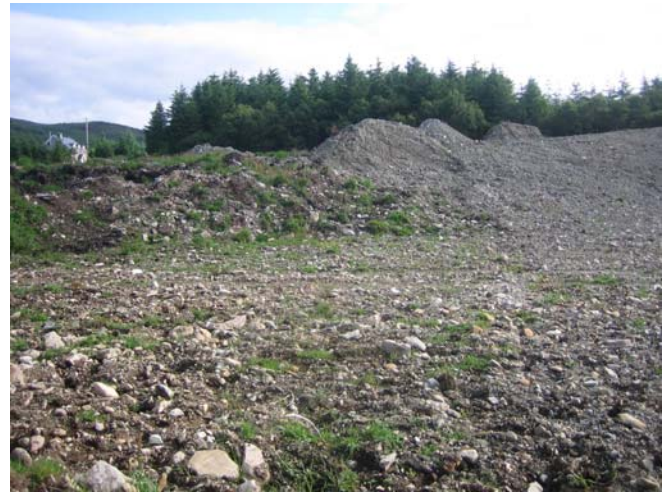
Site 11 Site clearance in the riparian zone

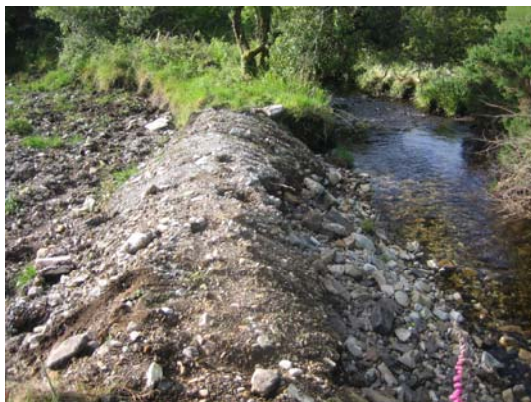
Site 11 Photo 10 removed bank vegetation

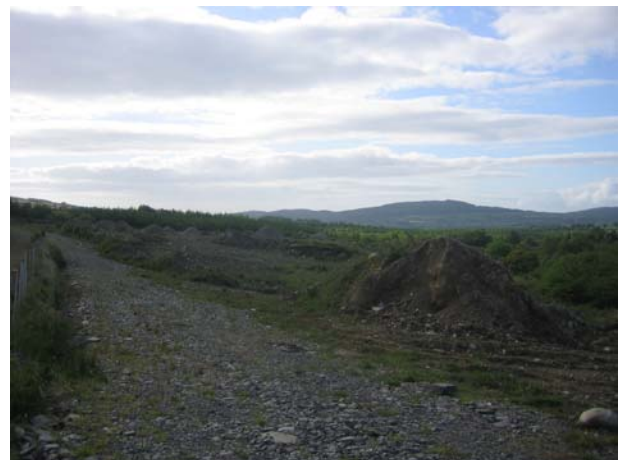
Site 11 Photo 13 Associated roading and stock piles

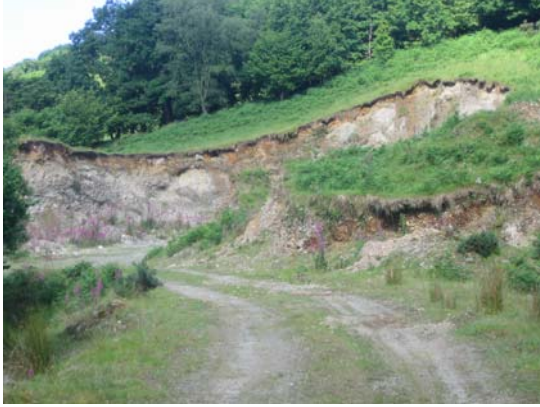
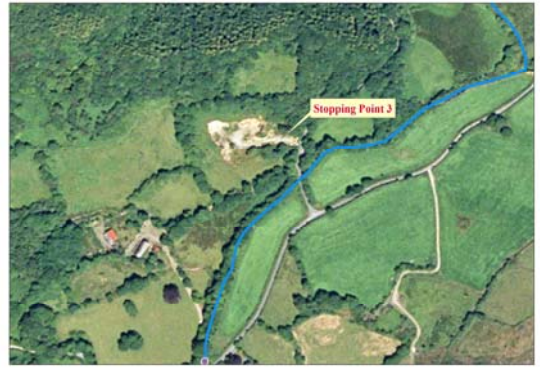
Four quarries were identified and located within the Bandon catchment during the course of the catchment walkover risk assessments at stopping points 3, 4, 5 & 6 as indicated on Figure 2. The quarry located at Stopping point 3 appears to be a small, occasionally used quarry, however, the Upper Caha channel is located directly across from the entrance to the site. **Mid Cork Stone Quarries** is located at stopping point 4. It is a large quarry which currently does not appear to be used on a frequent basis. It is approximately 800m (as the crow flies) from the Lower Caha. At present it does not appear to be registered with Cork County Council. Mid Stone Quarries has a second location approximately 700m away from the site at stopping point 3. Again, this looks largely unused at the moment. However, a small tributary runs along adjacent to the site. As with the previous Mid Cork Stone quarries site it is recorded as invalid or not registered by Cork CoCo. The fourth quarry is located at stopping point 6 in the Ardcahan area. It is a significant quarry which is currently active. On the day in which the survey took place sprinklers were active on the spoil heaps.
