**NS 2 FRESHWATER PEARL MUSSEL SUB-BASIN
MANAGEMENT PLANS**

**REPORT ON MORPHOLOGICAL MONITORING AND
CATCHMENT WALKOVER RISK ASSESSMENTS IN THE
GEARHAMEEN CATCHMENT**

September 2009

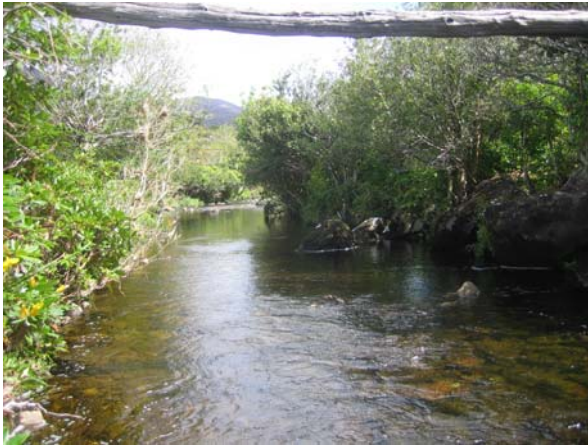
RHAT 5 – Site 5 Photo 3

Three RHAT surveys were carried out throughout the Gearhameen catchment. The results of these surveys can be found in the electronic appendix. Two were deemed to be at good status, one in the lower reaches of the catchment (RHAT number 6) on the Gearhameen before it flows into Upper Lough below the confluence with the Owenreagh. The second good status reach was located at the lower end of the Owenreagh (RHAT Number 5). Despite the classification of good status (from a morphological point of view) at RHAT number 5 a continuous cover of silt and algae was found along this stretch with dead mussels evident along the banks. Both the bank structure and stability together with the bank vegetation scored quite low along this reach as high levels of bank erosion and slumping was recorded.

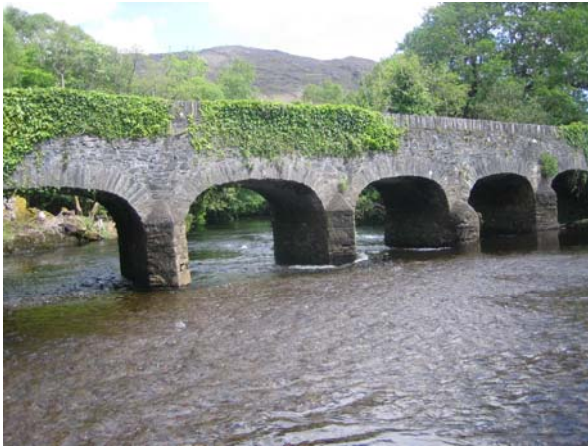
RHAT 6 – Site 6 Photo 6

RHAT number 6 was carried out in the vicinity of Lord Brandon's cottage. A five arched stone bridge spans the channel at this point with 6 in channel abutments and slightly alters the flow of the channel. Scouring and loss of habitat was recorded on the left bank at the bridge. Excessive filamentous algae and siltation was recorded along the length of the survey stretch with the substrate condition attribute scoring quite low as a result. Some amenity grassland management is carried out along both banks but also sheep are allowed to freely graze along the survey stretch with no fencing of the channel. The channel can freely connect with the floodplain which is evident from the trash line which was recorded approximately 2.5m from the left bank.

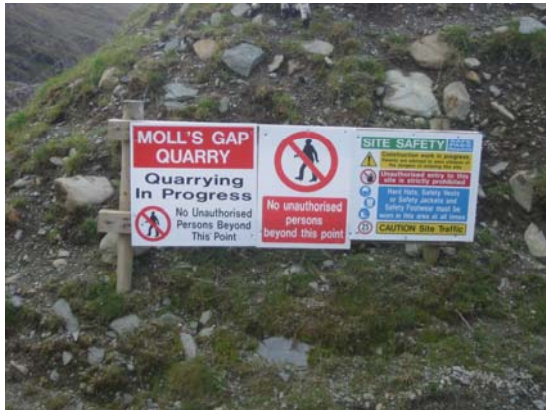
Site 1 Photo 1

One quarry, **Moll's Gap Quarry**, was recorded as active at the top of Moll's Gap on the verge of the R568 where it joins the N71. This quarry is on a steep slope which drains into the main Owenreagh channel upstream of a pearl mussel location.

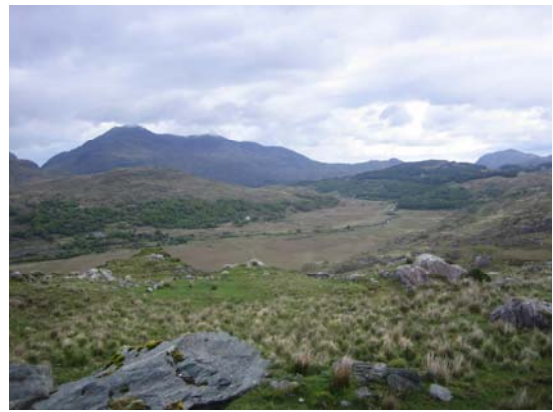
Site 1 Photo 4 Owenreagh valley across the road from Quarry

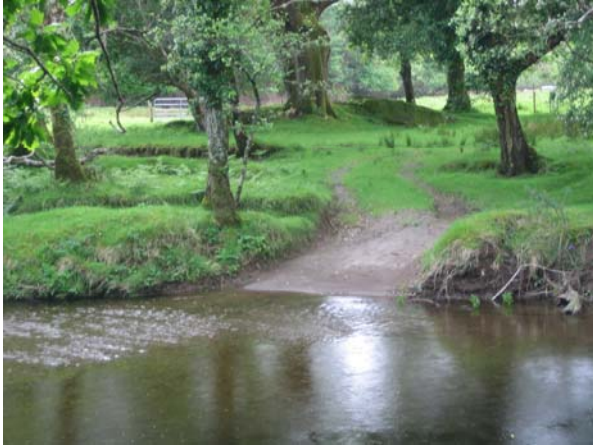
One significant Ford was recorded within the catchment at Site 6. This Ford has significant vehicular access with the landowner entering the channel on the right bank crossing the approximately 12 metre wide channel and exiting a little downstream on the left bank. Although the pearl mussel records are located upstream of this location the presence of the ford is still a significant pressure within the catchment.

Ford entry point Site 6, Photo 10

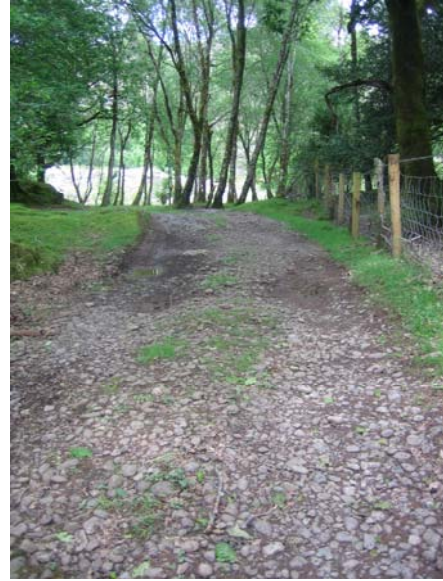
Ford exit point Site 6, Photo 12
