**NS 2 FRESHWATER PEARL MUSSEL SUB-BASIN
MANAGEMENT PLANS**

**REPORT ON MORPHOLOGICAL MONITORING AND
CATCHMENT WALKOVER RISK ASSESSMENTS IN THE
DAWROS CATCHMENT**

September 2009

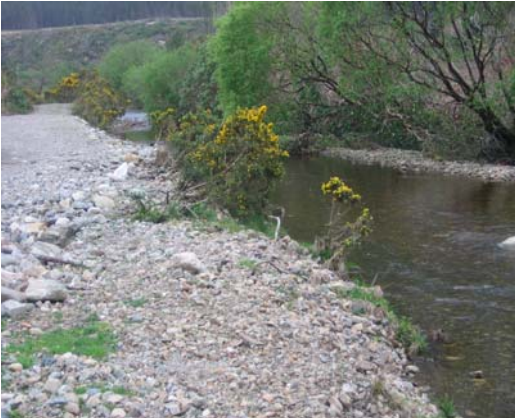
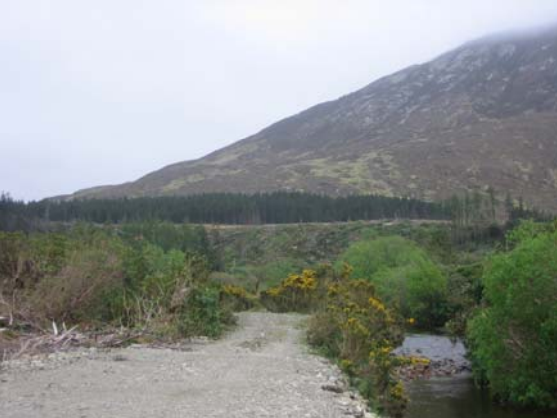
<p>Site 5 Roding along Polladirk River where bank side vegetation has been removed</p>	<p>Site 5 Forestry upstream of river, felling on right bank, associated roading.</p>

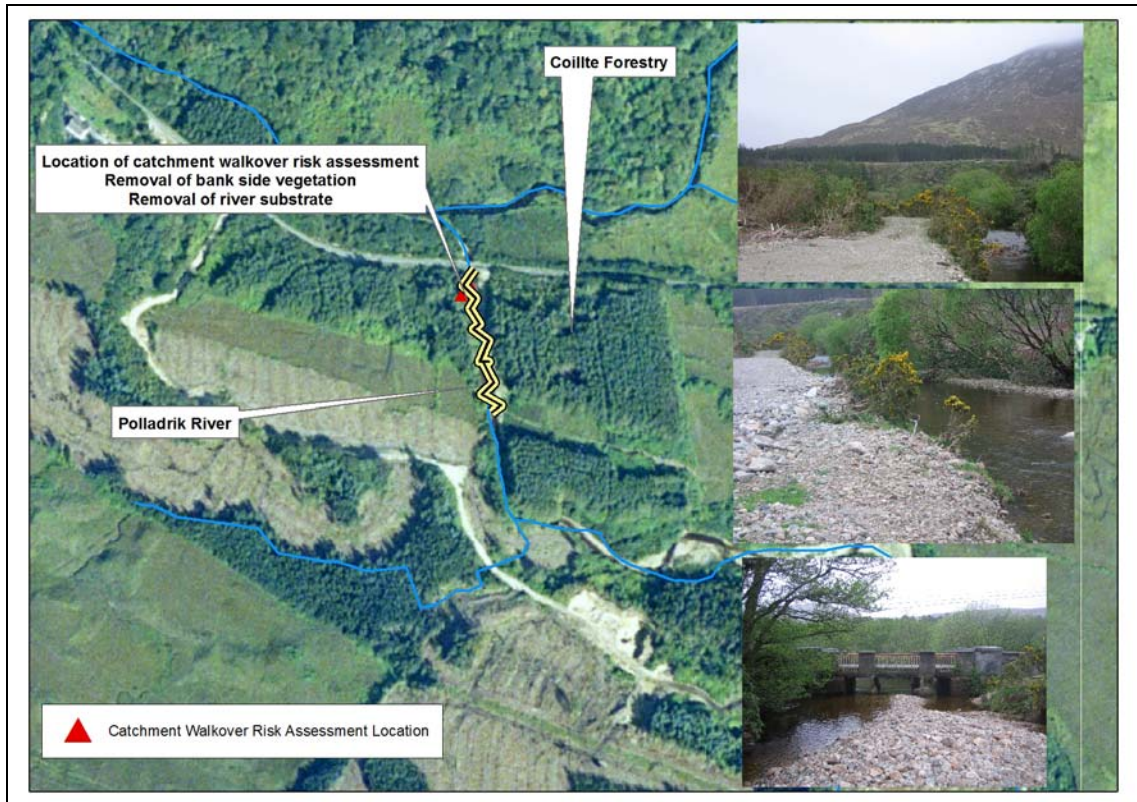
Figure 3 Aerial overview of Polladrik River where bank side and in channel vegetation removal was recorded

A total of nine sites were surveyed in the Dawros sub-basin catchment, with a risk assessment carried out at all nine of these sites. **Figure 2** outlines the locations of the High to Low Risk Assessment results from the Catchment Walkover Risk Assessments. Seven high risk sites were recorded out of the nine that were assessed. The remaining two sites were recorded as medium risk, meaning no low risk sites were recorded within this catchment. Figure 3 outlines the percentage of sites classified at high and medium risk throughout the catchment. One particular assessment which highlights the extreme damage which has occurred within this catchment is site 5. This assessment was undertaken along the Polladirk River which is fed from the Connemara National Park. Coillte felling had taken place in this location in the past with measures taken by them to avoid damage to the bank side vegetation and channel. However, during the week commencing August 11th 2008 the removal of the bankside vegetation within the Coillte property and removal of debris from the river was carried out, without the prior knowledge or permission of Coillte, by Galway Co. Council. It seems this was in order to prevent damage due to the flash flood to the public road bridge nearby. (Coillte harvesting had ceased at the time of the Galway Co. Council work in view of the flood warning it (Coillte) received from the Fisheries Board.).
