**NS 2 FRESHWATER PEARL MUSSEL SUB-BASIN  
MANAGEMENT PLANS**

**REPORT ON MORPHOLOGICAL MONITORING AND  
CATCHMENT WALKOVER RISK ASSESSMENTS IN THE  
DERREEN CATCHMENT**

**September 2009**

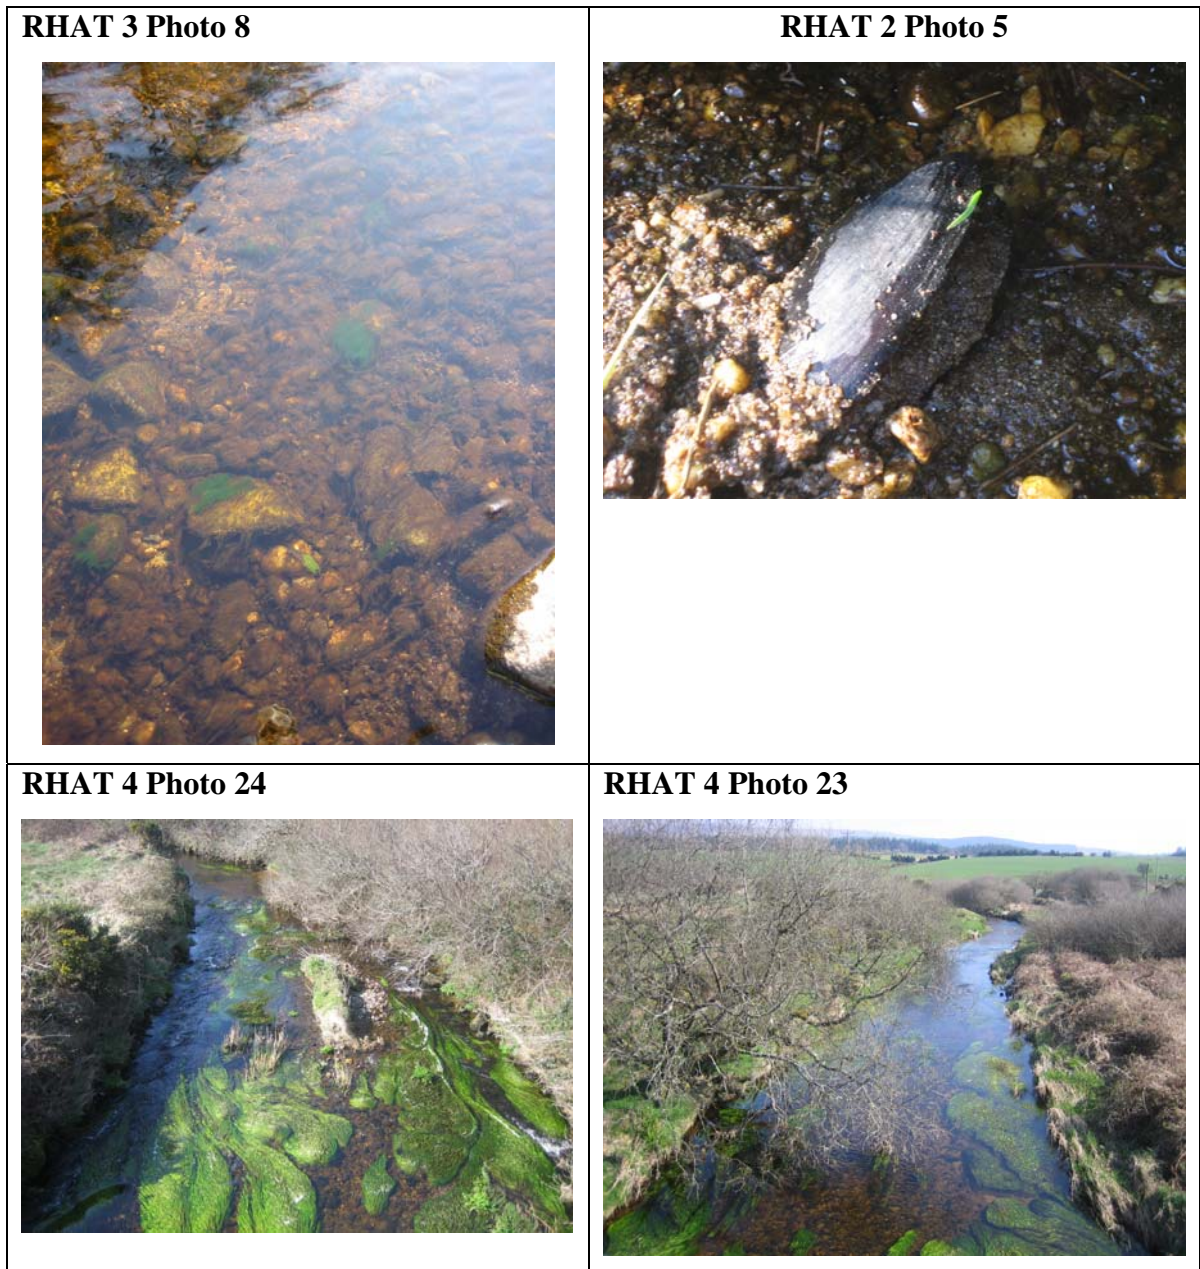
**Plate 3.3 Representative photographs from reach**

RHAT number 3 was carried out North East of Hacketstown. Some resectioning and over widening was recorded together with poaching on both the right and left bank. Again as with RHAT 1 significant *Ranunculus* was recorded along the entire survey stretch. This stretch is a pool-riffle-glide channel and whiles the floodplain connectivity and barriers to continuity are not a problem along this stretch the channel vegetation and substrate condition are a particular issue. The nature of the substrate in this catchment has led to significant levels of fine sands in the channel with dead mussels found on the banks full of sediment. Filamentous algae was found through the channel growing on the cobbles and boulders. The riparian landcover also scored quite low due to excessive levels of animal trampling along the survey stretch. Overall, this stretch was classified as good status.
