**NS 2 FRESHWATER PEARL MUSSEL SUB-BASIN  
MANAGEMENT PLANS**

**REPORT ON MORPHOLOGICAL MONITORING AND  
CATCHMENT WALKOVER RISK ASSESSMENTS IN THE  
OWENCARROW CATCHMENT**

**September 2009**

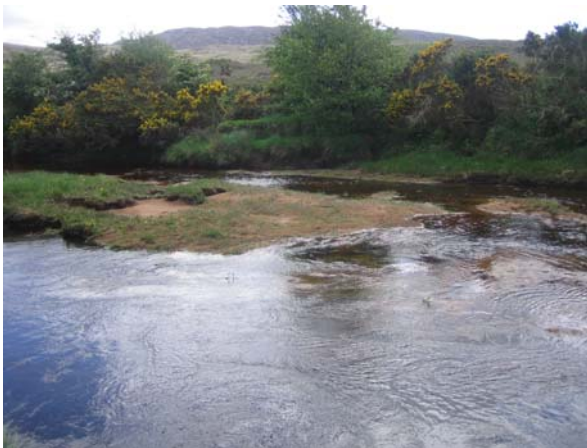
**RHAT 1 Site 3 Photo 9**

Two RHAT surveys were carried out throughout the Owencarrow catchment. The results of these surveys can be found in the electronic appendix. Both were classified as being at good status. RHAT number one was carried out from site 3 to 4 along a lowland meandering channel over a distance of 2,800m. Only the channel form and flow type together with the barriers to continuity scored well. All other attributes scored between 1.5 and 3 out of a possible four. In particular the bank structure and stability together with the bank vegetation scored low (1.5). This is due to the lack of buffer zone together with considerable slumping of the river banks. While the surrounding substrate of the catchment does appear to have a sandy nature high levels within the channel are allowing for excessive macrophyte growths including *potamogeton*, *ranunculus*,

*myriophyllum*, *callitriche* and filamentous algae. All of which are unfavourable for pearl mussel growth. Overall this stretch was classified as being at good status.
