**NS 2 FRESHWATER PEARL MUSSEL SUB-BASIN
MANAGEMENT PLANS**

**REPORT ON MORPHOLOGICAL MONITORING AND
CATCHMENT WALKOVER RISK ASSESSMENTS IN THE
LICKY CATCHMENT**

September 2009

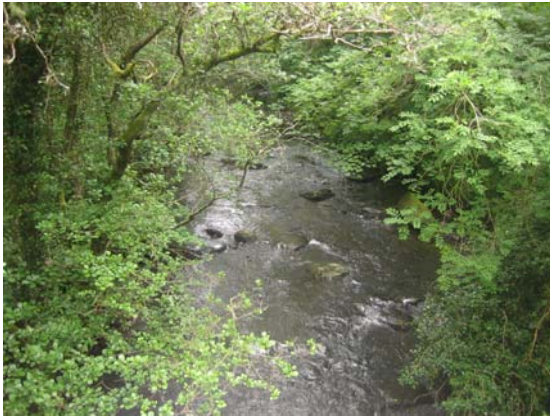
<p>RHAT 1</p>

Three RHAT surveys were carried out throughout the Licky catchment. The results of these surveys can be found in the electronic appendix. Two were deemed to be at moderate status in the upper reaches of the catchment where as the survey stretch at the lower end of the catchment was at Good status. RHAT number 1 scored well on all attributes except for bank vegetation, riparian land cover and floodplain connectivity. This was due to the pressure of forestry on the left bank with a poor buffer zone and steep banks. However, siltation was not a problem at this site which is evident from the macrophyte growth.

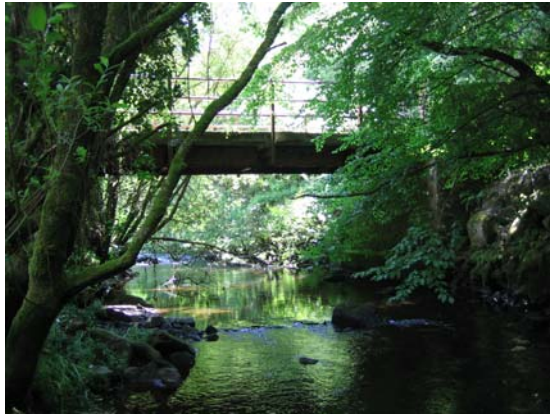
<p>RHAT 2</p>

RHAT number 2 scored well on all attributes except bank vegetation, riparian landcover & floodplain connectivity. Again along this stretch some conifer plantation can be

found on the left bank together with improved grassland and heavy poaching/trampling.

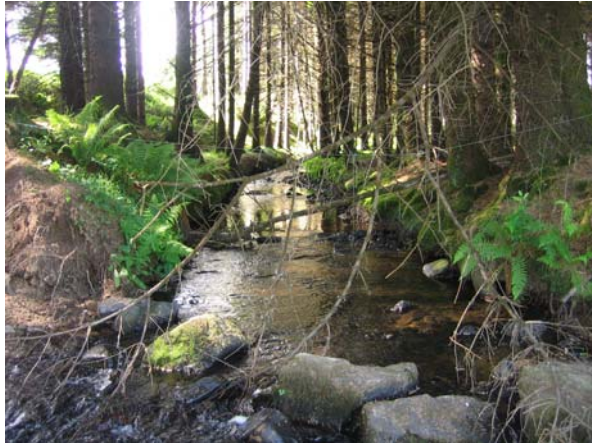
<p>RHAT 3</p>

RHAT number 3 scored well on all attributes except substrate condition, bank vegetation and riparian landcover. This is also as a result of the adjacent forestry plantation which has led to tunnelling and a build up of pine needles on the substrate which is blocking out light and leading to a growth of filamentous algae.

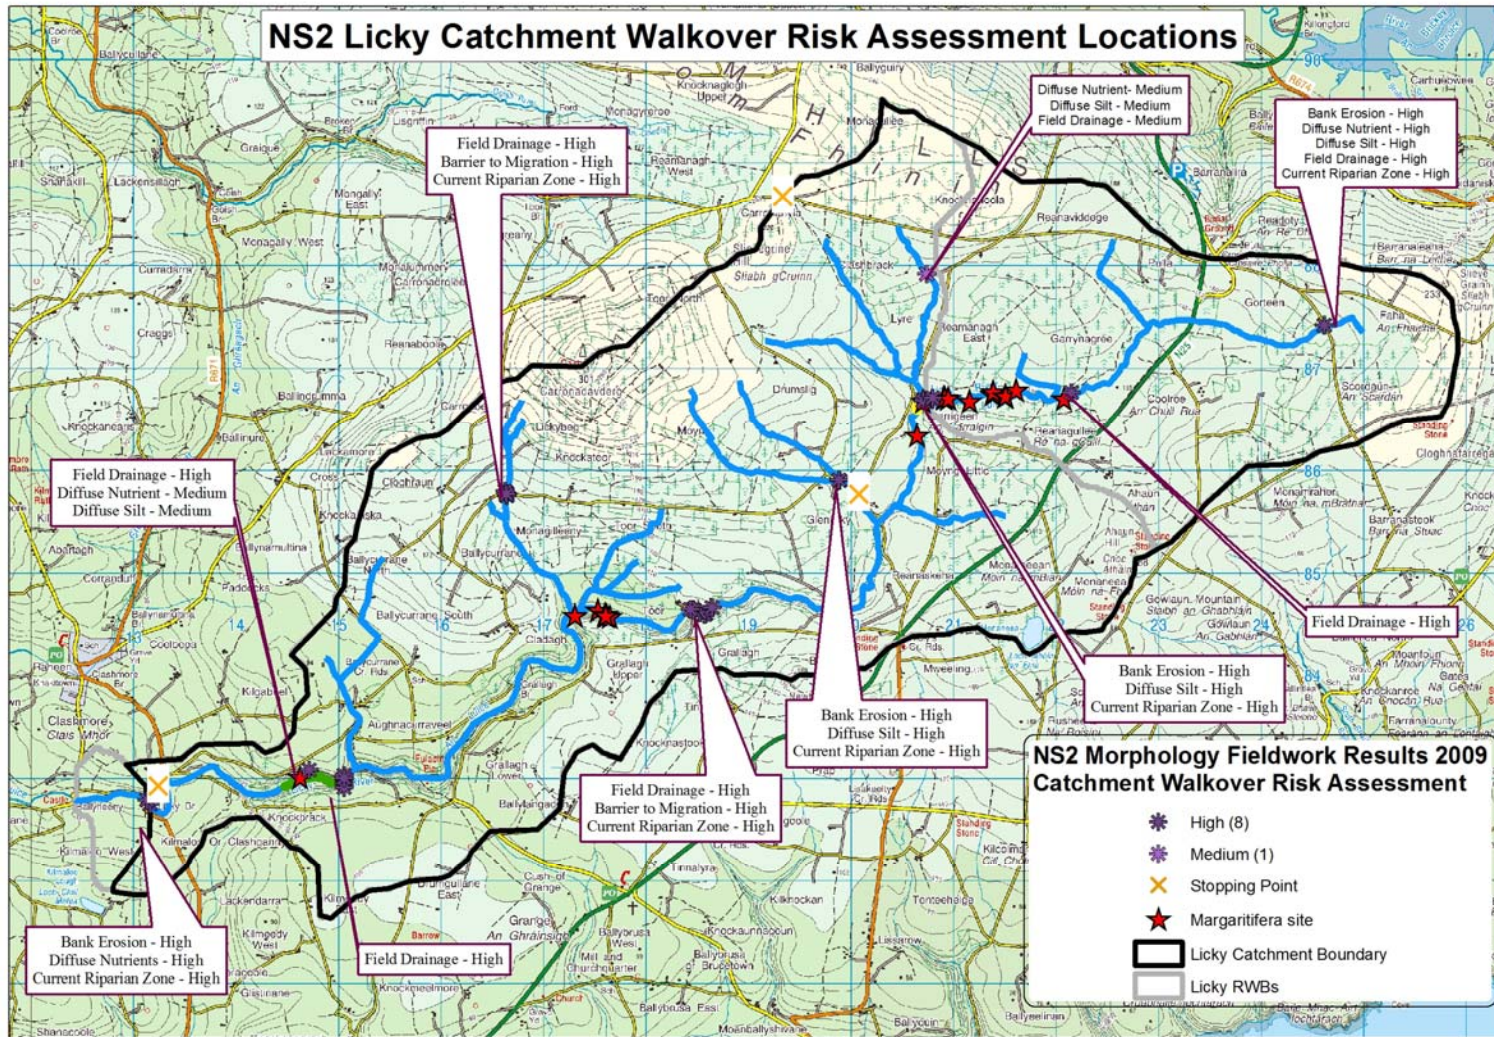
Figure 2 Location of Stopping points and Catchment Walkover Risk Assessments

Where one or any of these aspects is found to be the cause of significant impact to the riparian zone, or the channel along the stretch then this category may be assigned a high risk score. Figure 2 outlines the percentage number of sites at High, Medium or Low risk. Locations where pressures were evident in the field which were not highlighted through the desk based assessment were also noted as stopping points. These points were not selected prior to fieldwork, they were opportunistic as the catchment drive through was taking place. The pie chart in Figure 2 indicates the percentage of stopping points also.

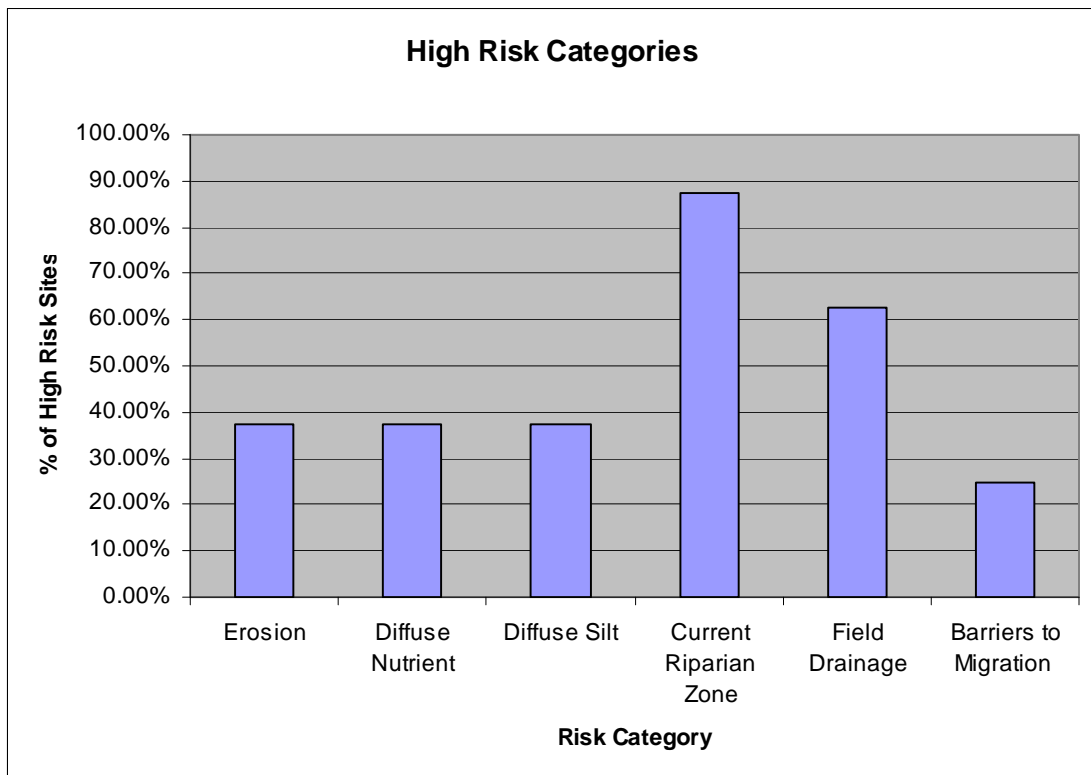
Figure 4 Breakdown of High Risk Categories

The current riparian zone category is a considerable pressure within this catchment, however this pressure generally relates to how a poor riparian zone can intensify other pressures e.g. animal trampling caused by a lack of fencing or increased diffuse nutrient as a result of an ineffective or poor buffer zone.

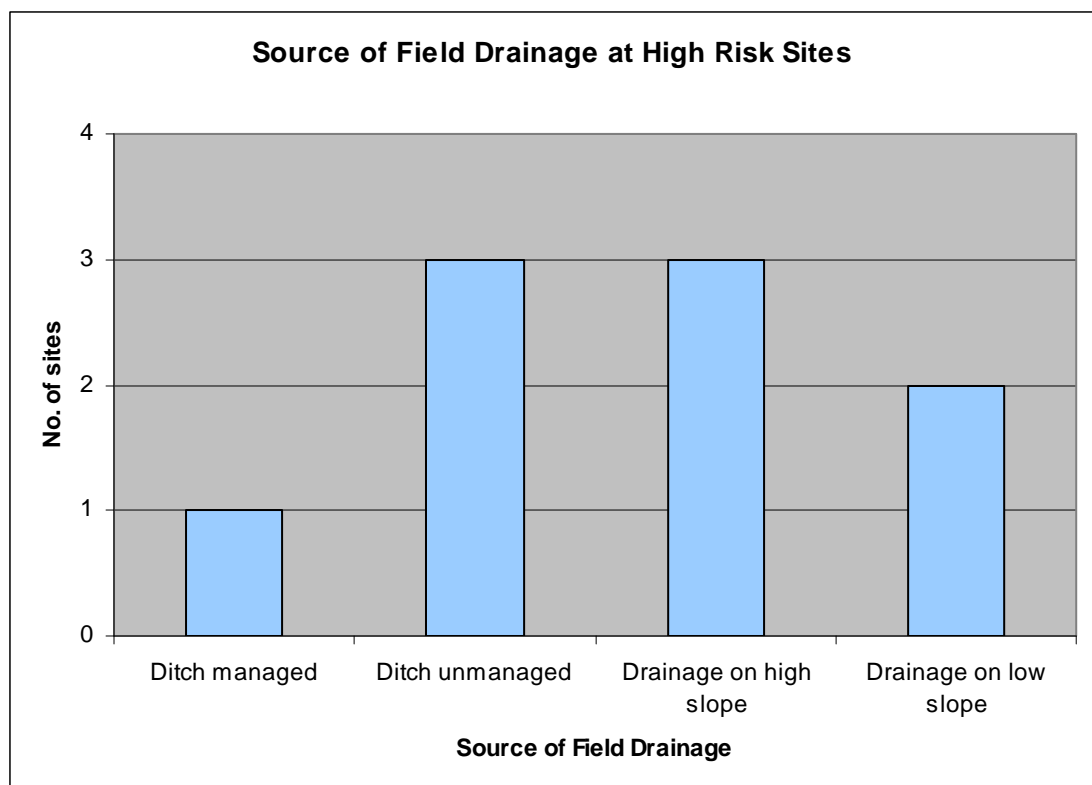
Figure 5 source of field drainage pressure at high risk sites

- A complete lack of fencing or insufficient fencing on agricultural land – within this catchment this has resulted in increased erosion from extensive animal trampling and fords, increased nutrient enrichment from animals being within and near channel, increased silt within channel as trampling causes patches of bare sediment which is washed into the river channel;
- A lack of adequate buffer or tree line in areas where the channel is within close proximity to forestry or intensive agriculture, this results in an increase in diffuse nutrient as nutrients are washed directly into the channel from agricultural land or forestry, increased levels of silt entering river as there is no buffer during forestry felling or crop harvesting.
- The most common sources of field drainage were unmanaged ditches and drainage on a high slop each creating a high risk pressure at three sites.
