**NS 2 FRESHWATER PEARL MUSSEL SUB-BASIN
MANAGEMENT PLANS**

**REPORT ON MORPHOLOGICAL MONITORING AND
CATCHMENT WALKOVER RISK ASSESSMENTS IN THE
MOUNTAIN CATCHMENT**

September 2009

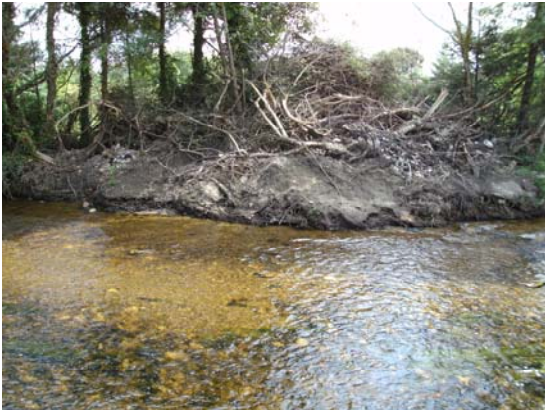
Plate 3.2 & 3.3 are sites which were surveyed as part of the catchment walkover risk assessments. These images provide an indication of the in channel clearance works, animal trampling/poaching and channel manipulation which has taken place along stretches of the Mountain.

Plate 3.2 Upstream of Borris – Scortreen River

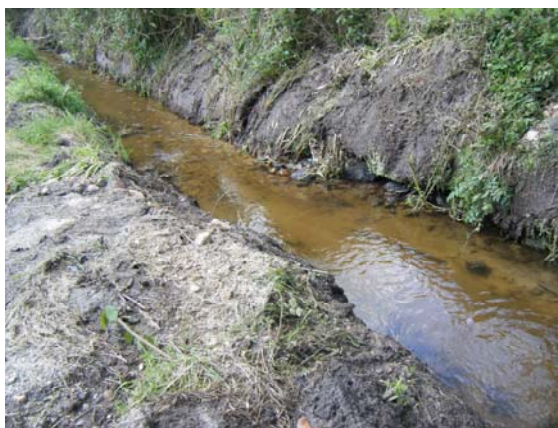
Plate 3.3 In-Channel and bank clearance works on the Glasheroge Stream

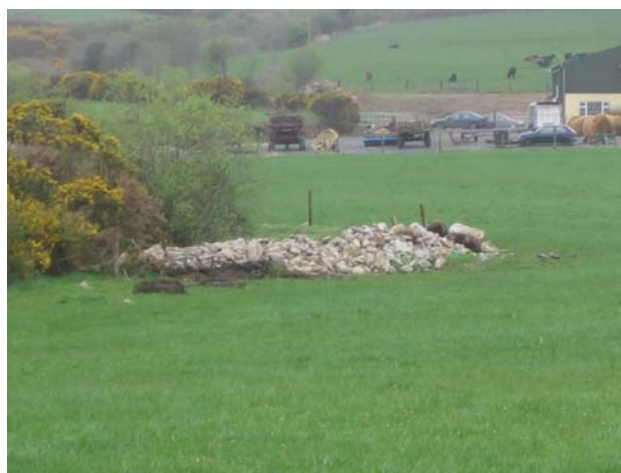
The intensive agriculture practised in some parts of the catchment coupled with the lack of a sufficient buffer strip and bank side removal works has led to increased levels of silt in the channel. This was particularly evident at site 7 (See **Figure 3.2**) in the upper reaches of the Aughnabrisky.

Plate 3.4 Site 7 Photo 10 removal of in-channel material

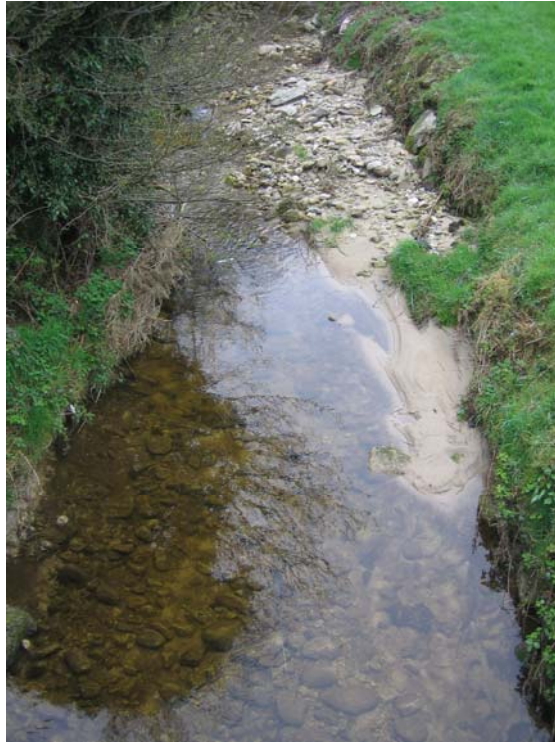
Plate 3.5 Increased levels of silt in-channel downstream of works

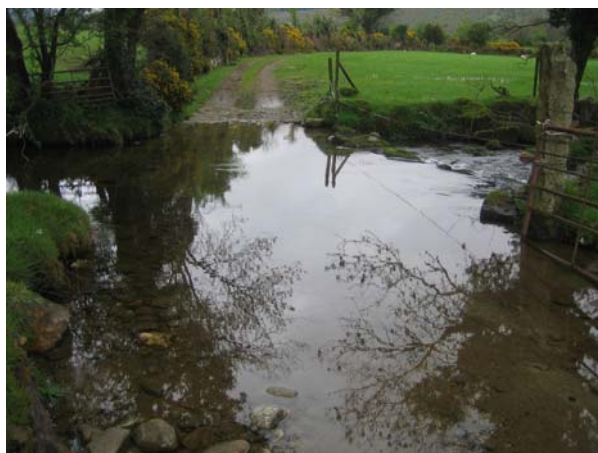
Three significant fords were observed within the catchment during the catchment walkover risk assessments. Both vehicular and animal, causing sediment loss from the vehicles/animals and the access roads, leading to excessive siltation in the river. These fords were located at site 6 and site 11 (See **Figure 3.2** above).

Plate 3.6 Most significant ford crossing in the Catchment as it is both vehicular and animal

Usage of the fords to stop immediately and alternative access also needs to be investigated.

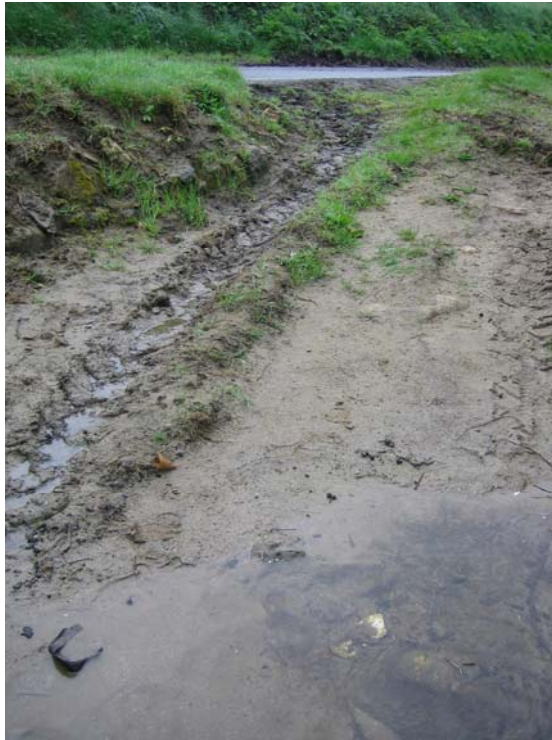
Plate 3.7 Third ford or access point to the river channel
