**An assessment into the potential impact of on-site wastewater treatment systems
on surface water quality.**

Summary Report

The National Centre for Freshwater Studies, Dundalk Institute of Technology

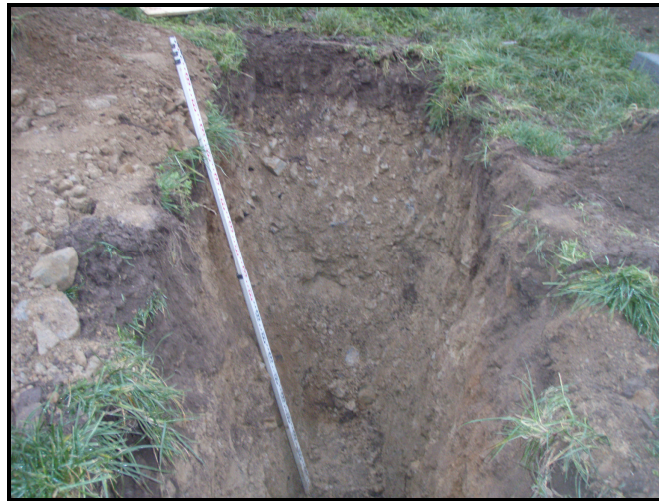
The soil sequences from the trial hole (Fig. 3) indicates that the rainwater falling in this area infiltrates through 0.55 /0.68 m of unsaturated topsoil throughout the year, and is capable of flowing through this material vertically as far as the subsoil layer. A small portion of this infiltrates, but most flows across the top of the impermeable subsoil layer as far as the stream during heavy rainfall, and during the winter months. The site is, therefore, not suitable for a conventional septic tank, but may likely be

suitable for a mechanical aeration system and discharge to ground, the 'T' values are less than 90, and the 'P' values are less than 50. At this site an average 'T' value rating >98.26 min/25 mm indicating poor percolation of the subsoil materials and a P' value rating of 24.79 min/25 mm, which would suggest good percolation characteristics of the topsoil material.

Plate 3. Trial hole, Site F. The well aerated topsoil material is visible and mottled and stiff to very stiff subsoil (photo: Robert Meehan).

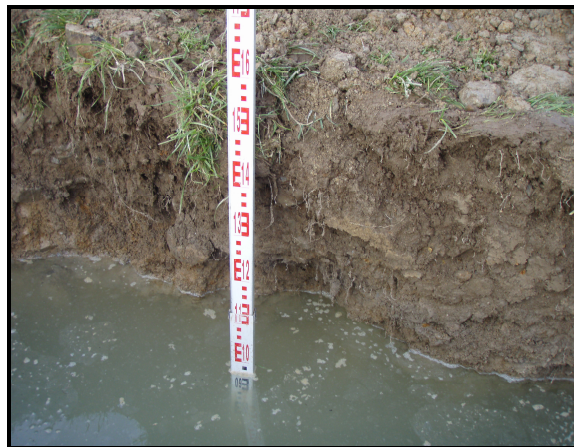
Plate 4. Trial hole, Site K. Note the mottled nature of the material above the perched water table (photo: Robert Meehan).

Examination of the trial hole (Fig. 4) indicates that the rainwater falling in this area infiltrates through only 0.14/0.15 m of unsaturated topsoil throughout the year, and is

able to flow through this material laterally on the site above the impermeable subsoil. The rainwater can infiltrate the subsoil in summer, when the material dries out, but ‘fills’ with water again in winter, when a perched water table forms. On the day of excavation the hole was dry, but water began infiltrating immediately. At this site little rainfall infiltrates to groundwater and the majority runs off the site.

The site is, therefore, not suitable for a conventional septic tank or for a mechanical aeration system as the average ‘T’ value recorded at this site was >82.06 min/25 mm. In addition a ‘P’ value rating of 50.04 min/25 mm was measured indicating poor percolation characteristics in the topsoil material. It should be noted that the soakaway on the site has been by-passed and a pipe discharges directly from the septic tank to the stream.
