**NS 2 FRESHWATER PEARL MUSSEL SUB-BASIN
MANAGEMENT PLANS**

**REPORT ON MORPHOLOGICAL MONITORING AND
CATCHMENT WALKOVER RISK ASSESSMENTS IN THE
LEANNAN CATCHMENT**

September 2009

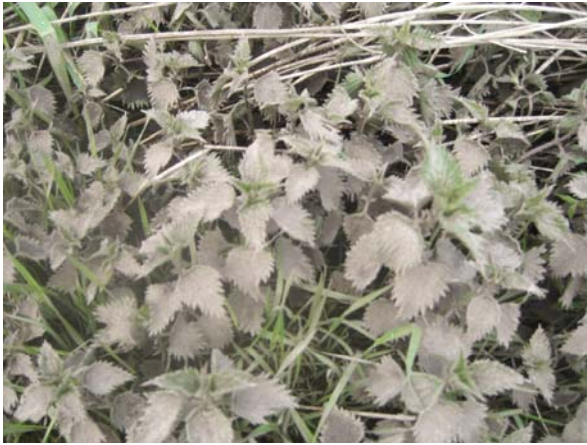
RHAT 3 – Site 3 Photo 11

RHAT number 3 which was carried out just upstream of Fern Lough was found to have large silt deposits which were left behind following recent flooding. The receding waters have left behind a film or fine silt on the bank vegetation as is evident in Site 3, Photo 11. The lowest scoring attributes on this stretch were the substrate condition, bank vegetation and riparian landcover. All other attributes scored 3 – 4. Again, resectioning and reinforcement were evident on both the left and right bank. Land drainage and site clearance work was also noted along this stretch which led to these low scores.

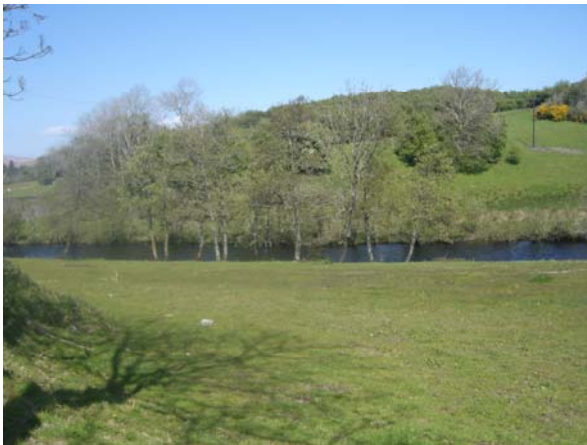
RHAT 18 – Site 18 Photo 4

RHAT number 18 was carried out just at the outlet from Gartan Lough on a stretch downstream of Gartan Bridge. Resectioning (Site 18 Photo 4) was noted on both the left and right bank together with reinforcement on the right bank. One weir was recorded (Site 18, Photo 6) and although it has altered the channel form and flow it did look passable. Again the bank structure & stability, Bank vegetation and Riparian Landcover scored lowest from the 8 attributes due to the morphological alterations along this stretch.

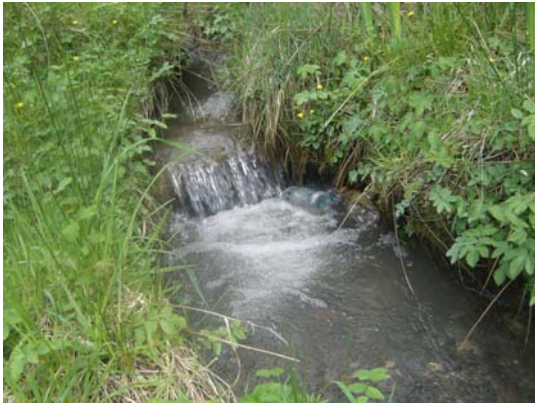
Site 9 Photo 6

Two quarries were located in the vicinity of the catchment walkover risk assessments. The first, **Barnes Limestone Quarry Ltd**, was located in the north of the catchment on a tributary of the Lurgy, An Chamabhainn near Site number 9. Slightly coloured, grey water containing suspended solids were found in the stream adjacent to the quarry. The Lurgy is an important tributary of the Leannan which contains the main pearl mussel population. Any suspended solids entering the river should be stopped immediately.

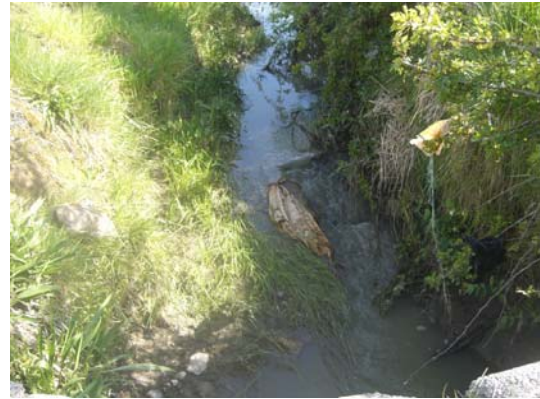
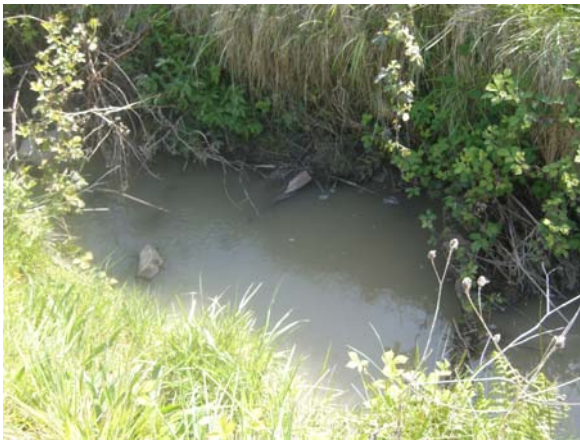
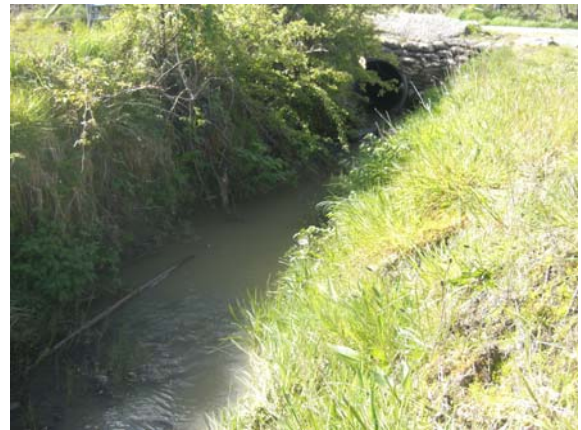
The second quarry, **Churchill Quarries Ltd**, was located just upstream of the Sruhancam which is a tributary of the Glashagh River at Site 16. In early November 2008 a serious pollution incident occurred from this quarry. This involved the release of several thousand cubic metres of Limestone slurry from the quarry into the Glashagh River which is again a tributary of the Leannan. During the 2009 survey season the small tributary which comes from the Quarry and joins the Sruhancam was found to contain grey water indicating continued release of silt from the Quarry at Site 16, Photo 3, 4, 5.
