shannon
international
river basin district

Freshwater Morphological Assessment in Rivers
Risk Assessment Refinement, Classification and Management
Outcome Report – March 2008

Freshwater Morphological Assessment in Rivers Risk Assessment Refinement, Classification and Management Outcome Report – March 2008

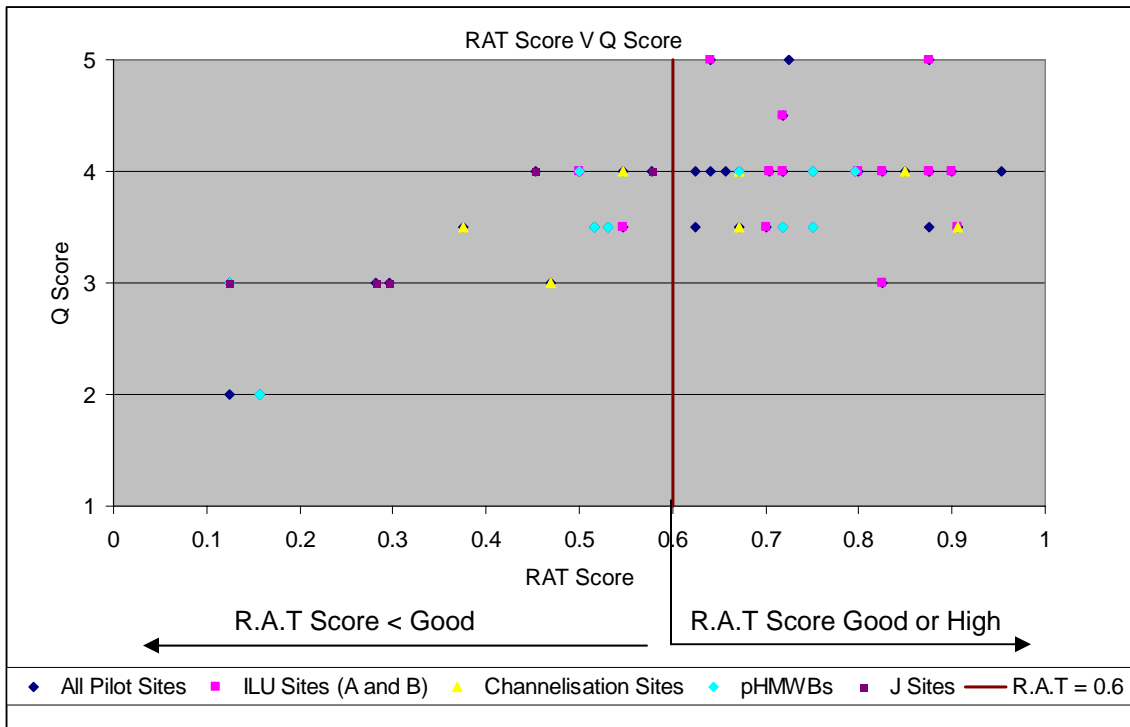
Figure 3: R.A.T Scores and Corresponding Q Scores – All Pilot Waterbodies (Ireland) (Refer to Table 4 for Waterbody Categories)

Figure 3 shows the corresponding Q Score (1 – 5) against R.A.T score for each of the Pilot Waterbodies surveyed in Ireland.

In general, an upward trend of increasing Q Score with R.A.T score is evident. Sites with R.A.T scores less than 0.6 (i.e. less than good status) generally have biological Q scores less than 4 (less than good status in terms of macroinvertebrates) as per Figure 1. Whilst there is a low correlation, it can be demonstrated that a R.A.T score lower than 0.6 is more likely to impact Q score.

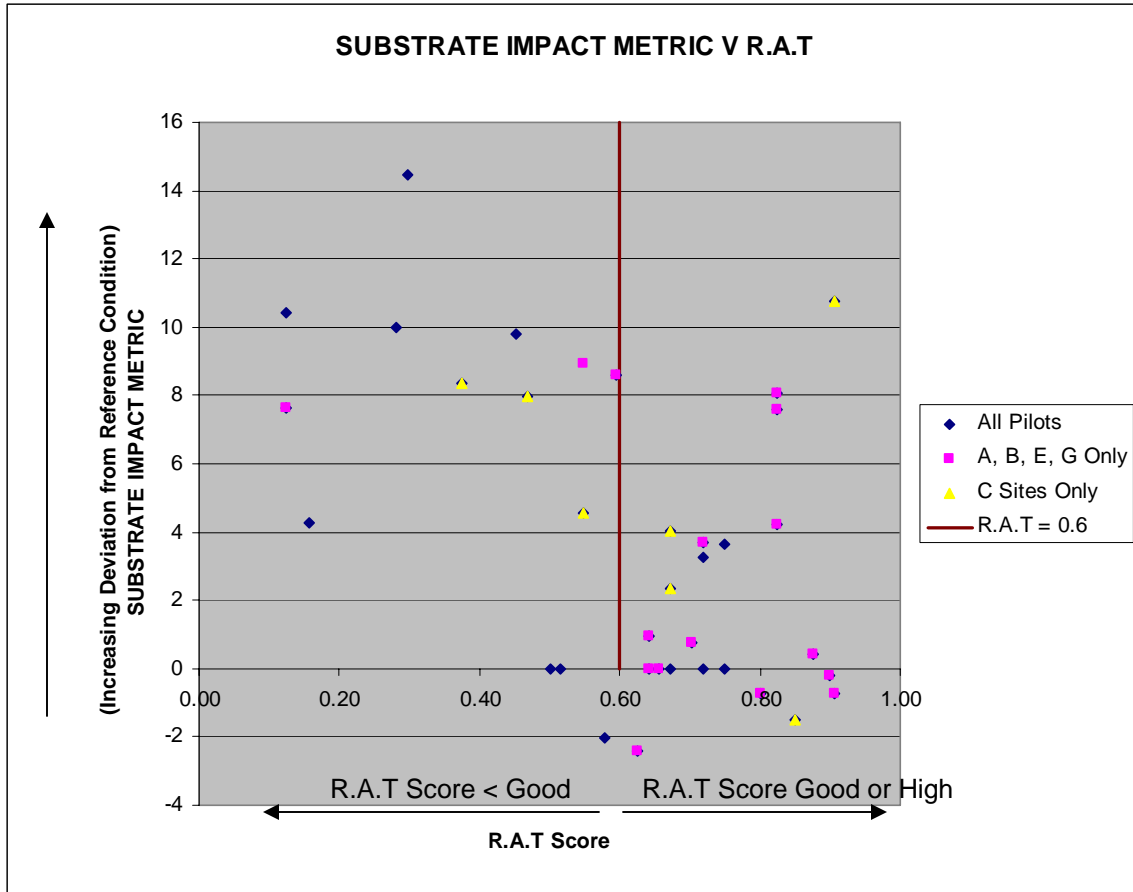
Figure 5: R.A.T Score Against Substrate Impact Metric

In general, sites with high Substrate Impact metrics have low R.A.T scores. The majority of sites with Substrate Impact Metrics greater than 5 have R.A.T scores less than 0.6 (less than good morphology status).

A subset of the relevant Pilot Waterbodies (Categories A, B, E and G, refer to Table 4) sites are highlighted in pink. These sites are subject to intensive land use pressures in isolation or were found to deviate from reference condition due to these pressures under separate research. The R.A.T score for these sites drops below 0.6 when the substrate impact metric is greater than 8.0.

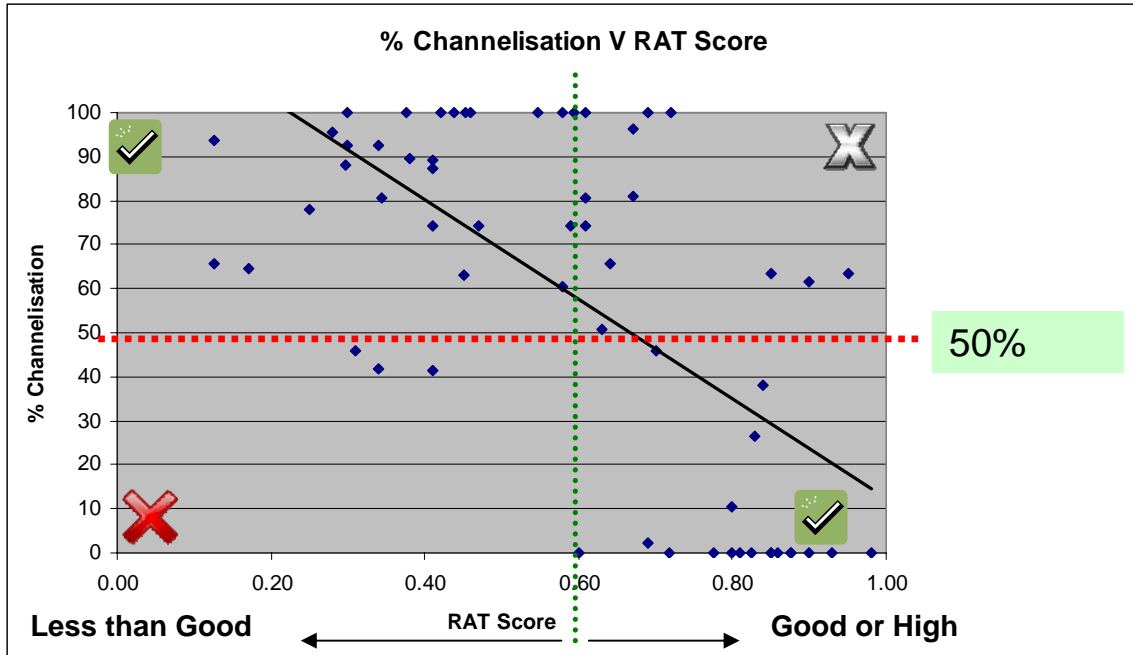
Figure 6e: 50% ILU threshold

Figure 6e applies a 50% threshold to the matrix.

42% of sites with greater than 50% channelisation have a R.A.T score of less than 0.6 (i.e. less than good). 29% of sites with less than 50% channelisation have R.A.T scores greater than 0.6. Therefore in total 71% of sites are classified correctly using the 50% threshold for channelisation.

It is recommended that the 15% threshold between good and less than good status is increased to 50%.

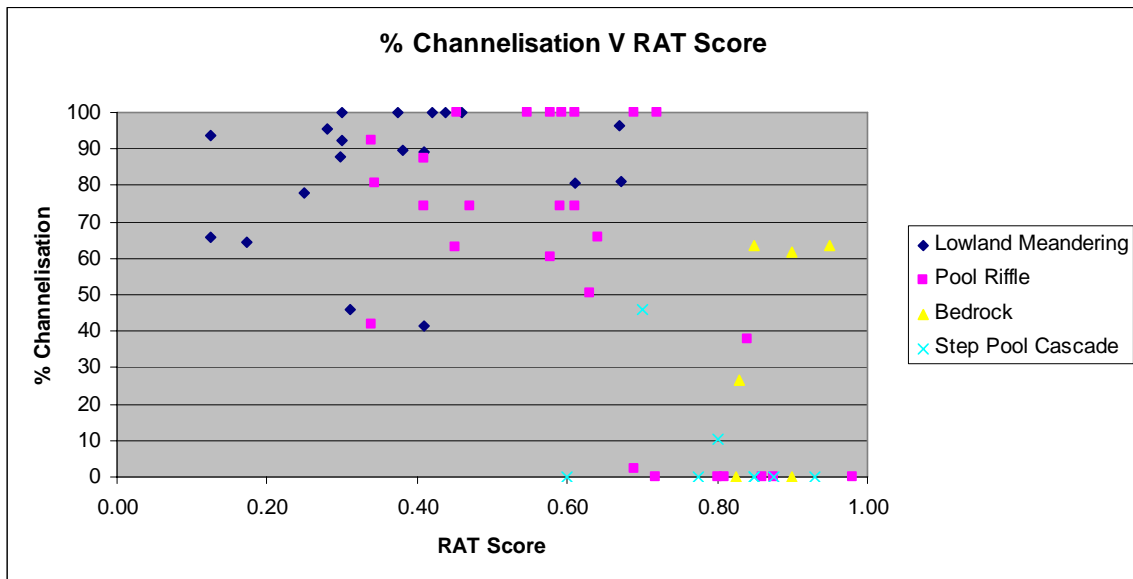
Figure 6f: % Channelisation against R.A.T Score According to Channel Type

Figure 6c indicates that upland rivers (i.e. bedrock and step-pool cascade) are less susceptible to channelisation pressures and tend to have high R.A.T scores (greater than 0.8).

The majority of rivers with high percentages of channelisation and R.A.T scores below 0.6 are lowland meandering and pool riffle. These rivers are more susceptible to the pressure, in particular lowland meandering. Whilst it could be argued that a higher threshold between good status and less than good status could be applied to upland rivers it is recommended that 50% is applied throughout since the majority of rivers subjected to drainage are lowland meandering and pool riffle.

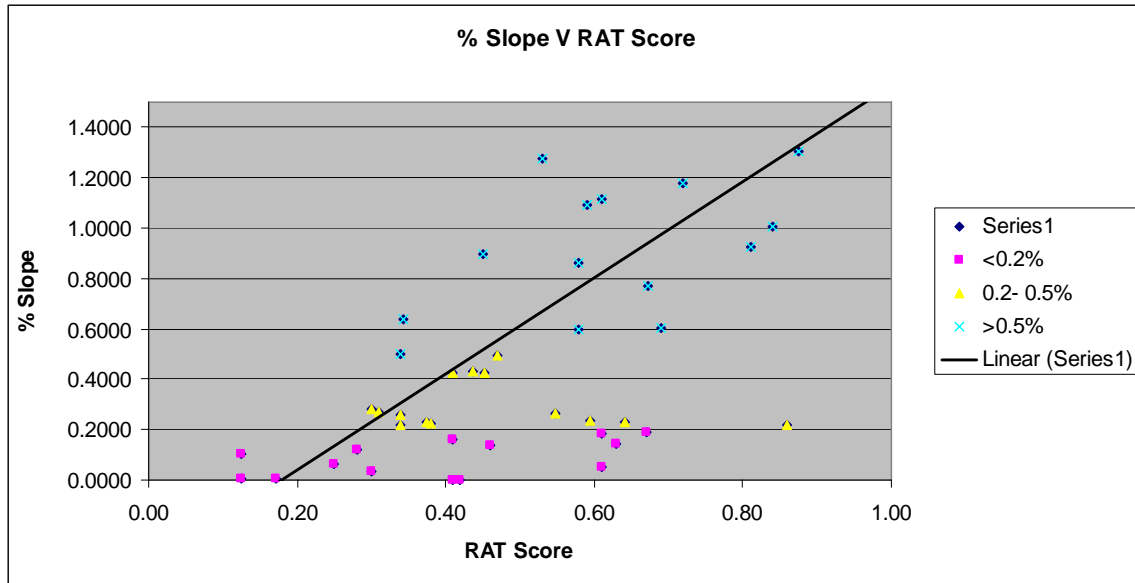
Figure 6h: % Slope against R.A.T Score per Site

OPW advised that since the R.A.T system scores morphology based on deviation from reference condition, then it must be recognized that very low gradient rivers have should have lower expectations in terms of the morphological attributes and their reference condition. This is further illustrated by plotting channel slope against R.A.T score as per Figure 6h.

Again, it is clear that the lowest gradient rivers (<0.2%) generally score a WFD class (Hydromorph score of 0.2) behind lowland meandering rivers within the 0.2-0.5% slope category.

Since R.A.T is the chosen surveillance monitoring method for EPA and EHS it is recommended that this is accounted for in the survey i.e. very low gradient rivers should be scored accordingly, by noting that the reference condition for these rivers is naturally less than higher slope rivers.

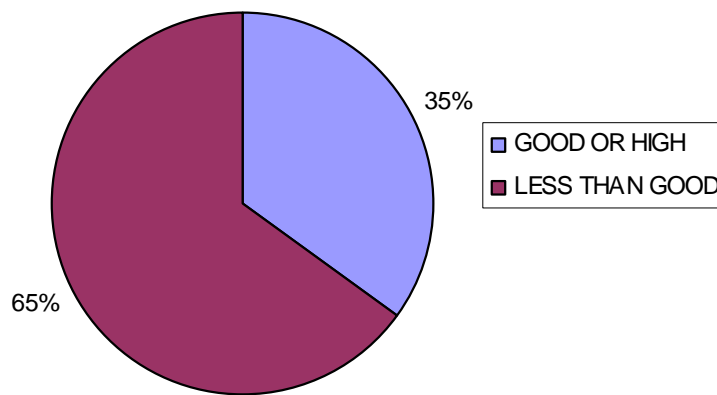
Maintenance records for the survey sites subject to channelisation were sought from the Office of Public Works (OPW) in Ireland and DARD Rivers Agency in NI. Figures 7 and 8 illustrate the percentages of sites (*for which records were available*) that had good or less than good R.A.T scores.

Figure 7: Percentage of Maintained Rivers with Good or Less than Good R.A.T Scores

Figure 8: Percentage of Non Maintained Rivers with Good or Less than Good R.A.T Scores

65% of maintained rivers surveyed in RoI and NI have a R.A.T score lower than 0.6 (i.e. less than good).

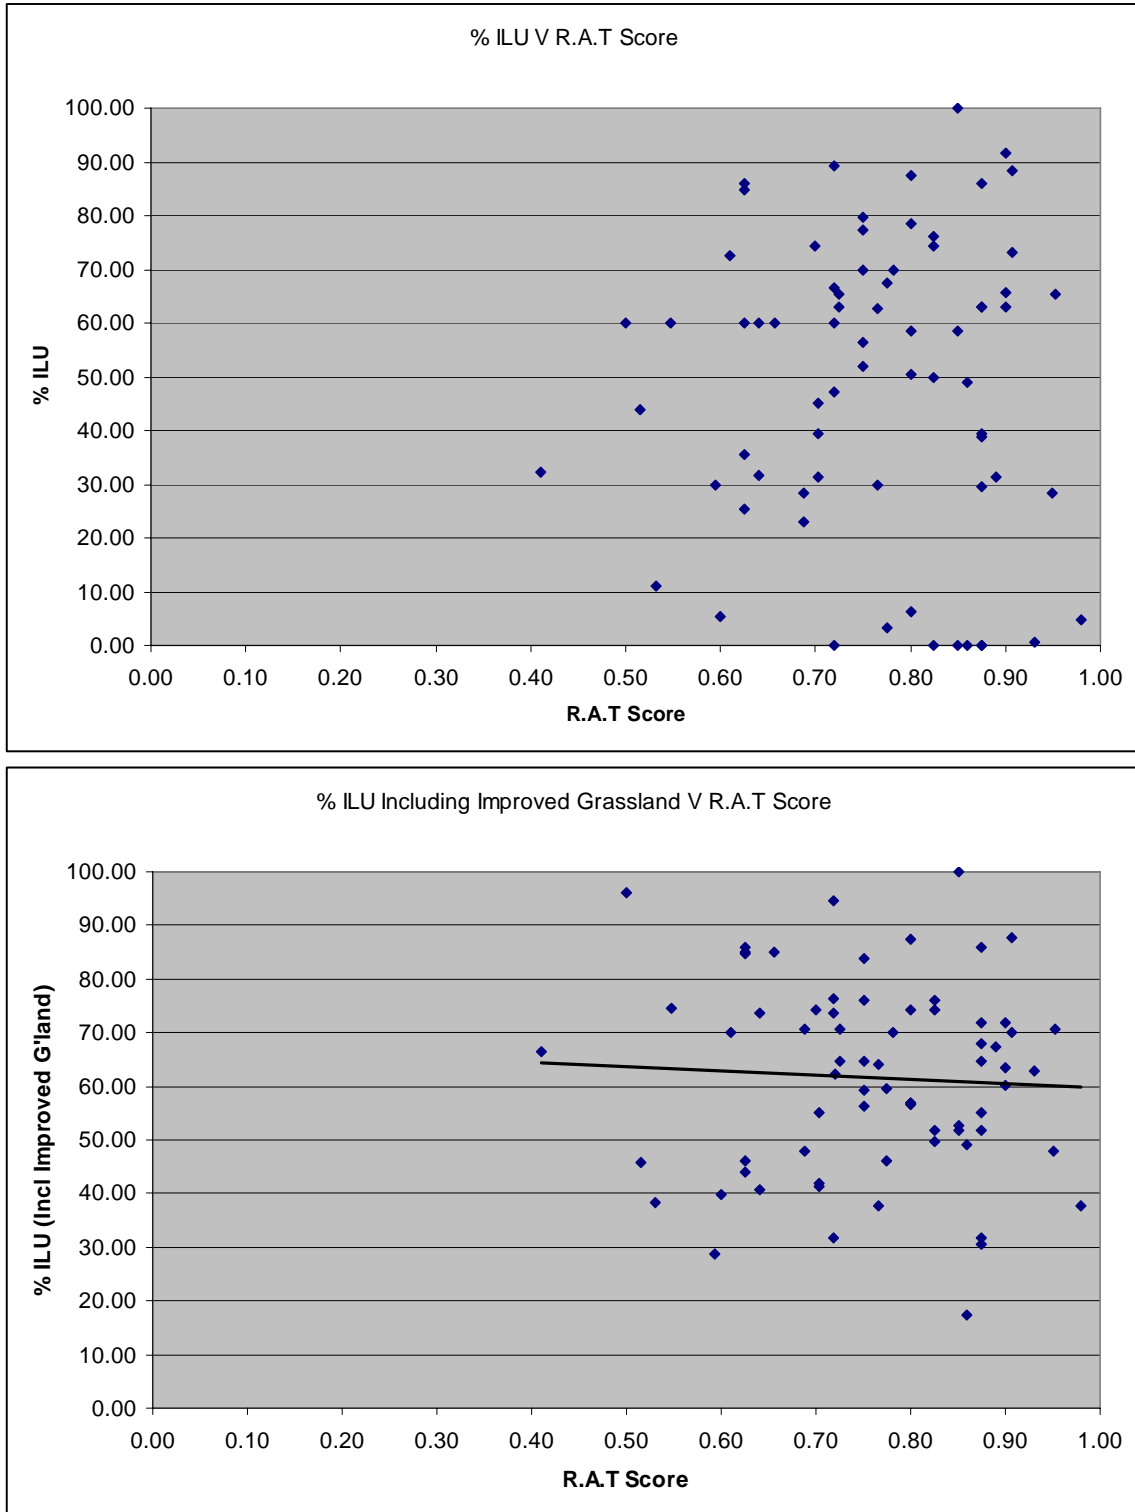
Figure 10: Comparison of Graphical Relationships when Improved Grassland is included as an ILU Category (Top graph excluding Improved Grassland, bottom graph including Improved Grassland).

Figure 10 overleaf is a graphical comparison of pilot sites indicating % ILU against R.A.T score excluding and including improved grassland. The top graph represents % ILU as per Figure 9 (excluding improved grassland), the bottom graph represents % ILU including Improved Grassland as a land use category.

Whilst a weak correlation, there is an improved relationship between % ILU and R.A.T score when improved grassland is included as an ILU category. Table 7 highlights the improved relationship by outlining the difference in range of % ILU above and below a R.A.T score of 0.6.

There is an improved relationship between % ILU and R.A.T score when Improved Grassland is included. It is recommended that Improved Grassland is included in the refined ILU risk assessment.

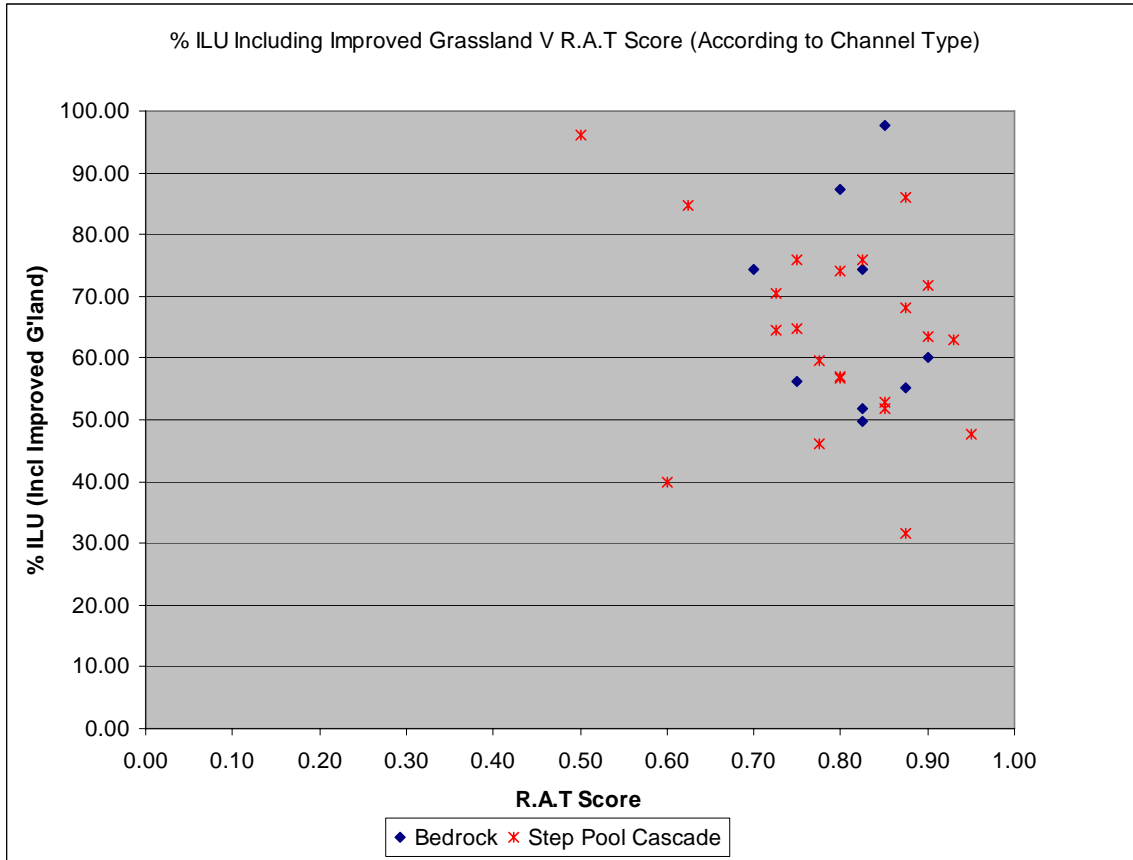
Figure 11a – % ILU V R.A.T Score – Bedrock and Step Pool Cascade Channels

Bedrock and Step Pool Cascade – An inverse correlation between % ILU and R.A.T score is evident but only 2 sites have a R.A.T score of 0.6 or less. Upland rivers tend to have good R.A.T scores regardless of % ILU. This suggests that upland rivers are less sensitive to ILU pressures or that ILU within a catchment causes impact further downstream in the system.

In comparing Figure 11a to Figure 10 bedrock and step-pool-cascade rivers remain largely unchanged in terms of % ILU when improved grassland is included as an ILU type. This is because improved grassland is more prevalent in lowland rivers. As a consequence, it is more likely to cause direct morphological impact (e.g. cattle poaching and removal of riparian zones to maximize the extent of available pasture).

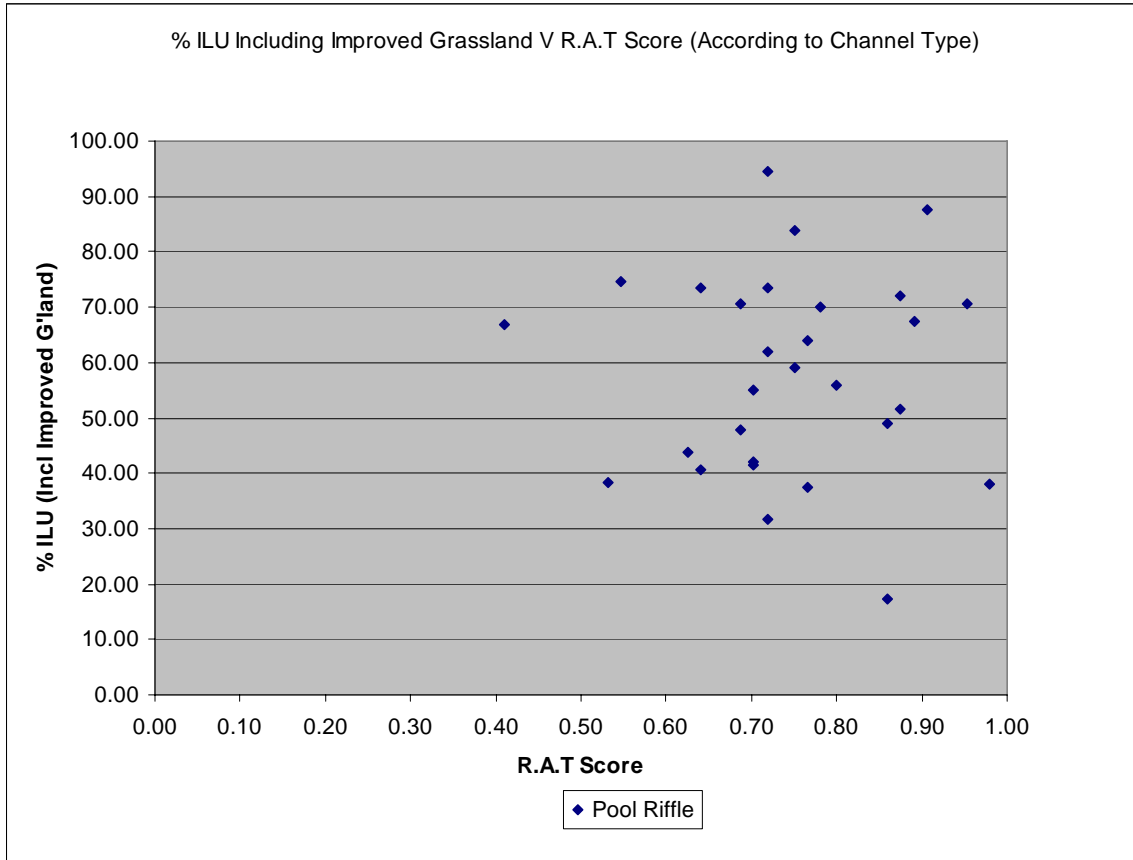
Figure 11b – % ILU V R.A.T Score – Pool Riffle Channels

Pool Riffle - The range of % ILU at sites with R.A.T < 0.6 is 38% to 75%.

A relationship for pool riffle channels is not evident. A risk assessment threshold must be applied that optimises the number of sites assigned correctly in terms of risk (refer to Section 2.5.5).

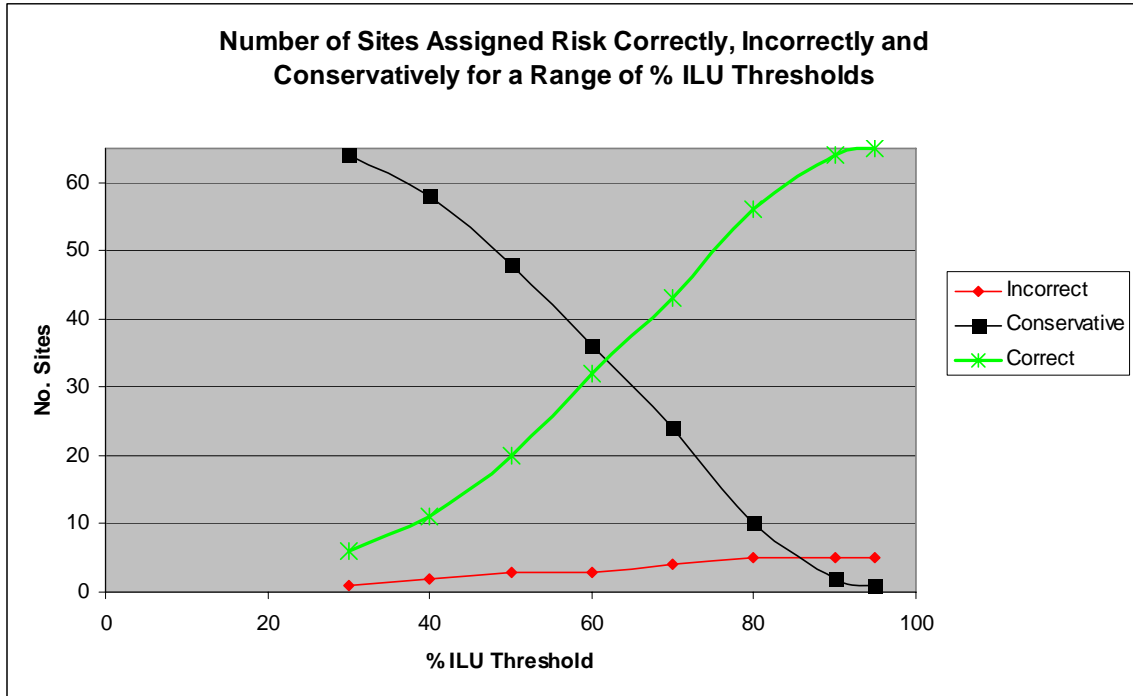
Figure 15: No. Sites Assigned Risk Correctly, Incorrectly and Conservatively for a Range of % ILU Thresholds

Figure 15 presents the data in Table 9 in graphical format.

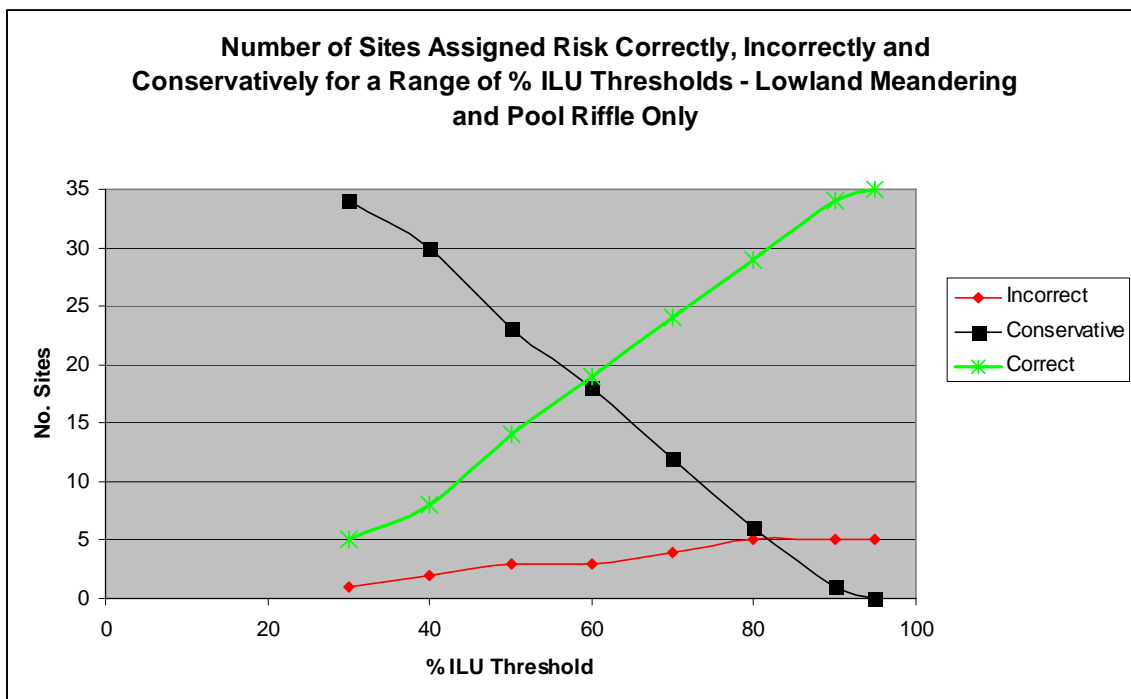
Figure 16: No. Sites Assigned Risk Correctly, Incorrectly and Conservatively for a Range of % ILU Thresholds (Lowland Meandering and Pool Riffle Only)

Figure 16 presents this data in graphical format.

Similarly, based on the results, the ILU percentage could increase beyond 70%.

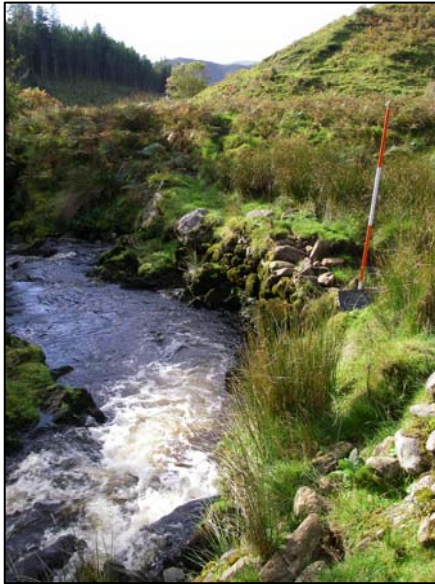
Site G4: Goulaun River

Sites G3 and G4 were surveyed using R.A.T, Q and CBAS. Site G3 is the Goulaun River at the upstream end of the catchment. Site G4 is the Srahmore River at the downstream end of the catchment just upstream of Lough Feeagh.

The Srahmore Catchment is a well researched catchment in Ireland and is known for the current intensive forestry pressures and sheep overgrazing in the past. The deterioration in R.A.T score between the sites is a reflection of the loss of naturalness in the catchment as one moves downstream, although both scores are high or good. However both sites have Q Scores of 4. The Substrate Impact Metric (CBAS) increases from low to high between the sites indicating that the intensive land use between the upstream and downstream site is impacting the siltation regime of the river system.

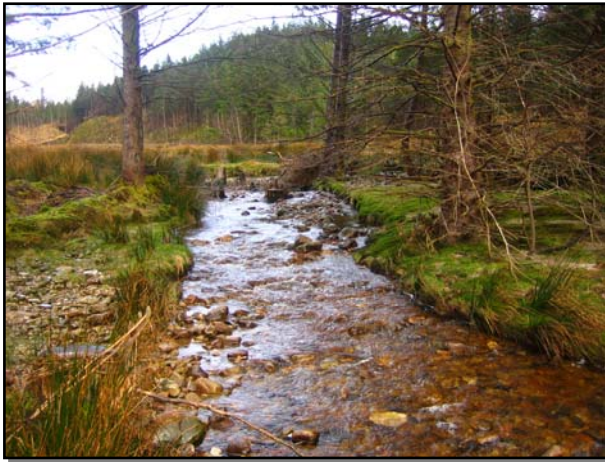
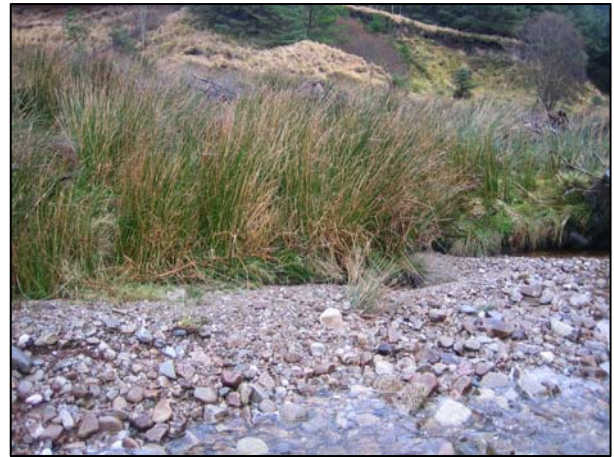
However, the field visit highlighted that there are sites within the catchment that are more accurate reflectors of the morphological pressure and would have lower R.A.T scores if surveyed. Photographs of areas in the catchment where morphological impact from forestry is more prevalent are provided below.

Excessive Siltation and Erosion in Upland Streams Downstream or Adjacent to Forested Areas (Srahmore Catchment)
