**NS 2 FRESHWATER PEARL MUSSEL SUB-BASIN  
MANAGEMENT PLANS**

**REPORT ON MORPHOLOGICAL MONITORING AND  
CATCHMENT WALKOVER RISK ASSESSMENTS IN THE  
BUNDORRAGHA CATCHMENT**

**September 2009**

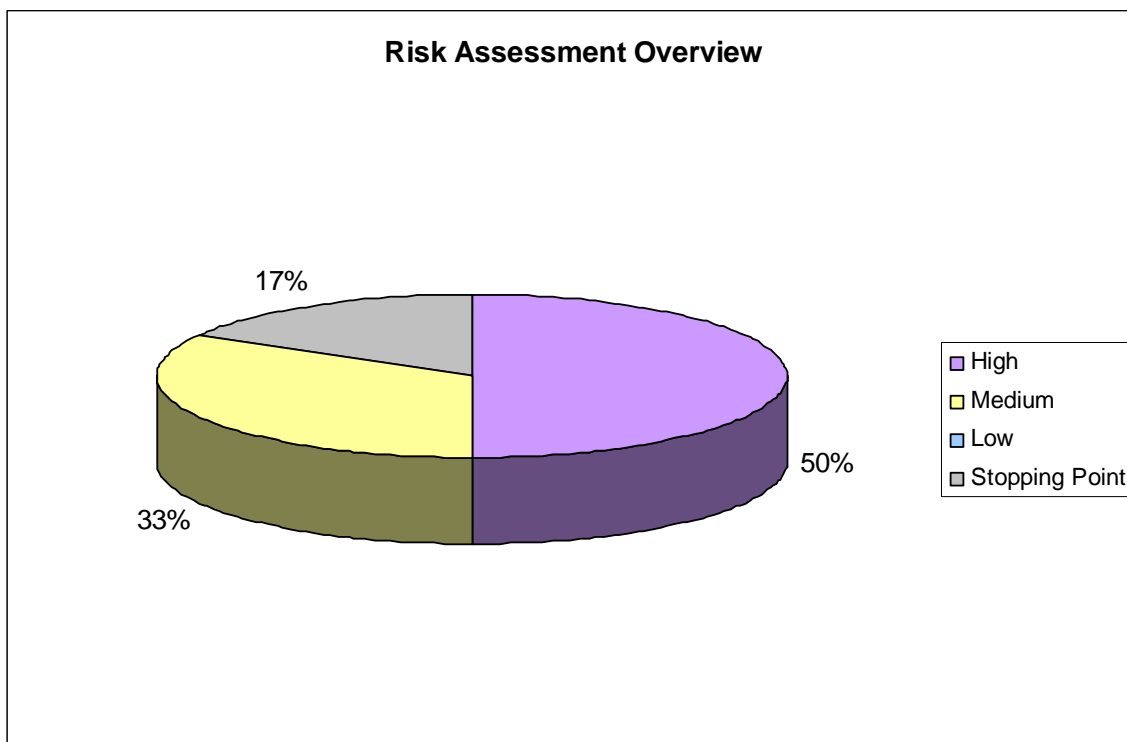
**Figure 3. Risk Assessment Overview**

Where one or any of these aspects is found to be the cause of significant impact to the riparian zone, or the channel along the stretch then this category may be assigned a high risk score. **Figure 2** outlines the percentage number of sites at High, Medium or Low risk. Locations where pressures were evident in the field which were not highlighted through the desk based assessment were also noted as stopping points. These points were not selected prior to fieldwork, they were opportunistic as the catchment drive through was taking place. The pie chart in **Figure 3** indicates the percentage of stopping points also.

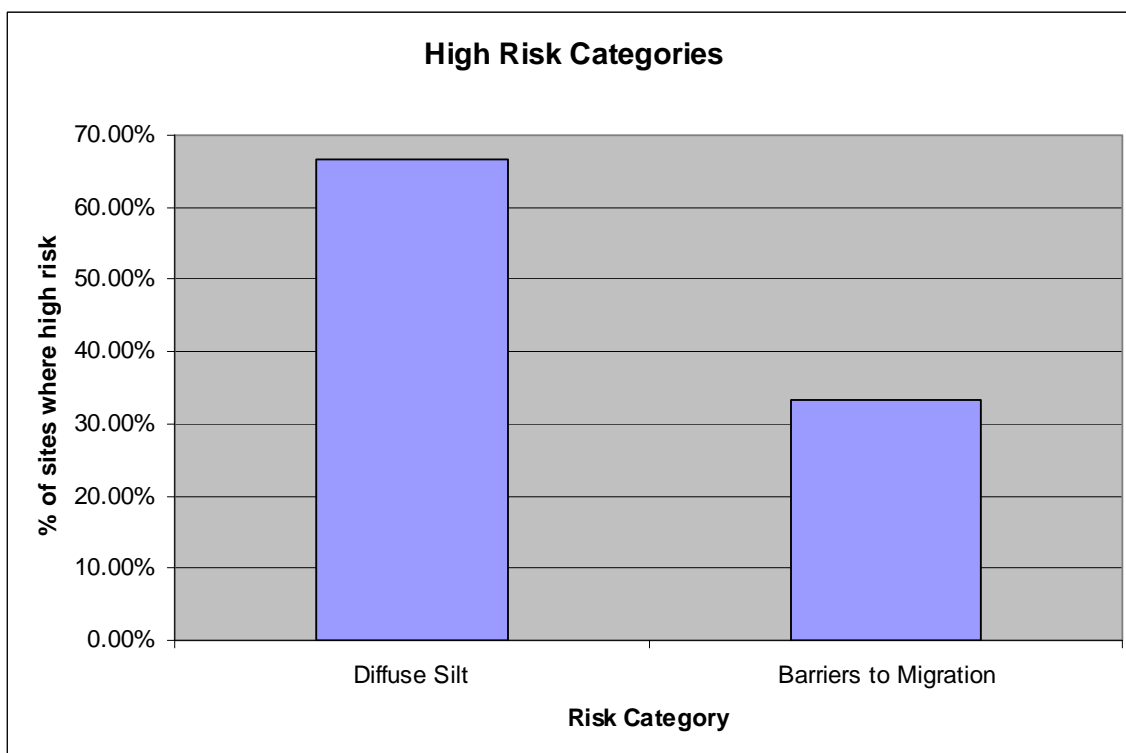
**Figure 4 Breakdown of High Risk Categories**

- Diffuse Silt – at 67% of high risk sites,
- Barriers to Migration –at 33% of high risk sites.

The break-down of high risk categories leading to a high risk site are shown below, as can be seen diffuse silt and barriers to migration were the only high risk categories recorded:

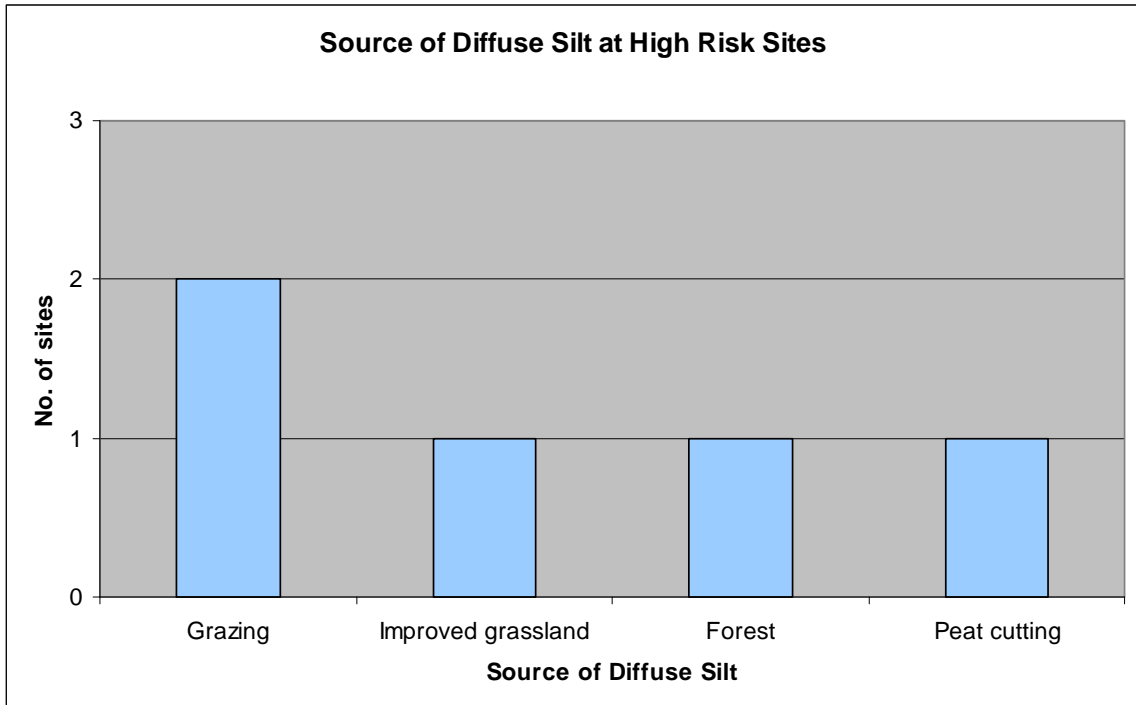
**Figure 5 Sources of Diffuse Silt at High Risk Sites**

The most common source of diffuse silt is grazing which caused a high risk classification at two sites, the remaining high risk sources of diffuse silt are shown below:

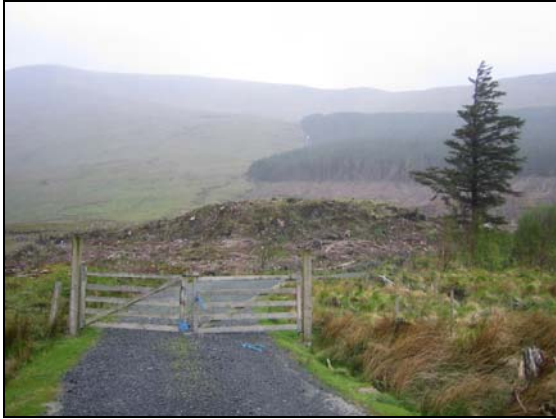
**Site 5 Photo 1**

Forest stands in the Bunndorrogha Catchment are located in two pockets, in the upper part of the Glenummera river, which flows into Doo Lough (Coillte forest stands) and to the west on the Owennaglogh river a tributary of the Bunndorrogha river (private forest stands). During the catchment walkover risk assessment at Site 5 high levels of silt were recorded within the Glenummera river. Felling and replanting were noted within the Glenummera valley.

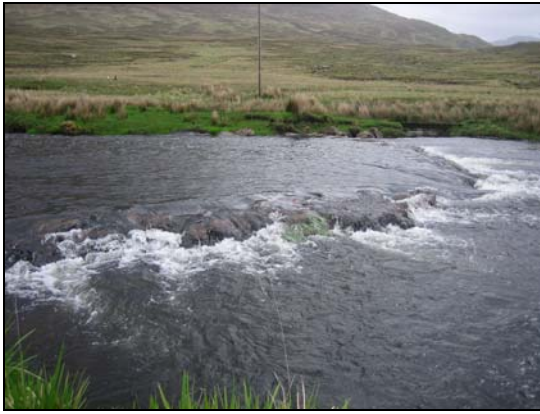
Site 1 Photo 12

A significant number of weirs were recorded along the Bundorragha river during both the RHAT morphology surveys and the catchment walkover risk assessments. Several V-notch stones weirs were recorded along the survey stretch which was found to alter the flow of the channel and have lead to the build up of silt within the pools and interstices. Generally weirs are constructed at least seven channel widths in distance apart except in high gradients, the weirs found on the Bundorragha were separated at equal distances which verifies their use as fishery weirs. The river has nineteen named pools, some of which were created by the building of these stone weirs in the 1860s. Delphi Fishery is a private fishery which consists of the Bundorragha River, and two large lakes draining the Delphi Valley – Finlough and Doolough.

Short term impacts during construction of these in stream structures include increased siltation. Longer term damage to mussel habitat can be caused by erosion and ponding below the structures due to scour.

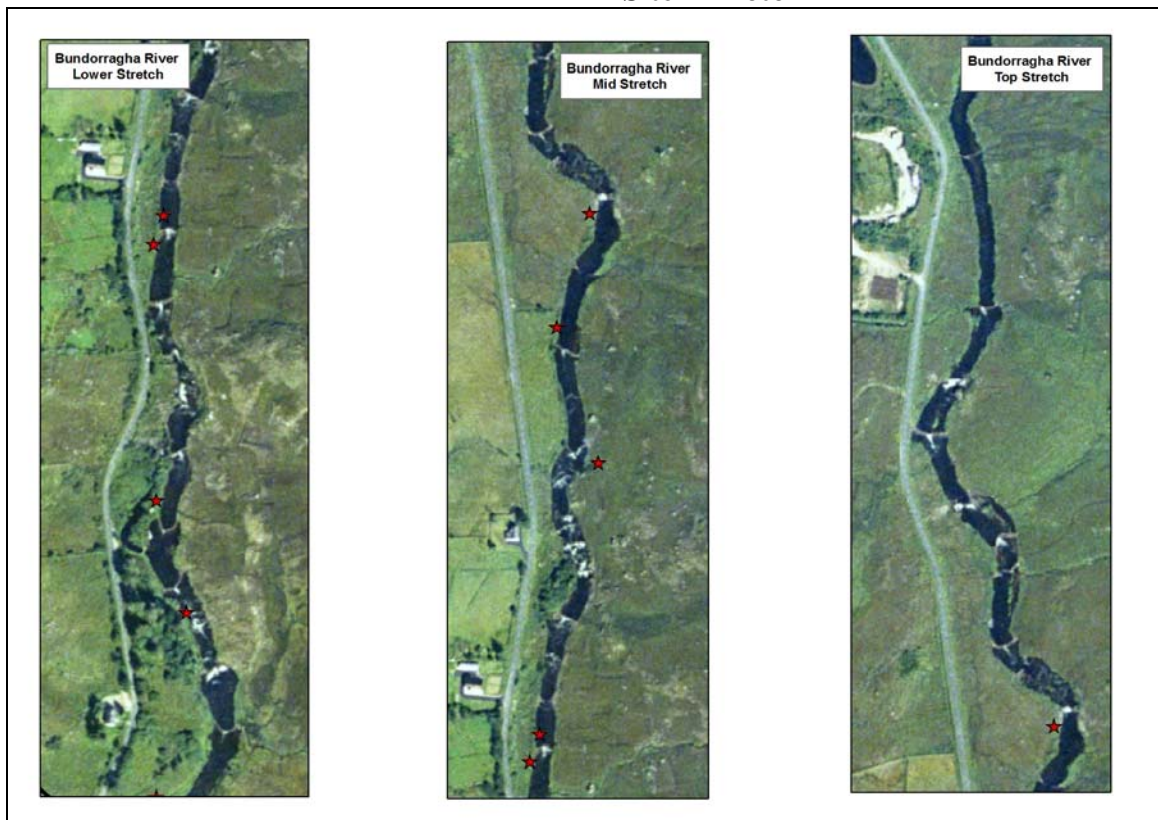
**Figure 6 Series of Fishery Weirs along the Bundorragha River which contain Freshwater Pearl Mussel Populations**

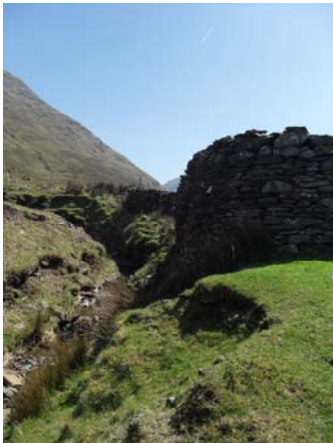
**Stopping point 1 Photo 1**

The sheep dipping units found in the Bundorragha catchment consist largely of stone structures adjacent to rivers or lakes. This is indicated in the pictures below from Stopping point one, the sheep dipping unit which is located on the eastern shore of Doolough Lake.

The sheep dipping facilities located in the Bundorragha are within the SAC boundary. The SAC Farm plan guidelines should be applied in these areas where Sheep dipping facilities should generally not be sited within target areas and spent sheep dip must not be spread on target area. Sheep dipping facilities and disposal of spent sheep dip must respect GFP and/or relevant legislation.

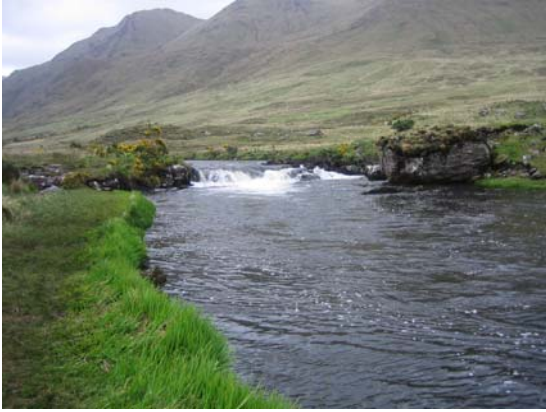
**Site 2 Photo 1**

While no activities were taking place during the period in which our morphology field surveys took place, excessive bank side trampling was noted along the lower stretch of the Bundorragha river from fisheries access. It has also been noted through consultation with the WRBD Technical Conservation Committee that Kayaking is operated along the lower stretch of the Bundorragha River. Further discussions with Galway Kayak Club confirmed that through an agreement with Delphi Fisheries, kayaking does take place along the Bundorragha River in the months outside of the fishing season which covers from 17<sup>th</sup> of October to the 1<sup>st</sup> of February when the river is in spate. Kayakers gain access across the road from the Delphi Adventure Centre and exit just above the road bridge at 84146 263387.
