**NS 2 FRESHWATER PEARL MUSSEL SUB-BASIN  
MANAGEMENT PLANS**

**REPORT ON MORPHOLOGICAL MONITORING AND  
CATCHMENT WALKOVER RISK ASSESSMENTS IN THE  
OWENMORE CATCHMENT**

**September 2009**

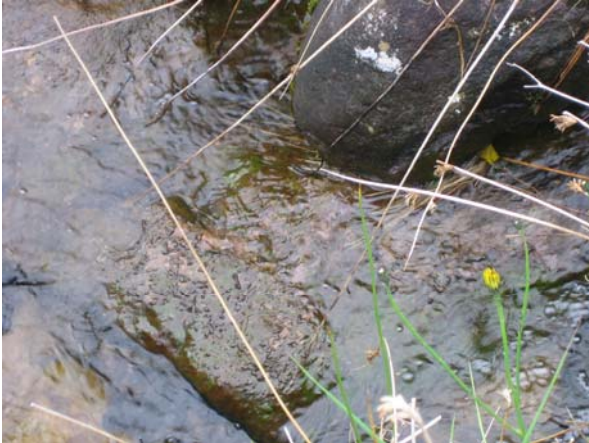
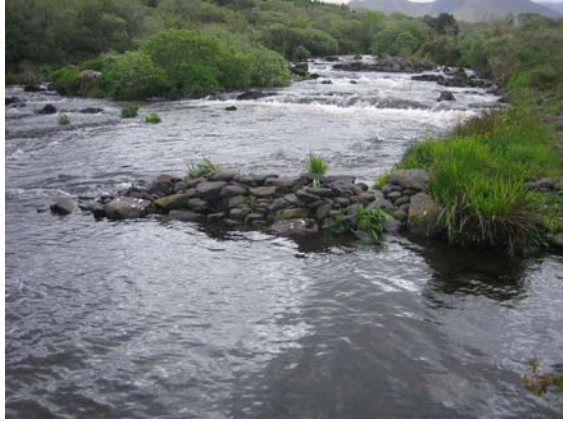
Two RHAT surveys were carried out throughout the Owenmore catchment. The results of these surveys can be found in the electronic appendix. One was deemed to be at high status in the lower reaches of the catchment at Boherboy where as the survey stretch at the upper end of the catchment was at good status. RHAT number 1 scored well on all attributes except for barriers to continuity which scored two out of four. Filmenteous algae were recorded on some of the cobbles and boulders within the survey stretch. A number of stone weirs and deflectors were also found along the survey stretch. The Owenmore fishery is operated along this stretch, an embankment runs along a considerable length of the survey stretch on the left bank. Overall this stretch was classified as being at good status. Dead mussels were also found along the banks of this survey stretch. Gunnera was recorded on the left bank which may be a sign of previous

disturbance along the bank. The inflowing tributary on the right bank upstream of the bridge had some fine silts contained in it also.

<p><b>RHAT 1 Site 1 Photo 11</b></p>

<p><b>RHAT 1 Site 1 Photo 9</b></p>

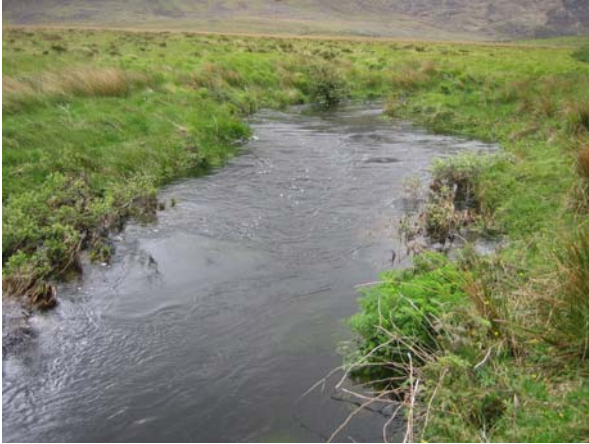
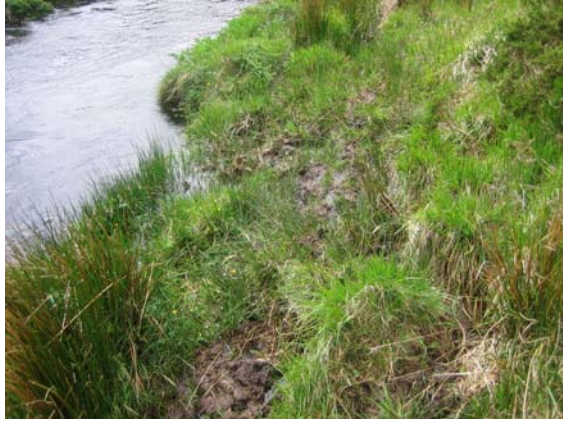
RHAT number 3 was carried out on the Cloghan River. This is a lowland meandering channel which is surrounding by areas of peat. This is largely a remote channel with no physical modifications to the river stretch. Two attributes were downgraded – channel vegetation and substrate condition. This is due to the presence of macrophytes in greater than expected quantities for a channel of this type indicating the presence of silt and perhaps nutrients in channel to allow the macrophytes to flourish.

<p><b>RHAT 3 Site 3 Photo 1</b></p>

<p><b>RHAT 3 Site 3 Photo 3</b></p>

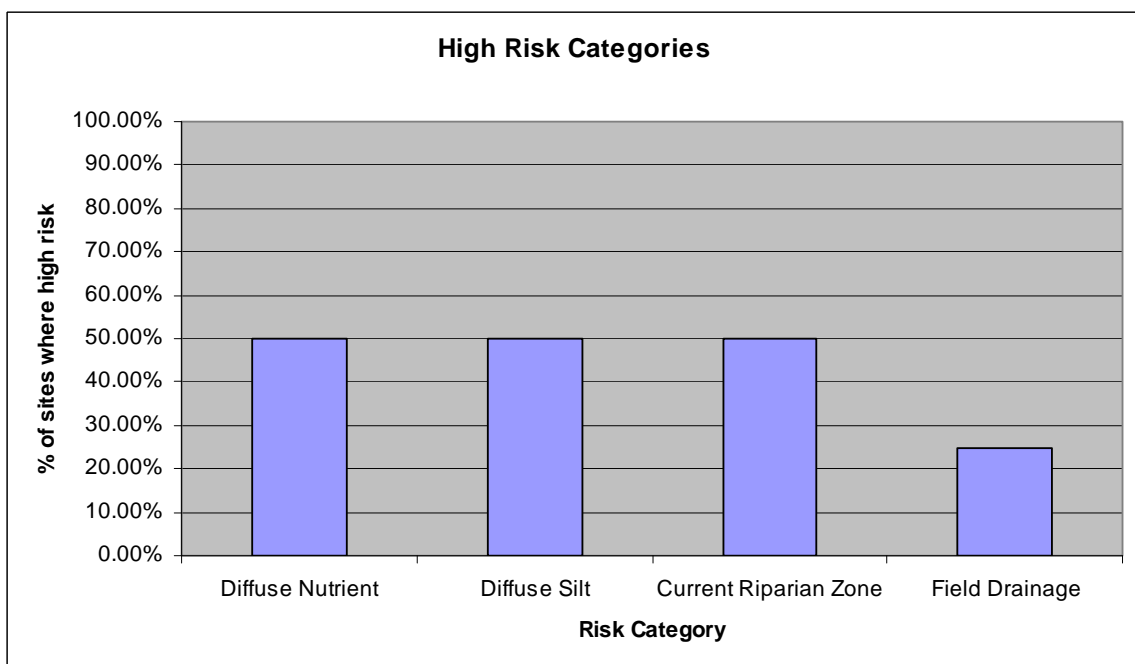
**Figure 3.4 Breakdown of High Risk Categories**

The most common high risk categories identified were:

- Diffuse Silt – at 50% of high risk sites.
- Diffuse Nutrient – at 50% of high risk sites,
- Current Riparian Zone – at 50% of high risk sites,

The break-down of pressure categories identified as high risk are outlined in **Figure 3.4**

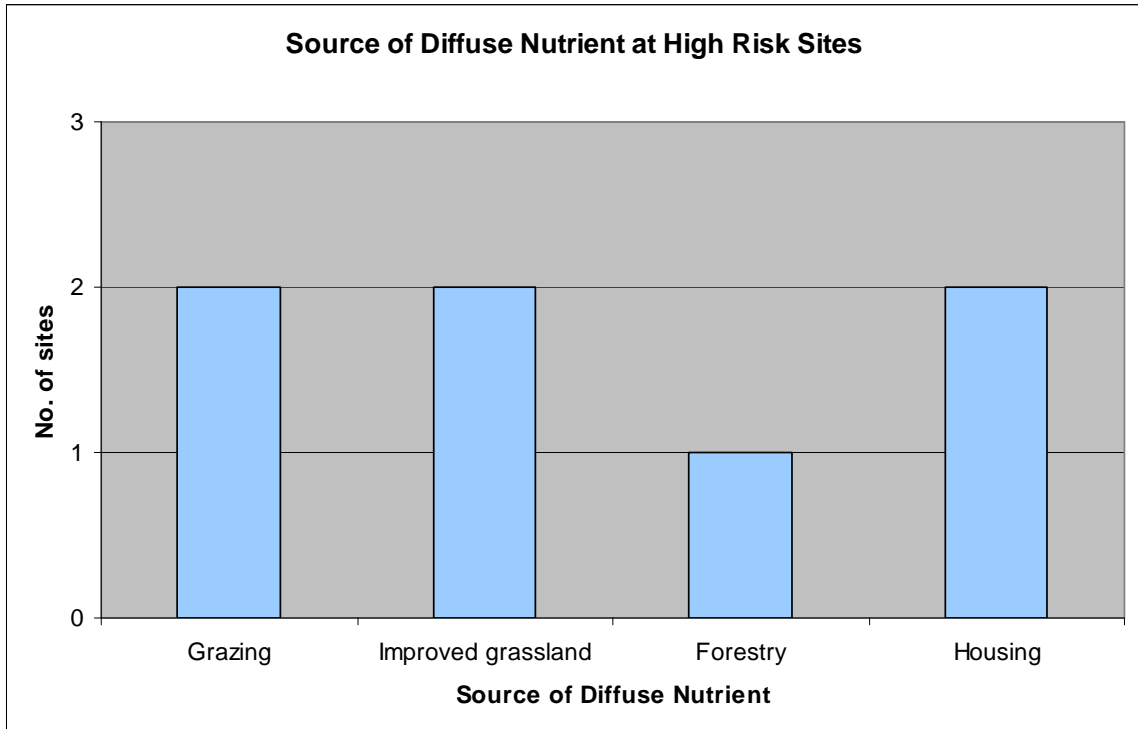
**Figure 3.5 Sources of Diffuse Nutrient at High Risk Sites**

The most common sources of diffuse nutrient at high risk sites were grazing, improved grassland and housing. The additional high risk diffuse nutrient categories can be seen below in **Figure 3.5**.

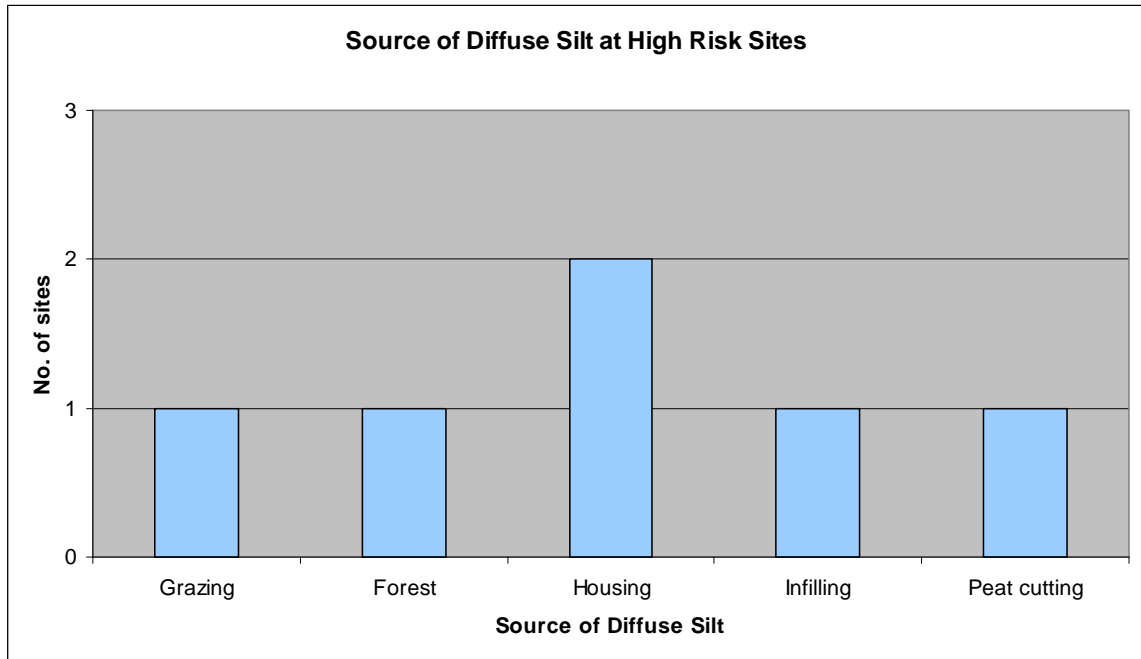
**Figure 3.6 Sources of Diffuse Silt at High Risk Sites**

The most common source of diffuse silt was housing which was evident at both sites high risk for diffuse silt. Other sources of diffuse silt evident at high risk sites are outlined below in **Figure 3.6**.
