## Summary: Awbeg (Buttevant)(West) Priority Area for Action Desk Study

This is a non-technical summary of the desk study on the Awbeg (Buttevant)(West) Priority Area for Action (PAA).

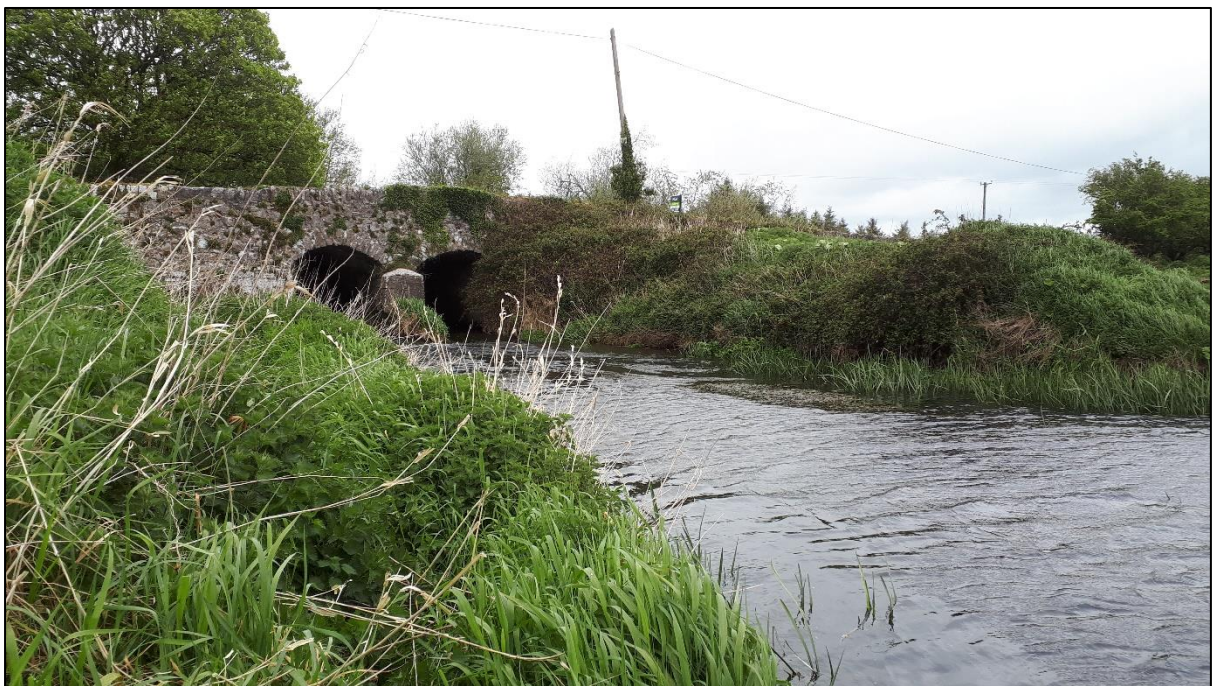
Photograph of WFD operational monitoring point at Annagh Bridge, taken on 26<sup>th</sup> of April 2019

We will assess and confirm if there are hydromorphological impacts along the main channel upstream of Annagh Bridge. We will assess biology by taking kick samples and sediment levels at different points in this waterbody. These assessments will inform if hydromorphology, agriculture and/or forestry are causing siltation and/or nutrients issues at outlet of the waterbody at Annagh Bridge.

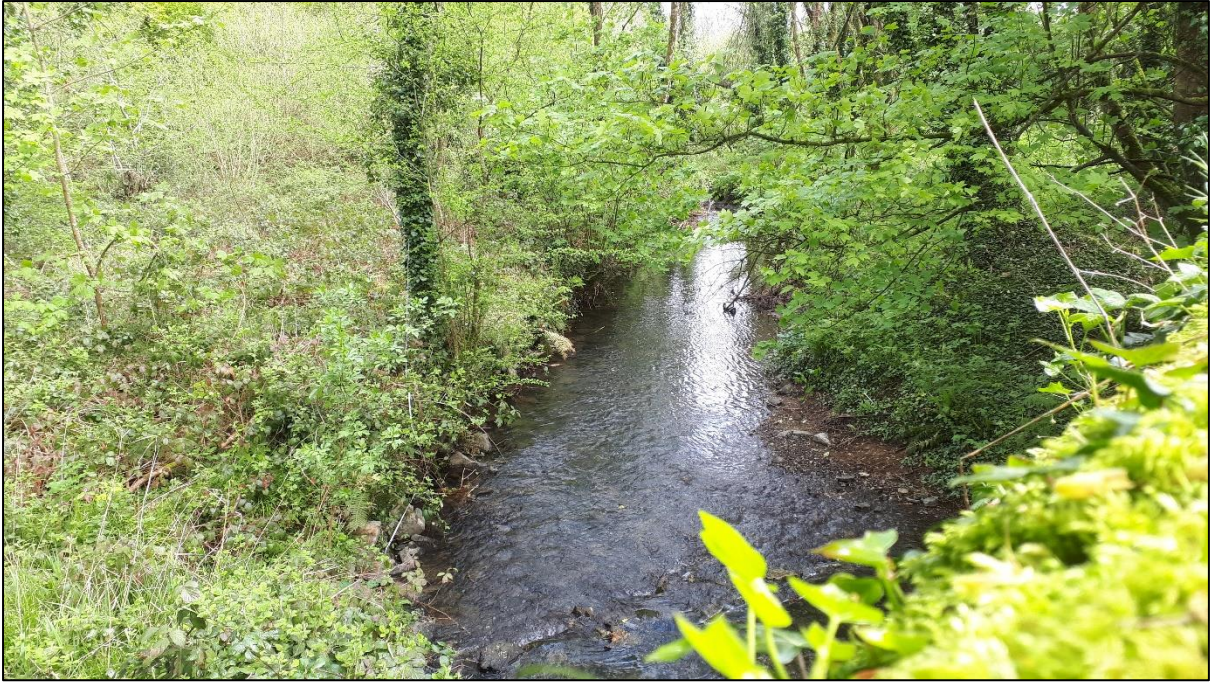
Photograph of WFD operational monitoring point at Bridge SE of Sunfort, taken on 26<sup>th</sup> of April 2019
