**NS 2 FRESHWATER PEARL MUSSEL SUB-BASIN
MANAGEMENT PLANS**

**REPORT ON MORPHOLOGICAL MONITORING AND
CATCHMENT WALKOVER RISK ASSESSMENTS IN THE
CARAGH CATCHMENT**

September 2009

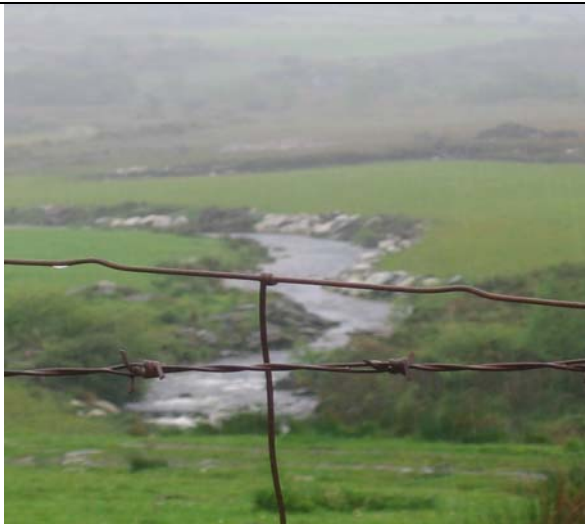
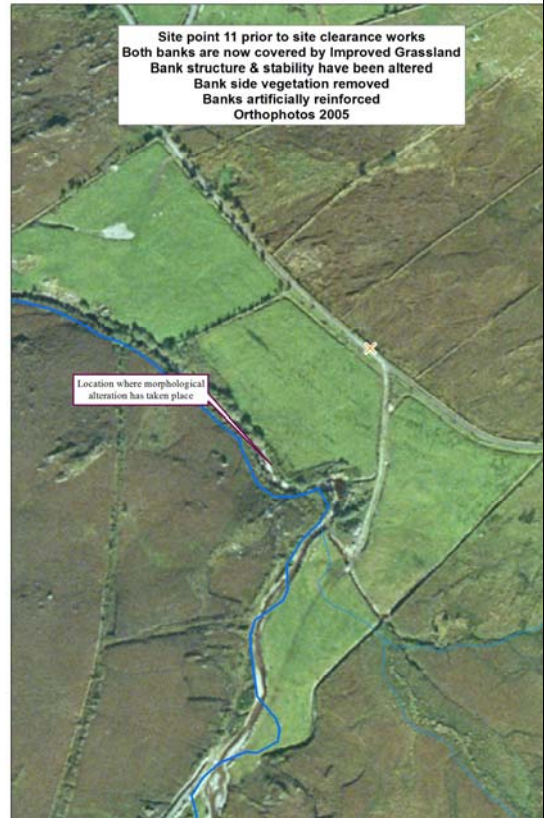
Figure 6 Location of stopping point 5 where significant land clearance has been undertaken adjacent to a river stretch containing pearl mussel records and habitat.
