**NS 2 FRESHWATER PEARL MUSSEL SUB-BASIN  
MANAGEMENT PLANS**

**REPORT ON MORPHOLOGICAL MONITORING AND  
CATCHMENT WALKOVER RISK ASSESSMENTS IN THE  
CLOON CATCHMENT**

**September 2009**

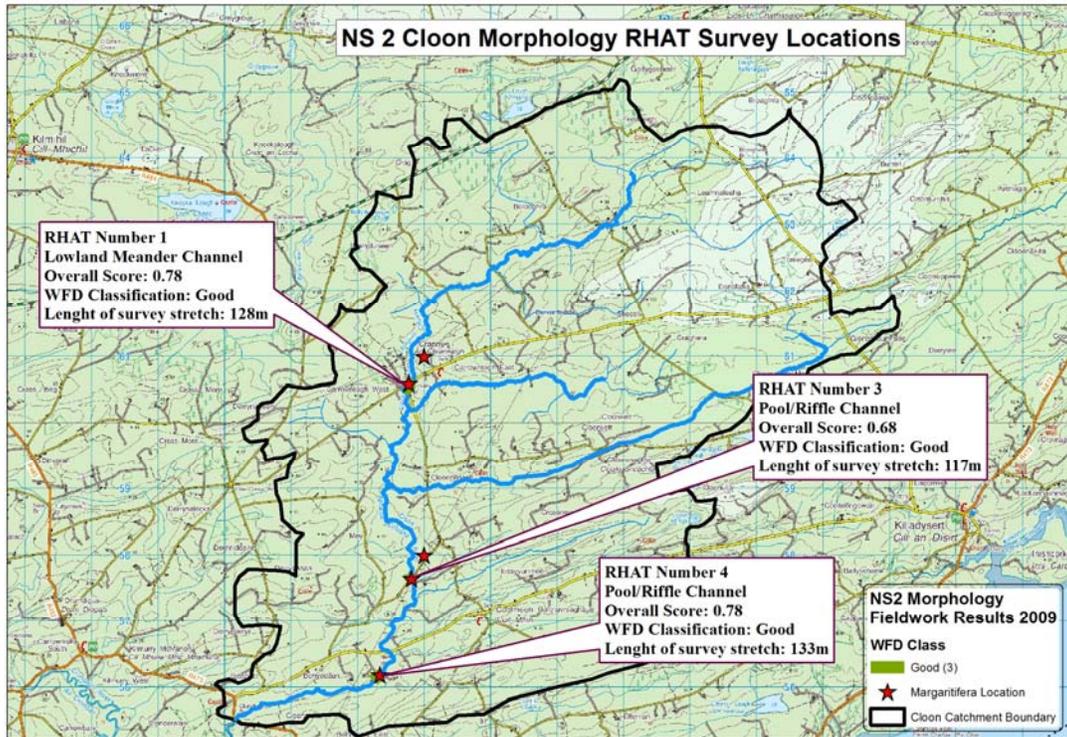
**Figure 1 Morphology RHAT Assessment Locations**

Three RHAT surveys were carried out throughout the Cloon catchment within the vicinity of the known pearl mussel records or habitat. The results of these surveys can be found in the electronic appendix. All three survey stretches were deemed to be at “Good” status. RHAT number 1 scored well on all attributes except for bank structure and stability and floodplain connectivity. This was due to the pressure from the small village of Cranny in the vicinity of the survey stretch. The banks are steepened on the lower end of the survey stretch while upstream of the bridge more natural bank instability was found due to cattle poaching and access points. On the left bank an embankment was noted along this stretch of the lowland meandering channel which has the effect of preventing floodplain connectivity.

RHAT number 3 scored three out of a possible 4 on all attributes except channel vegetation and substrate condition. Both of these attributes scored two out of a possible four. In regards the channel vegetation for this channel type rooted aquatic vegetation may be common at channel margins during the growing season however along this survey stretch excessive *Potamogetans*, and *Apium* species were recorded across the channel. This could indicate high levels of both silt and nutrients are contained within the substrate to allow the macrophytes to take root and flourish. The substrate condition although not visible along all of the stretch was also downgraded as the high levels of macrophyte growth would indicate the substrate has greater than expected levels of siltation. Where the substrate was visible it was found to be in poor condition.

RHAT number 4 scored low on channel form and flow types and substrate condition. This is largely due to the presence of one major bridge which has been altered numerous times over the past number of years. The bridge consists of two large box culverts and a number of round culverts which were added in recent years on either side. Underneath the bridge an artificial concrete substrate has also been put in place which is acting as a minor weir. The weir and bridge structure are altering the flow regime of the river. Again, the substrate condition along this stretch is quite poor with a heavy peat stain.

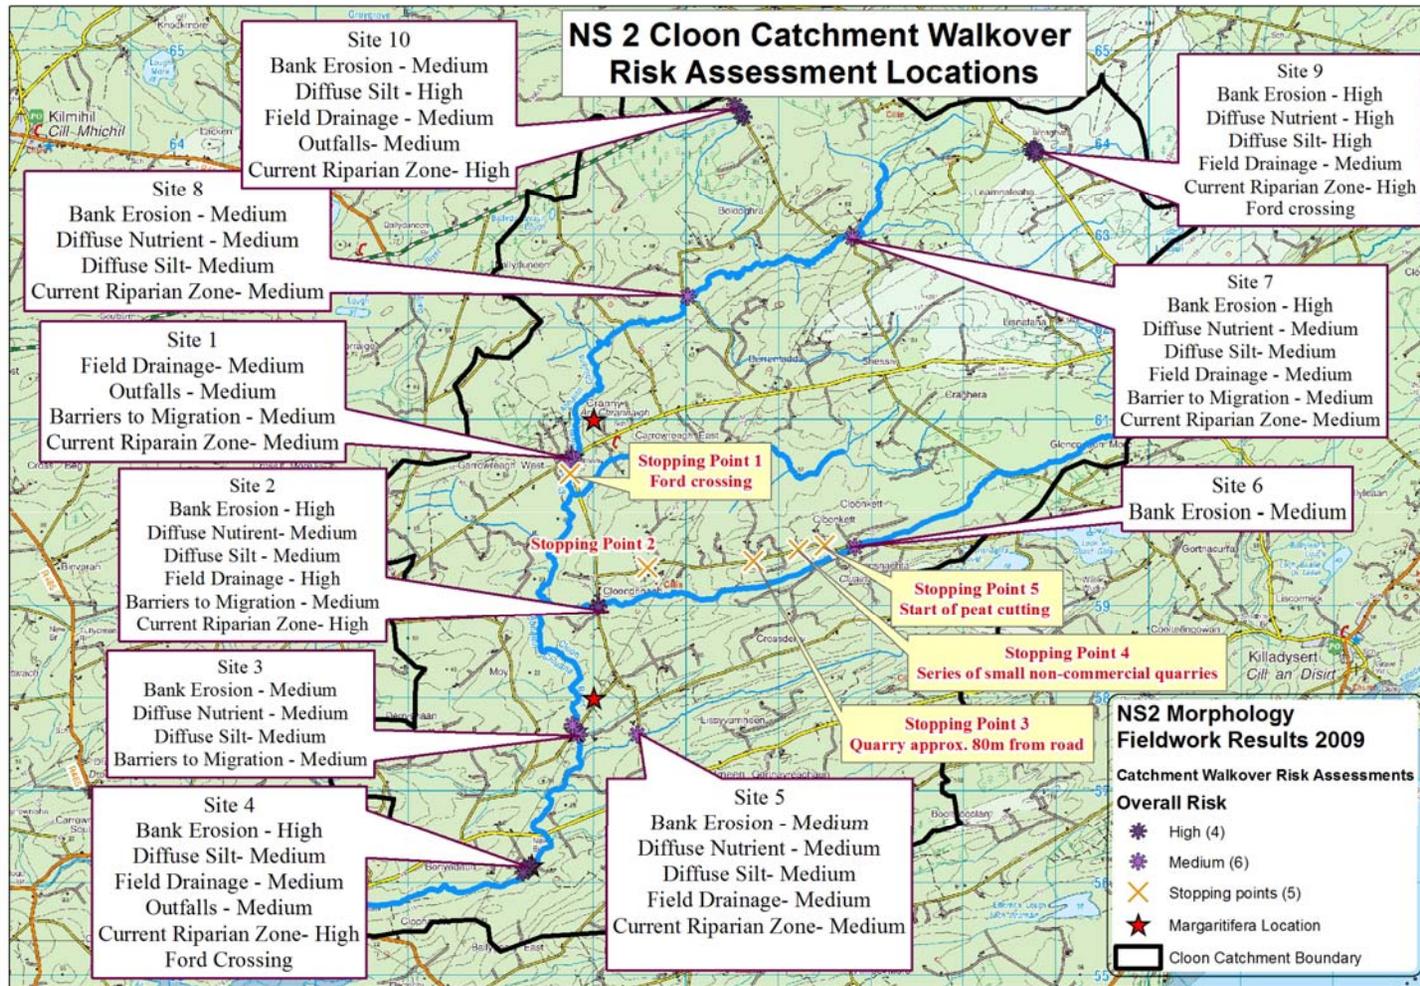
**Figure 2 Location of Stopping points and Catchment Walkover Risk Assessments**

A total of fourteen sites were surveyed in the Cloon Sub-basin catchment; with a risk assessment carried out at nine of these sites (five stopping points). Figure 2 outlines the stopping point locations together with the High to Low Risk Assessment from the Catchment Walkover Risk Assessments.

Two fords were found within the Cloon catchment. The first was located at Stopping Point 1 as indicated in Figure 2. The access point appears to be used by animals and perhaps more infrequently by vehicles. Boulders have been placed down stream of the access point in order to prevent cattle passing down the channel. The second ford is located at Site 4 again as indicated in Figure 2. This is a larger Ford in that the entry and exist points are a considerable distance apart. An access slip road slopes down to the

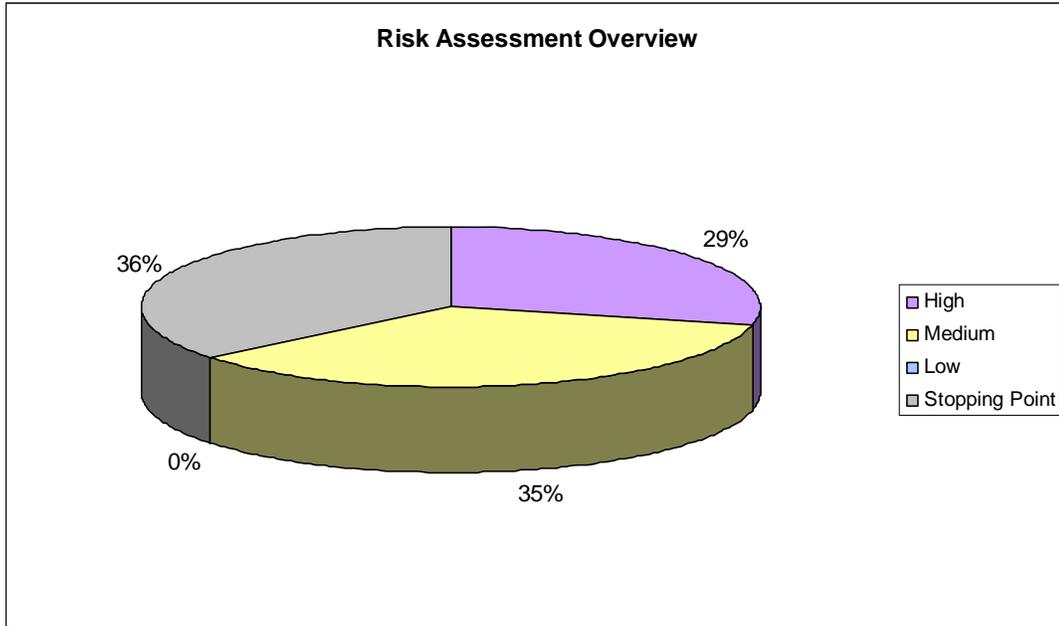
**Figure 3. Risk Assessment Overview**

Figure 3 outlines the percentage number of sites at High, Medium or Low risk. Locations where pressures were evident in the field which were not highlighted through the desk based assessment were also noted as stopping points. These points were not selected prior to fieldwork, they were opportunistic as the catchment drive through was taking place. The pie chart in Figure 3 indicates the percentage of stopping points also.

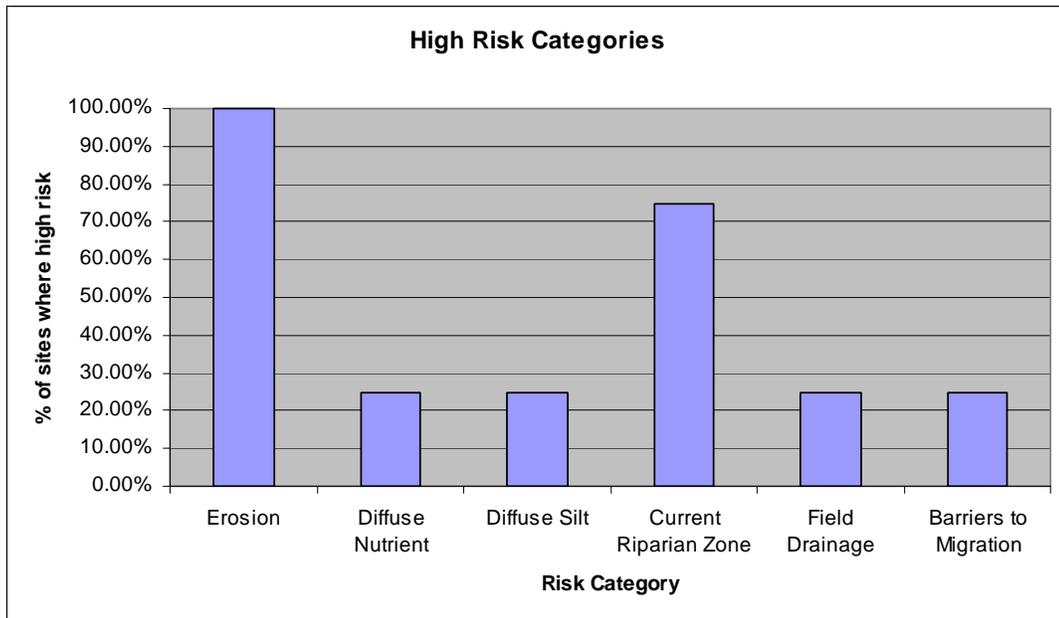
**Figure 4 Breakdown of High Risk Categories**

The break-down of pressure categories identified as high risk are outlined in Figure 3

The most common source of erosion is channel manipulation being evident at three of the four high risk sites. The additional sources of high risk erosion can be seen below:

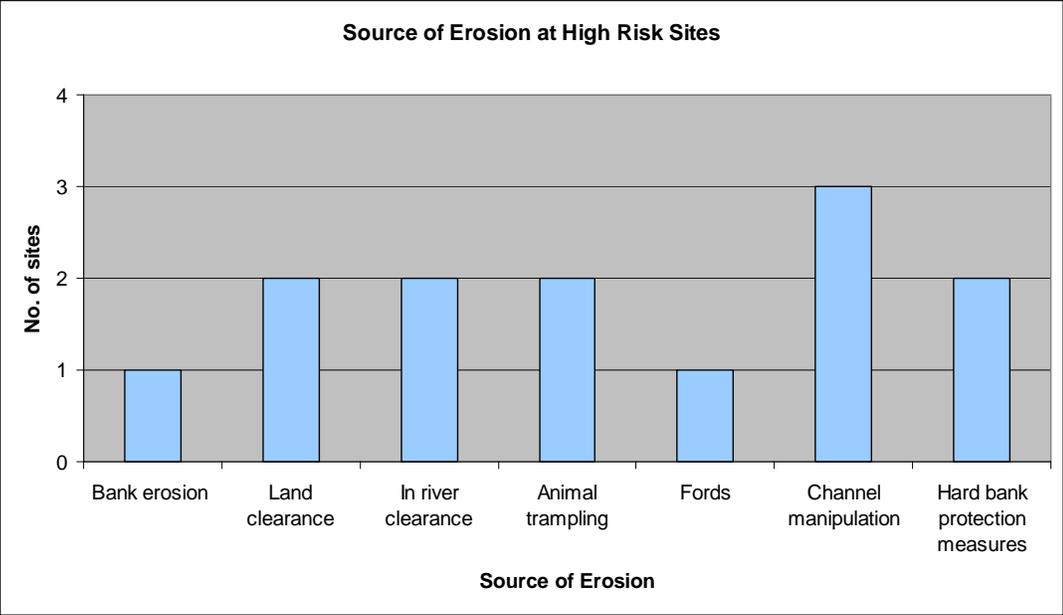
**Figure 5 source of field drainage pressure at high risk sites**

Evidence of drainage works were a common observation which is picked up in the channel manipulation category above, with many survey locations either within or in close proximity to stretches of channel that had been dredged, either recently or in the past. Many of the smaller tributaries had clearly been drained to form uniform channels, as field boundary ditches, with very little flow and totally choked with macrophytes.

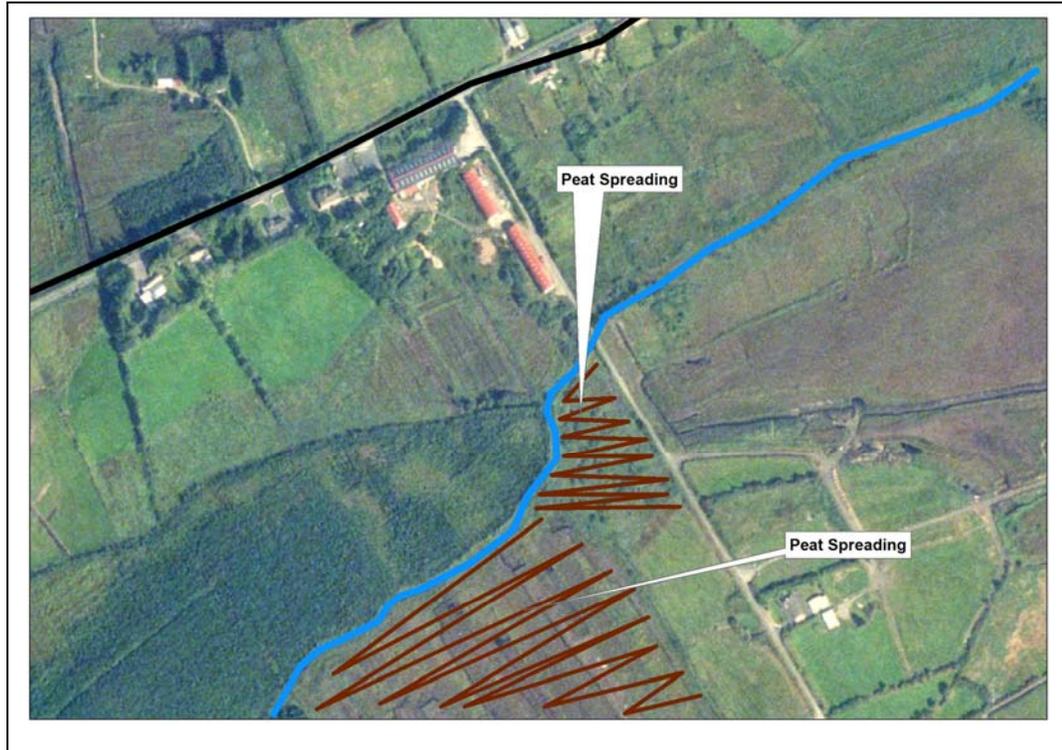
### Site 10 Aerial Imagery

Both pressures were found in close proximity and adjacent to the river channel with inadequate buffer zones in some instances. In combination these two pressures may lead to a significant source of silt in the river.
