**NS 2 FRESHWATER PEARL MUSSEL SUB-BASIN  
MANAGEMENT PLANS**

**REPORT ON MORPHOLOGICAL MONITORING AND  
CATCHMENT WALKOVER RISK ASSESSMENTS IN THE  
BALLYMURPHY CATCHMENT**

**September 2009**

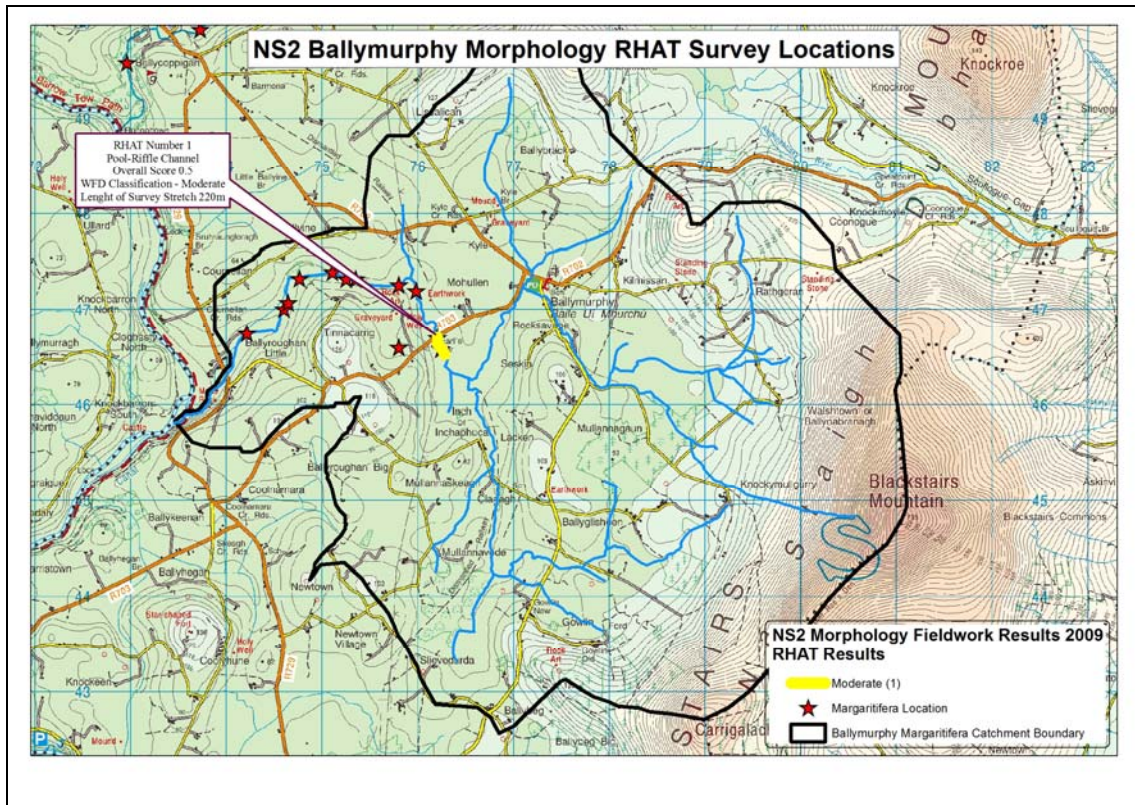
**Figure 1 Morphology RHAT Assessment Locations**

Figure 1 indicates where the Ballymurphy morphology RHAT assessments were carried out throughout the catchment.

(The RHAT numbering system corresponds to the site code which may mean they are not sequential where a RHAT was not carried out at a particular site)

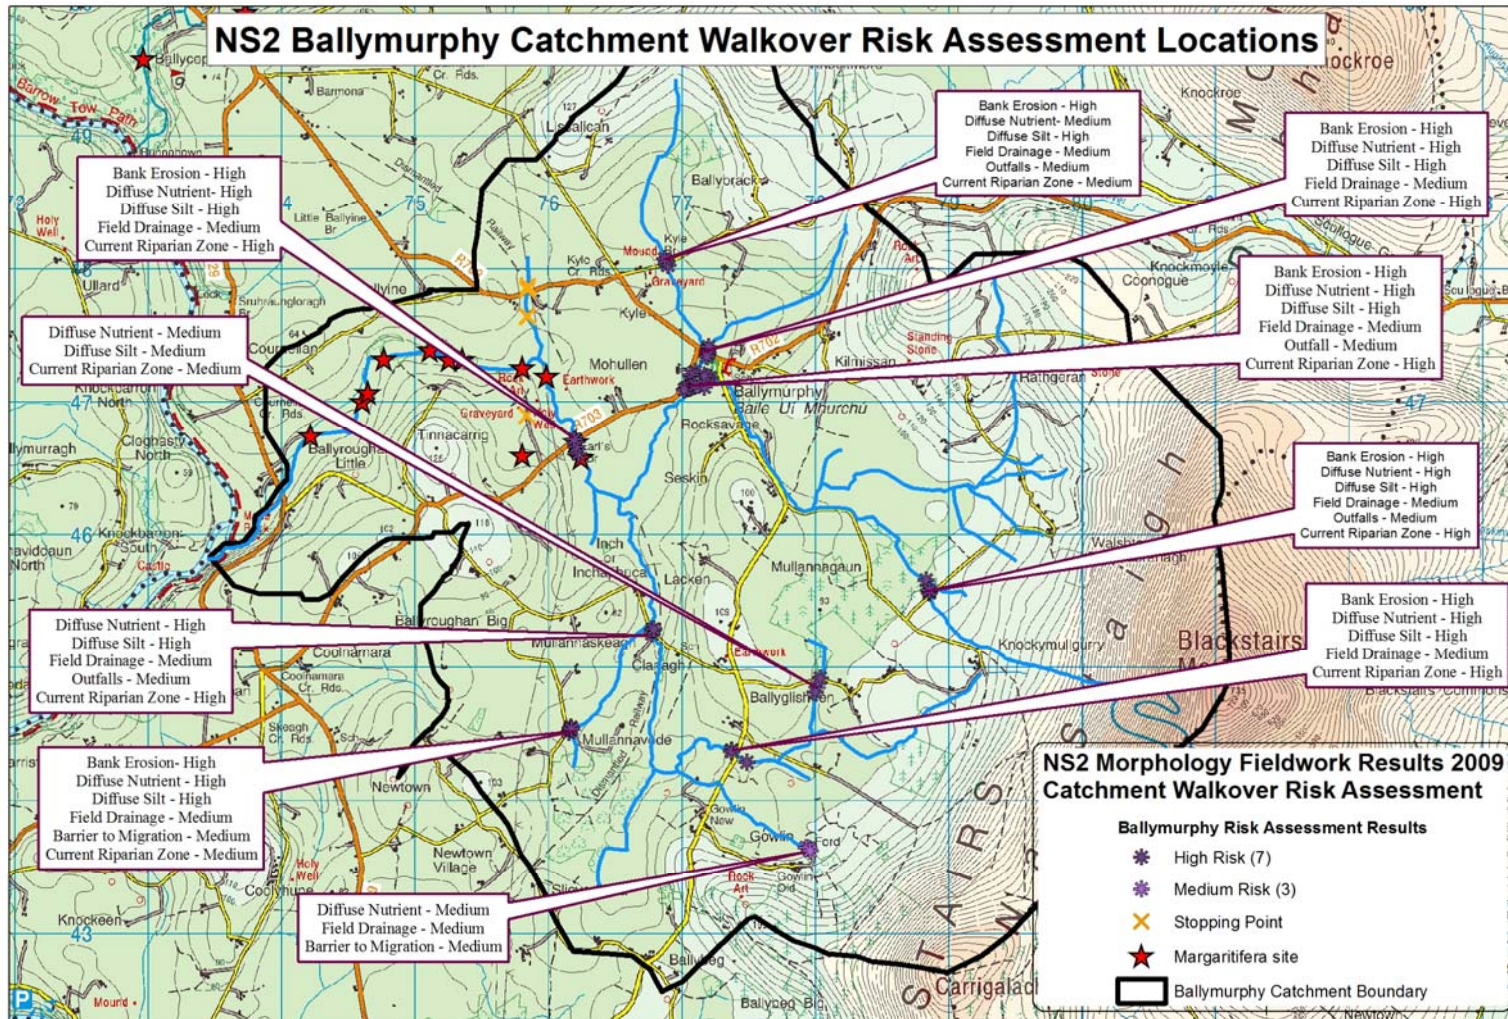
Figure 2 Location of Stopping points and Catchment Walkover Risk Assessments

A total of twelve sites were surveyed in the Ballymurphy sub-basin catchment, with a risk assessment carried out at ten of these sites (two stopping points). **Figure 2** outlines the stopping point locations in addition to the High to Low Risk Assessment from the Catchment Walkover Risk Assessments. Seven high risk sites were recorded out of the ten that were assessed. The remaining three sites were recorded as medium risk, meaning no low risk sites were recorded within this catchment. **Figure 3** outlines the percentage of sites classified at high and medium risk together with the number of stopping points throughout the catchment.

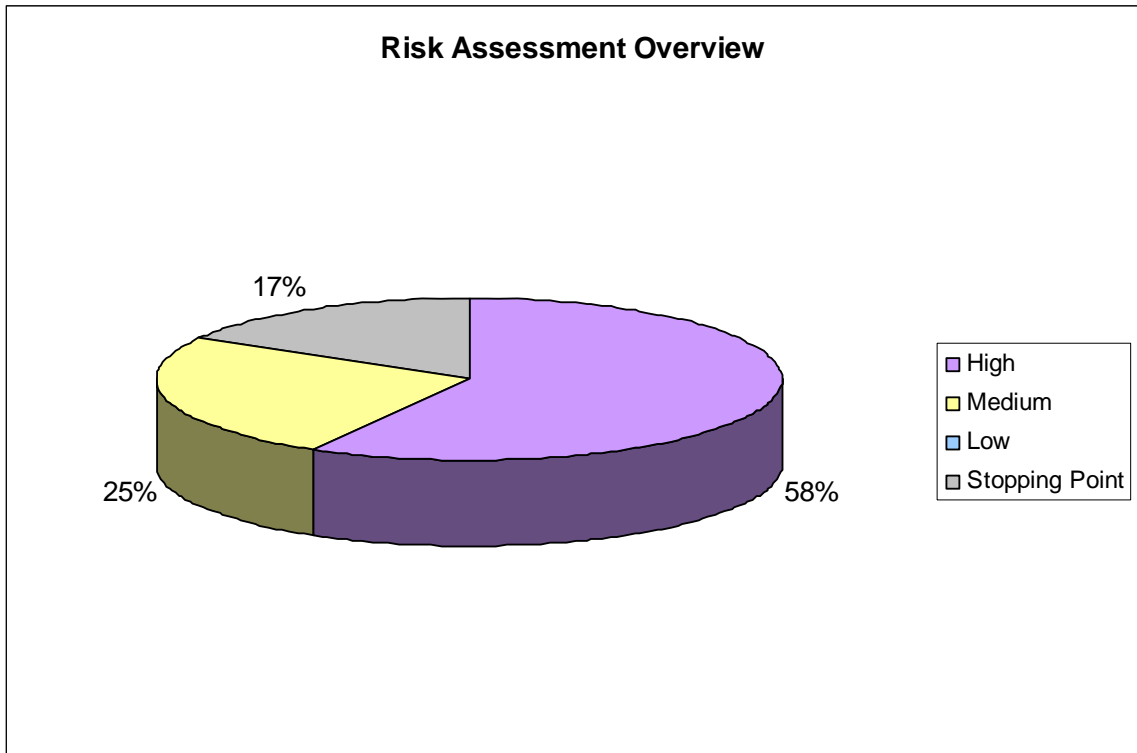
**Figure 3. Risk Assessment Overview**

Where one or any of these aspects is found to be the cause of significant impact to the riparian zone, or the channel along the stretch then this category may be assigned a high risk score. Within the Ballymurphy catchment the most significant pressures is from intensive agriculture with many of the current riparian zone aspects highlighting the impact this pressure is having such as a lack of fencing where sheep and cattle are grazing. Very poor or small buffer zone beside fields where slurry is being spread and in many areas direct access to the channel by cattle for drinking water. **Figure 3** outlines the percentage number of sites at High, Medium or Low risk. Locations where pressures were evident in the field which were not highlighted through the desk based assessment were also noted as stopping points. These points were not selected prior to fieldwork, they were opportunistic as the catchment drive through was taking place. The pie chart in **Figure 3** also indicates the percentage of stopping points also.

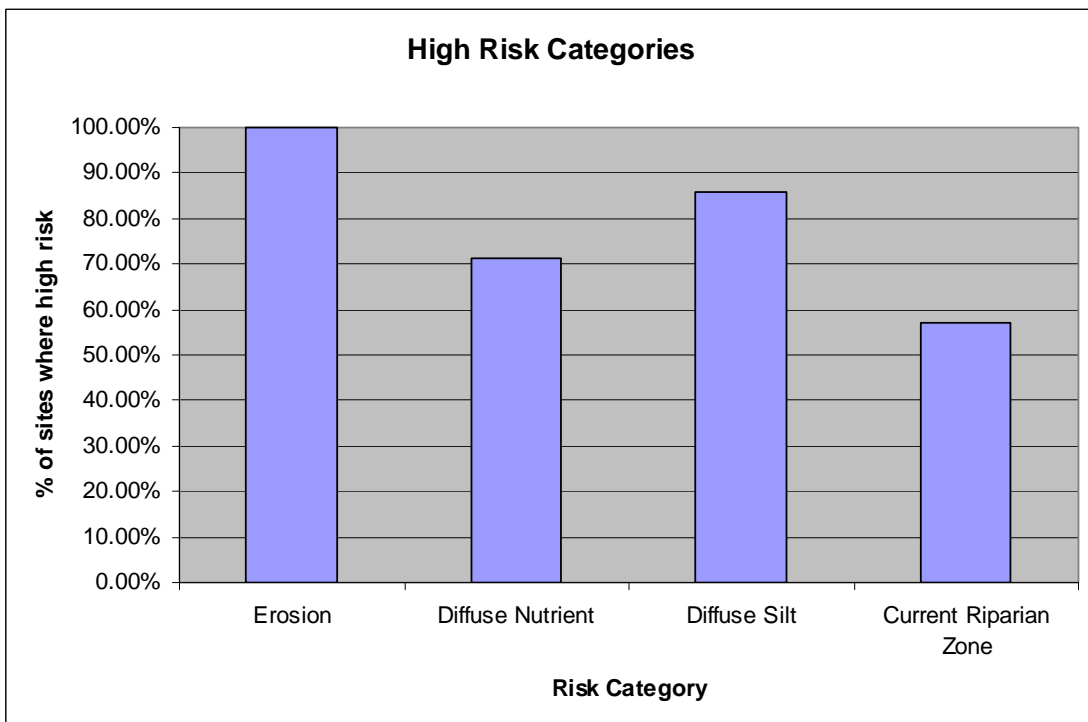
**Figure 4 Breakdown of High Risk Categories**

The break-down of pressure categories identified as high risk are outlined in Figure 4 with erosion and diffuse silt causing the most problems.

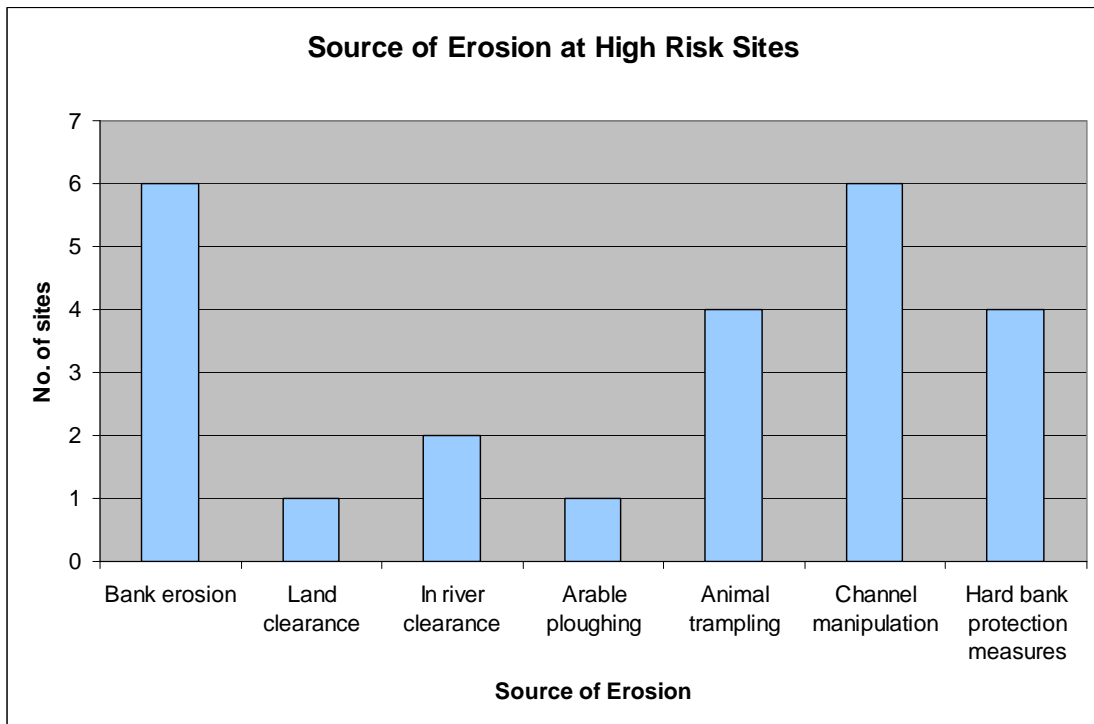
**Figure 5 source of erosion at high risk sites**

The most common sources of erosion were bank erosion and channel manipulation; each recorded as high risk at six sites. A break-down of the individual sources of erosion at high risk sites is given in Figure 5 below.

From figure 5 the main source of erosion is largely from bank erosion which is as a direct result of cattle and/or sheep access to the channel for drinking water. This is a significant issue in the Ballymurphy due to the erodible nature of the substrate. The pressure from this animal access is leading to an excessive build up of fine silts in the channel which in turn allows macropytes to take root and expand across the channel.
