**NS 2 FRESHWATER PEARL MUSSEL SUB-BASIN
MANAGEMENT PLANS**

**REPORT ON MORPHOLOGICAL MONITORING AND
CATCHMENT WALKOVER RISK ASSESSMENTS IN THE
BANDON CATCHMENT**

September 2009

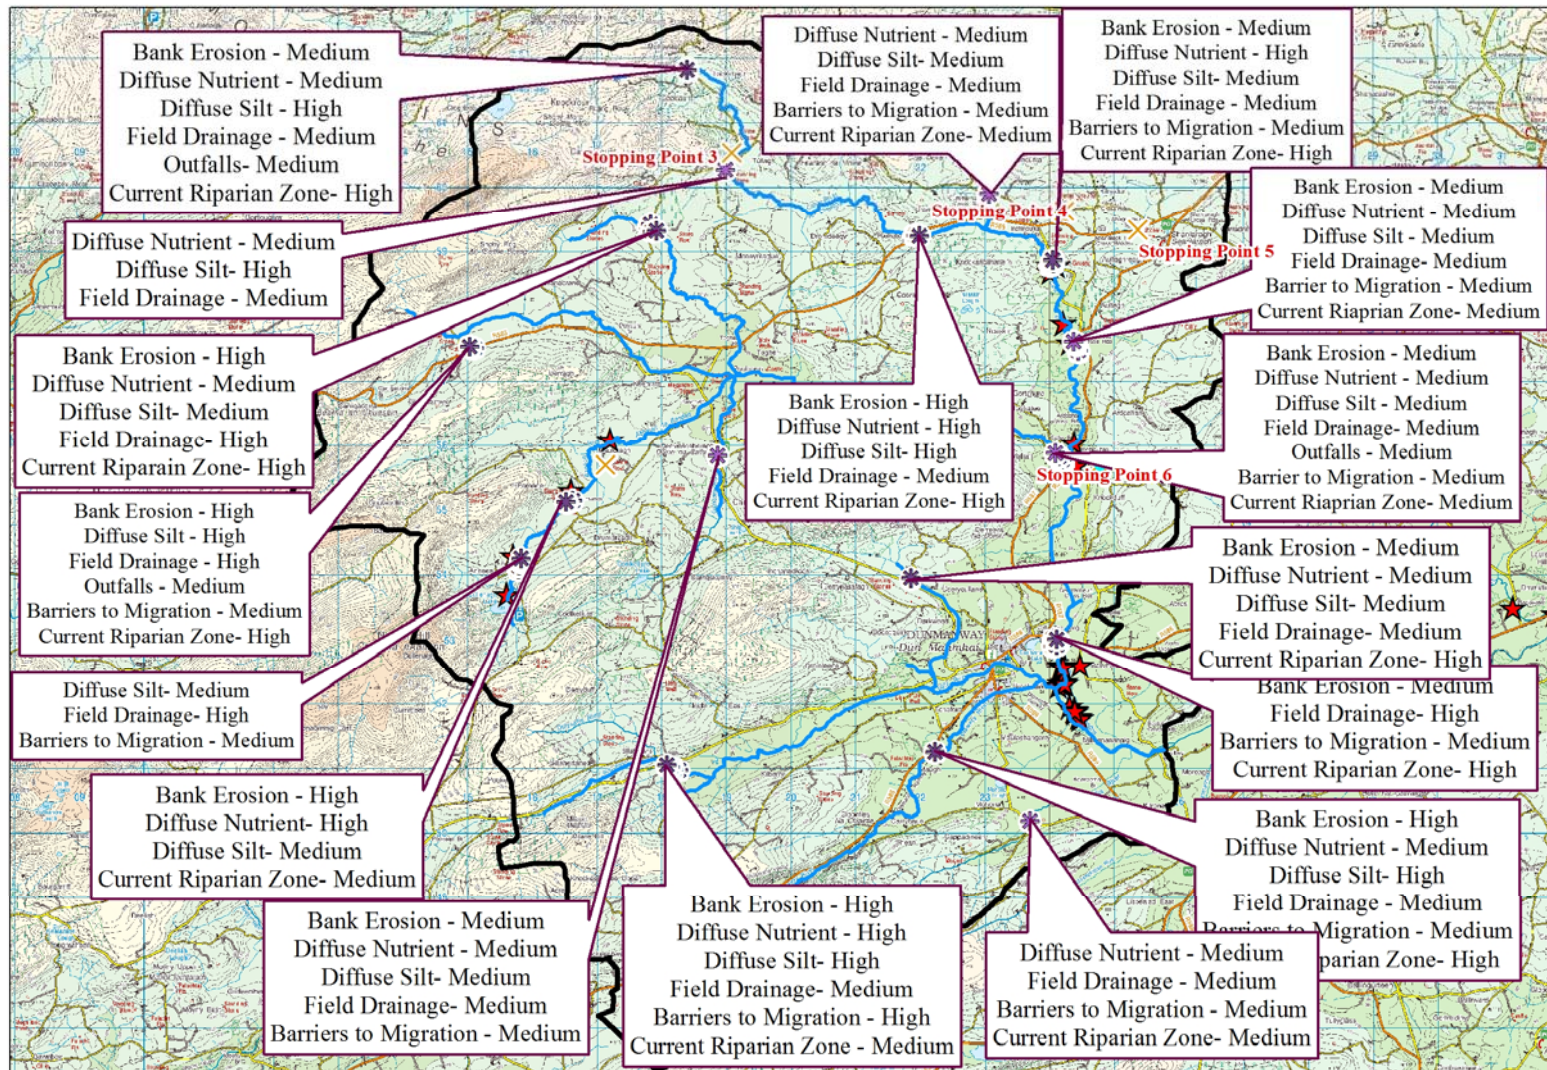
Figure 2 Location of Stopping points and Catchment Walkover Risk Assessments

A total of eighteen sites were surveyed in the Bandon sub-basin catchment, with a risk assessment carried out at sixteen of these sites (two stopping points). **Figure 2** outlines the stopping point locations in addition to the High to Low Risk Assessment from the Catchment Walkover Risk Assessments. Eleven high risk sites were recorded out of the sixteen that were assessed. The remaining five sites were recorded as medium risk, meaning no low risk sites were recorded within this catchment. **Figure 3** outlines the percentage of sites classified at high and medium risk together with the number of stopping points throughout the catchment.

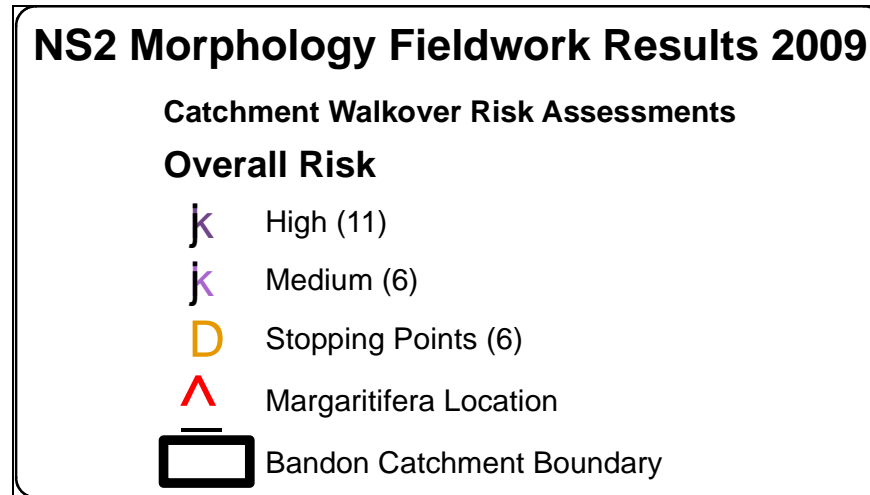
Figure 3. Risk Assessment Overview

Where one or any of these aspects is found to be the cause of significant impact to the riparian zone, or the channel along the stretch then this category may be assigned a high risk score. Figure 3 outlines the percentage number of sites at High, Medium or Low risk. Locations where pressures were evident in the field which were not highlighted through the desk based assessment were also noted as stopping points. These points were not selected prior to fieldwork, they were opportunistic as the catchment drive through was taking place. The pie chart in Figure 3 indicates the percentage of stopping points also.

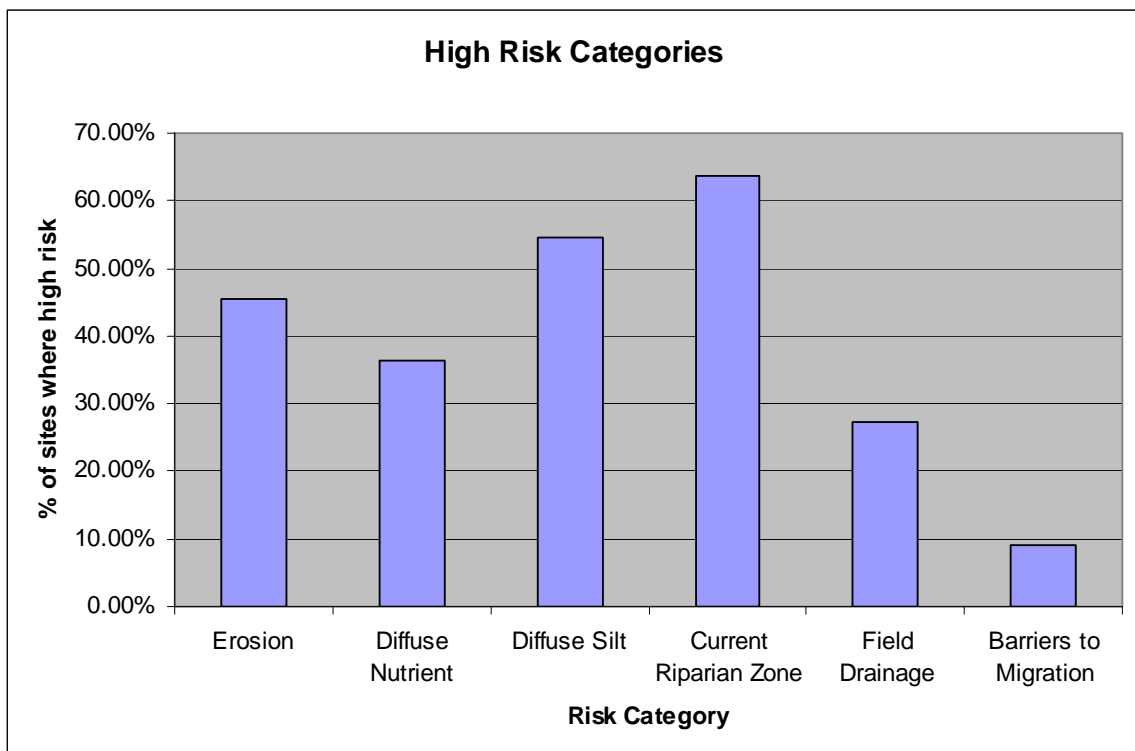
Figure 4 Breakdown of High Risk Categories

The break-down of pressure categories identified as high risk are outlined in Figure 4

- The current riparian zone is a considerable pressure within the Bandon Sub-Basin catchment, however this pressure is difficult to quantify as it generally relates to how a poor riparian zone can intensify certain pressures e.g. increased erosion from animal trampling caused by a lack of fencing, or conversely how a high quality riparian zone reduce potential impacts of certain pressures e.g. low risk diffuse nutrient as improved grassland is set back from river channel with effective tree-line at bank and tree-line buffer.

- The main issues identified within this catchment which lead to a high risk riparian zone were:
 - Insufficient fencing on agricultural land with animals having direct access to the channel – this has resulted in increased erosion from heavy trampling on banks, increased nutrient enrichment from animals being within or very close to channel, increased silt within channel from exposed soil on banks;

- In addition urbanisation and roads within close proximity to the banks has been identified as a pressure on the current riparian zone, this has caused an increase in diffuse nutrient and silt as the natural riparian zone has been removed.

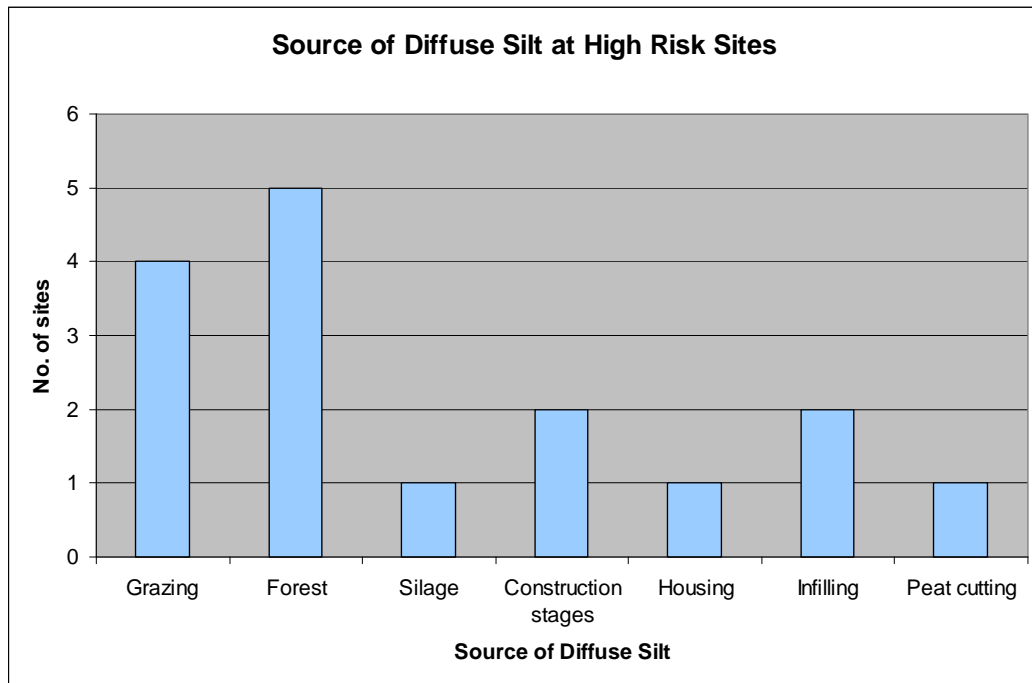
Figure 5 Source of Diffuse Silt at high risk sites

The most common source of diffuse silt is forestry which is evident throughout the catchment at five high risk sites, often within close proximity to the river channel. This coupled with a poor riparian buffer significantly intensifies the potential effects of diffuse silt on Freshwater Pearl Mussel Populations, each individual source of diffuse silt is illustrated below in Figure 5. Site 11 contained one of the most significant sources of this diffuse silt associated with land improvement works from what our field investigations and consultation with local NPWS staff could identify. A large area of the riparian zone along a tributary of the Bandon – Shanacrane East was recently cleared together with the removal of the top layer of vegetation for the construction of a road. This large area was cleared down to the river bank where the bank side vegetation was also removed. The substrate condition was very poor along this stretch with
