**NS 2 FRESHWATER PEARL MUSSEL SUB-BASIN
MANAGEMENT PLANS**

**REPORT ON MORPHOLOGICAL MONITORING AND
CATCHMENT WALKOVER RISK ASSESSMENTS IN THE
GEARHAMEEN CATCHMENT**

September 2009

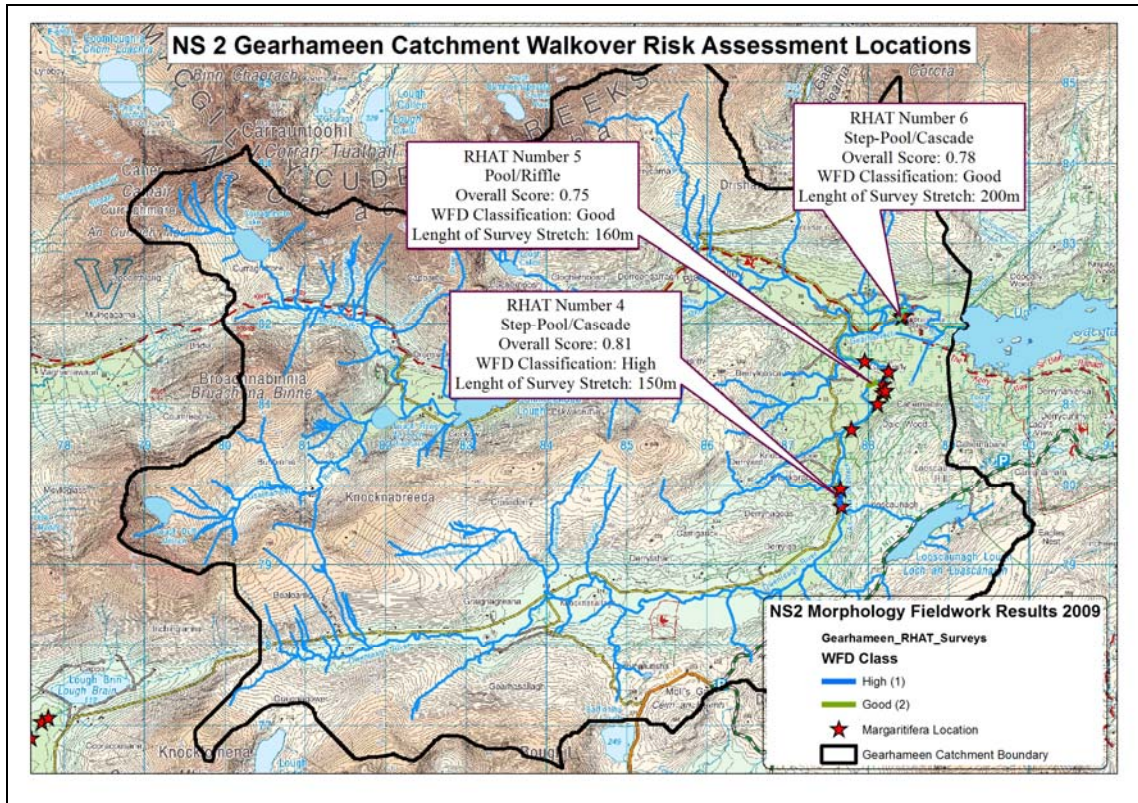
Figure 1 Morphology RHAT Assessment Locations

Three RHAT surveys were carried out throughout the Gearhameen catchment. The results of these surveys can be found in the electronic appendix. Two were deemed to be at good status, one in the lower reaches of the catchment (RHAT number 6) on the Gearhameen before it flows into Upper Lough below the confluence with the Owenreagh. The second good status reach was located at the lower end of the Owenreagh (RHAT Number 5). Despite the classification of good status (from a morphological point of view) at RHAT number 5 a continuous cover of silt and algae was found along this stretch with dead mussels evident along the banks. Both the bank structure and stability together with the bank vegetation scored quite low along this reach as high levels of bank erosion and slumping was recorded.

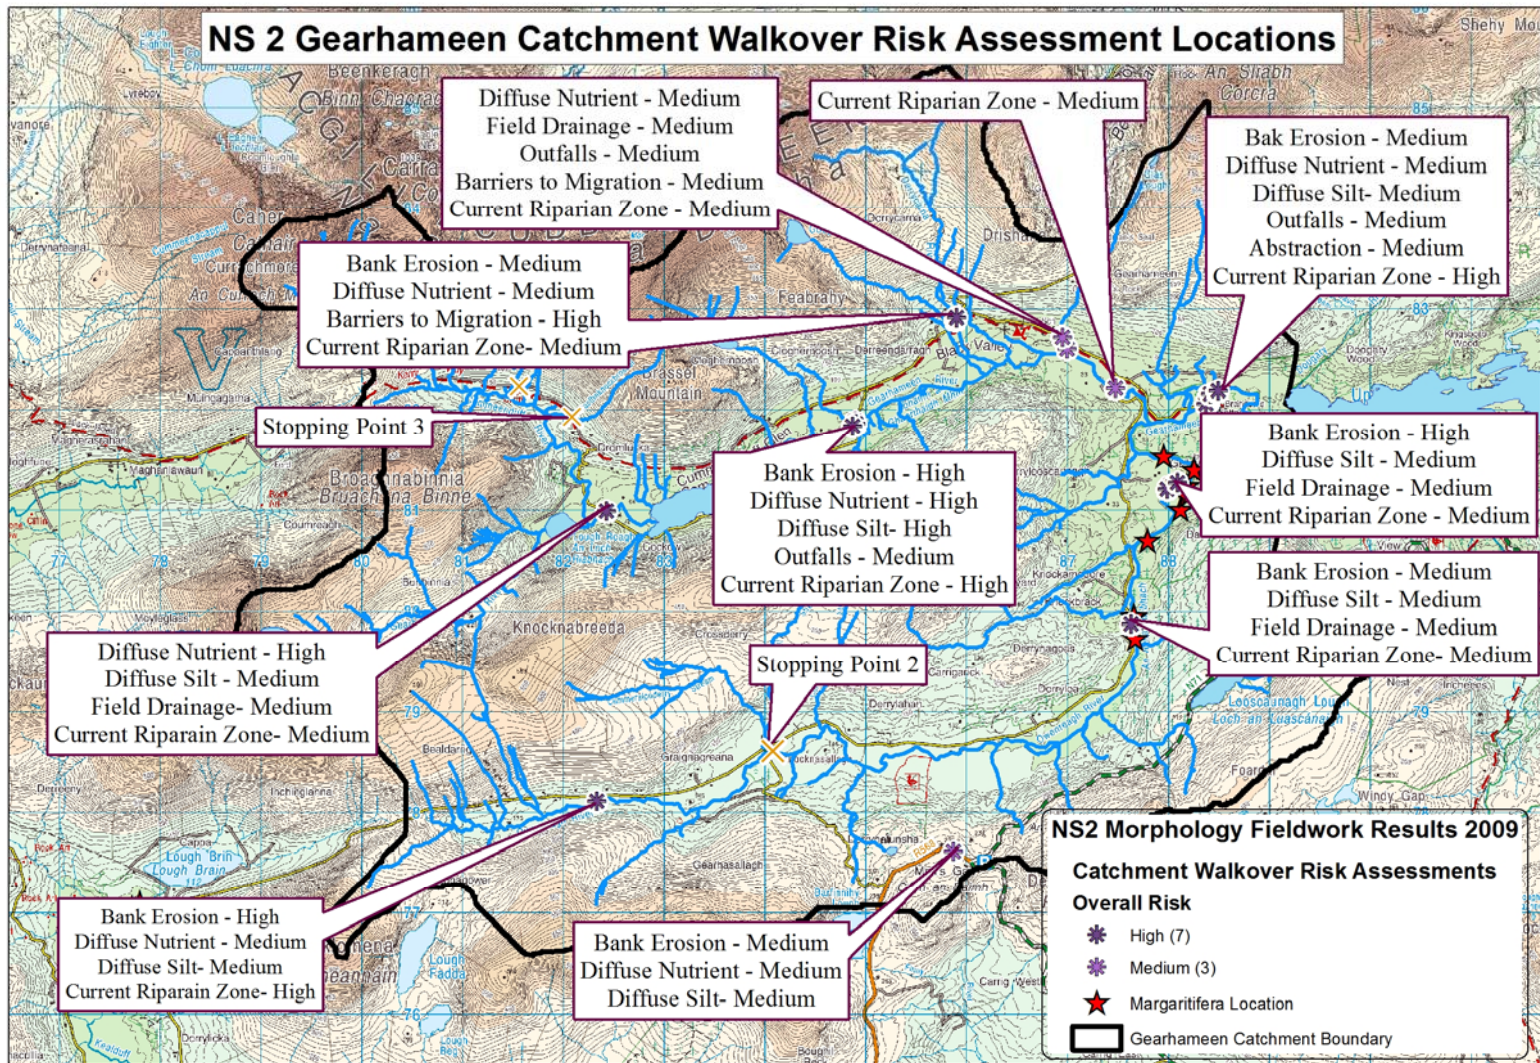
Figure 2 Locations of Catchment Walkover Risk Assessments and Stopping Point

A total of twelve sites were surveyed in the Owenreagh sub-basin catchment, with a risk assessment carried out at ten of these sites (two stopping points). Figure 2 outlines the stopping point locations in addition to the High to Low Risk Assessment from the Catchment Walkover Risk Assessments. Seven high risk sites were recorded out of the ten that were assessed. The remaining three sites were recorded as medium risk, meaning no low risk sites were recorded within this catchment. Figure 3 outlines the percentage of sites classified at high and medium risk together with the number of stopping points throughout the catchment. The most common high risk categories identified were:

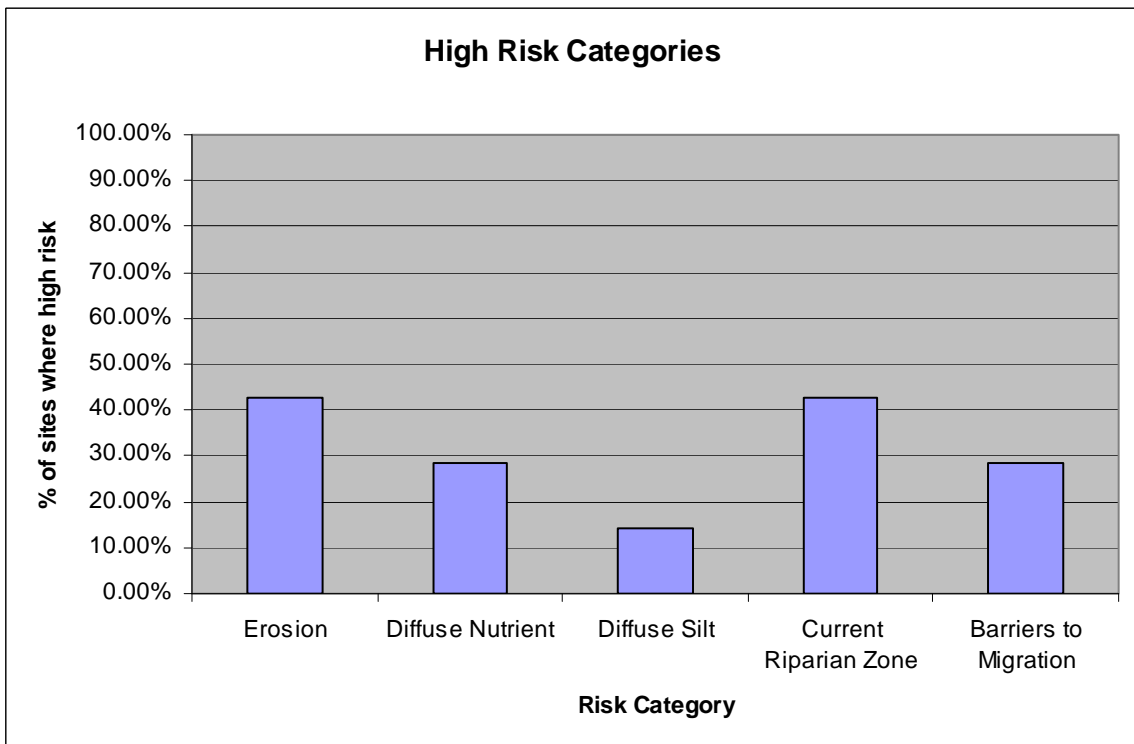
Figure 4 Breakdown of High Risk Categories

- Inadequate fencing on one or more banks in areas of grazing – this has led to increased animal trampling and as such overall erosion. In addition impacts from diffuse nutrient and diffuse silt are considerably increased since animals have such close contact with the channel.
- A lack of buffer or tree-line along areas of improved grassland and forestry- this has resulted in an increase in the impact of diffuse nutrient and diffuse silt as there is no buffer to reduce the impacts of these pressures.

As can be seen from Figure 4 just over 40% of sites which were deemed to be at high risk were due to the pressures identified in the current riparian zone.

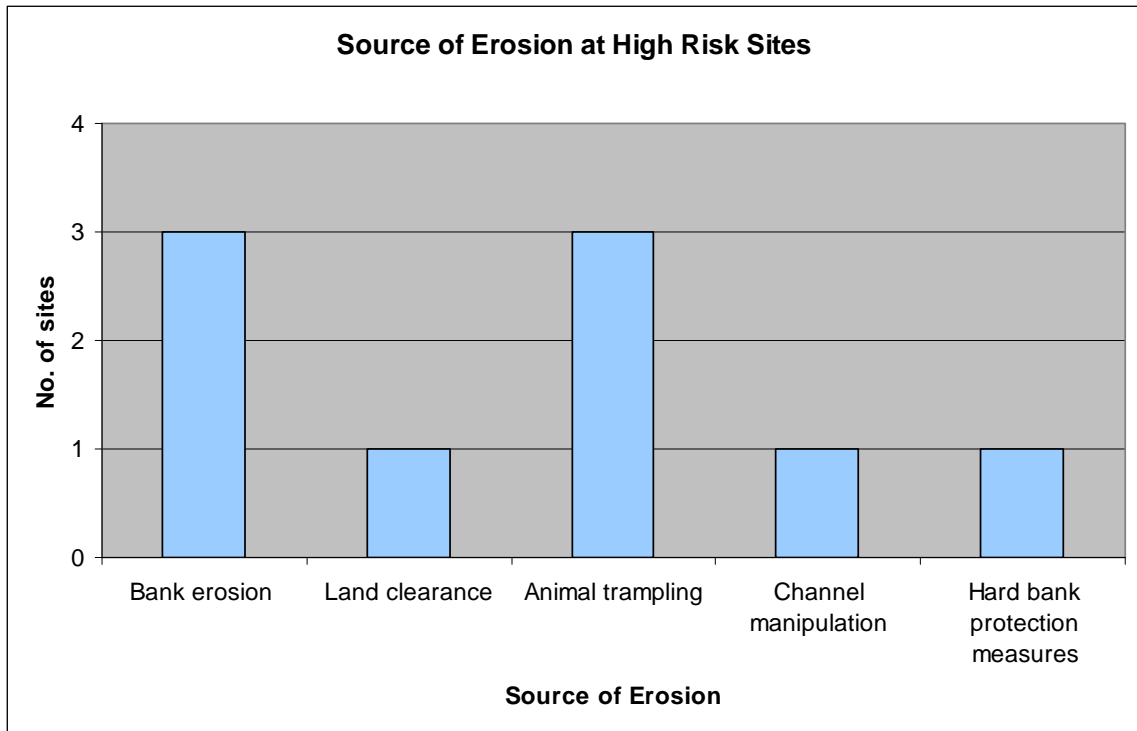
Figure 5. Sources of Erosion at High Risk Sites

The most common sources of erosion within the catchment were banks erosion and animal trampling each was evident at three high risk sites. The other sources of erosion at high risk sites are outlined below.
