**NS 2 FRESHWATER PEARL MUSSEL SUB-BASIN  
MANAGEMENT PLANS**

**REPORT ON MORPHOLOGICAL MONITORING AND  
CATCHMENT WALKOVER RISK ASSESSMENTS IN THE  
DERREEN CATCHMENT**

**September 2009**

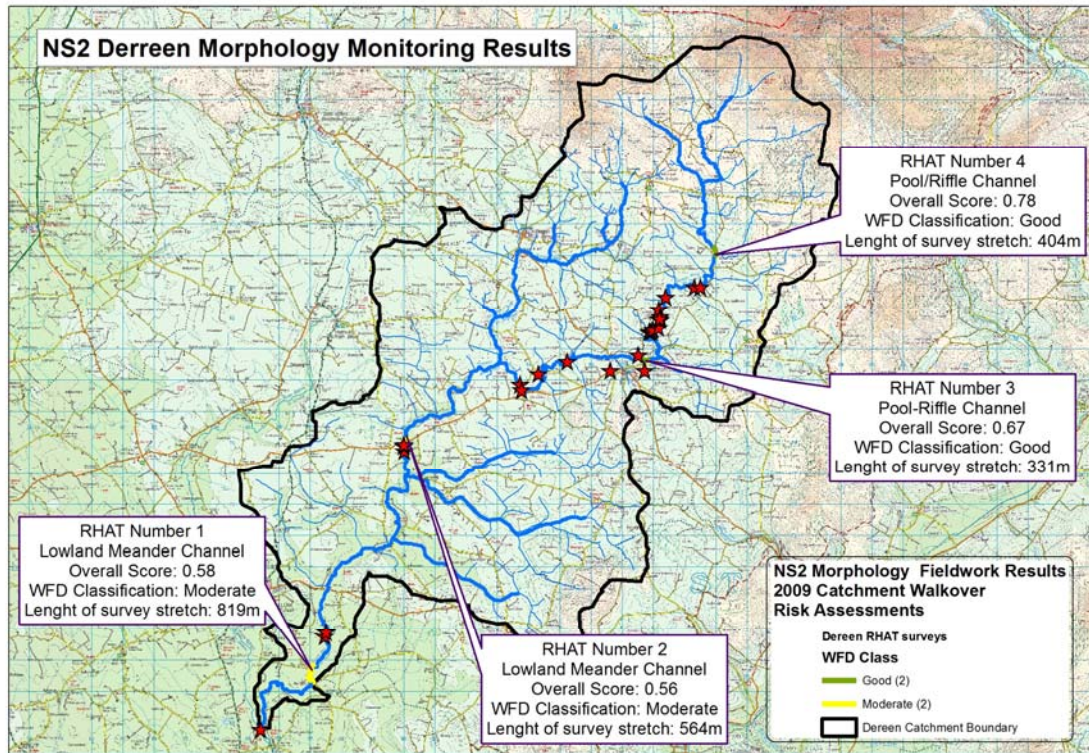
**Figure 3.1 Morphology RHAT Assessment Locations**

Four RHAT surveys were carried out throughout the Derreen catchment. The results of these surveys can be found in the electronic appendix. Two were deemed to be at moderate status in the lower reaches of the catchment where as the survey stretch at the upper end of the catchment was at Good status. RHAT number 1 scored low on all attributes in particular channel vegetation, bank structure & stability, bank vegetation, riparian landcover and floodplain connectivity. Siltation is a particular problem along the survey stretch which is evident from the at this site excessive macrophyte growth in channel leading to a score of zero for this attribute. This may be exacerbated along the survey stretch due to the very narrow buffer zone which has been left between the river and the recently ploughed agricultural land. In some parts of the reach the ploughing has taken place right up to the bank with no buffer strip left. Resectioning, reinforcement

and embankments were recorded on both the left and right bank. Bank side erosion was recorded which is perhaps adding the build up of fine sandy silts in the channel. *Ranunculus* growth was found to be significant along the survey stretch. RHAT number one was classified as being at good status.

RHAT number 2 was again along a lowland meandering channel with significant levels of fine sandy silt in the channel. Dead mussels were found on the banks of the survey reach full of silt. Only two attributes scored over 2.5 – floodplain connectivity and channel form and flow type. All other attributes scored between 2 and 2.5. The intensive land use surrounding the channel on both sides, lack of buffer zone and bank side vegetation together with the high levels of fine sands and silts in the channel and led to the combined low scores throughout. Significant morphological alterations are acting on this reach and preventing it from attaining its full potential. Overall, the reach was classified as being at moderate status.

RHAT number 3 was carried out North East of Hacketstown. Some resectioning and over widening was recorded together with poaching on both the right and left bank. Again as with RHAT 1 significant *Ranunculus* was recorded along the entire survey stretch. This stretch is a pool-riffle-glide channel and whiles the floodplain connectivity and barriers to continuity are not a problem along this stretch the channel vegetation and substrate condition are a particular issue. The nature of the substrate in this catchment has led to significant levels of fine sands in the channel with dead mussels found on the banks full of sediment. Filamentous algae was found through the channel growing on the cobbles and boulders. The riparian landcover also scored quite low due to excessive levels of animal trampling along the survey stretch. Overall, this stretch was classified as good status.

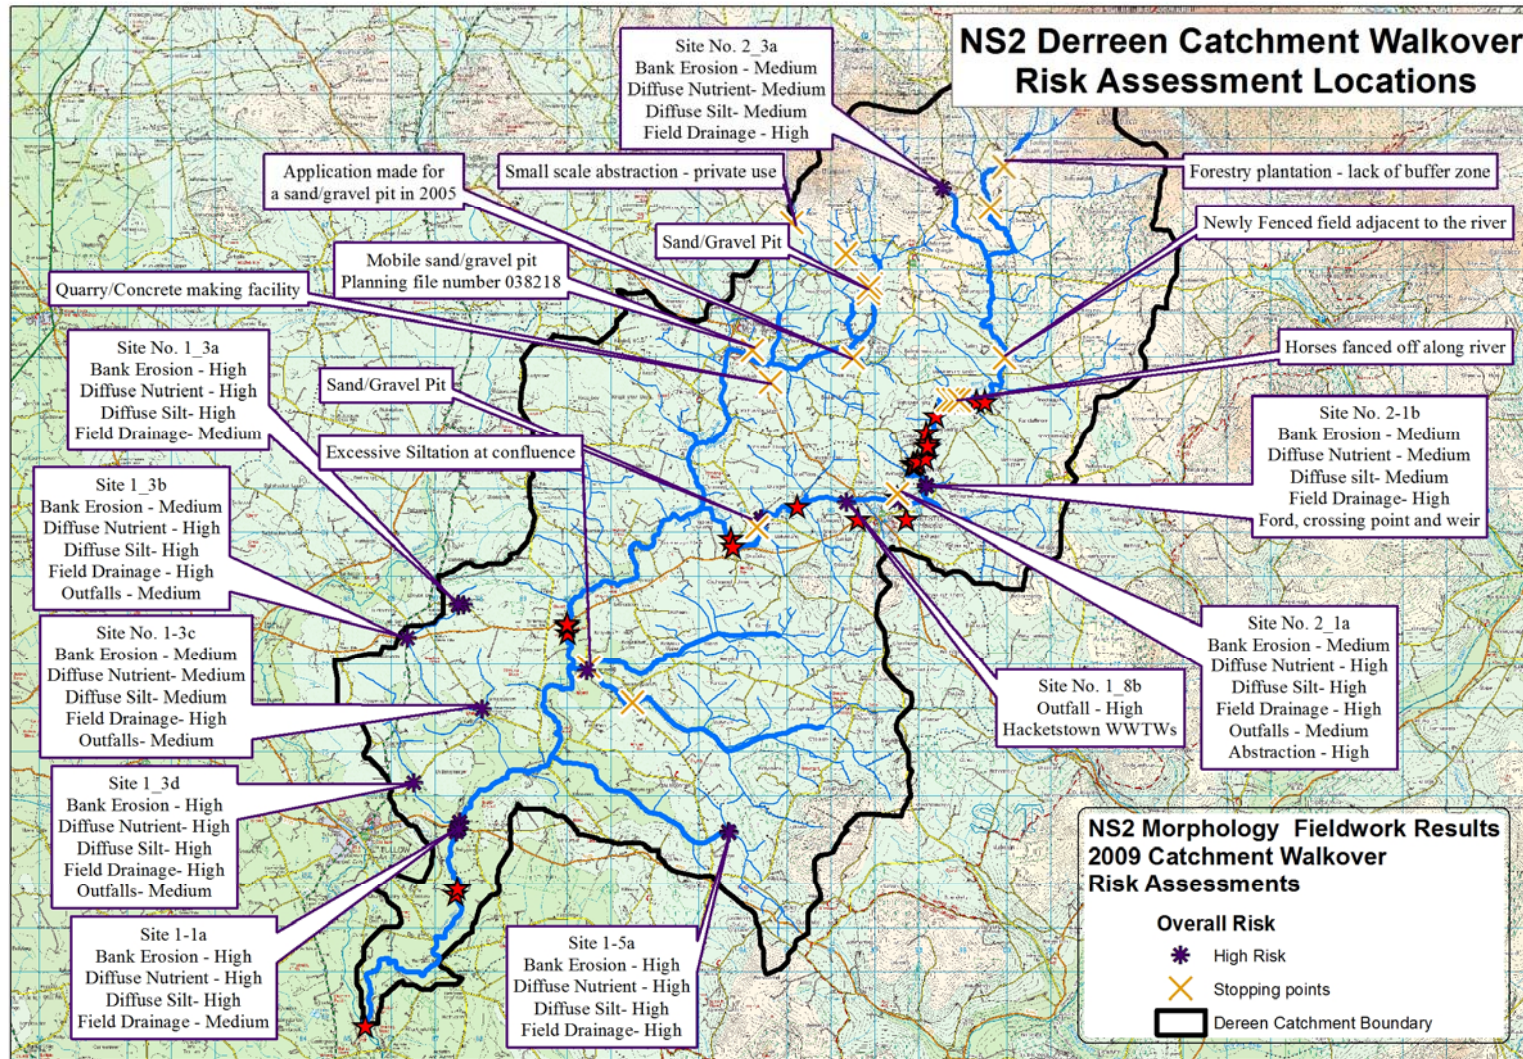
Figure 3.2 Location of Stopping points and Catchment Walkover Risk Assessments

A total of twenty-seven sites were surveyed in the Derreen sub-basin catchment, with a risk assessment carried out at thirteen of these sites (fourteen stopping points). **Figure 3.2** outlines the stopping point locations in addition to the High to Low Risk Assessment from the Catchment Walkover Risk Assessments. All thirteen risk assessment sites were recorded as high risk. **Figure 3.3** outlines the percentage of sites classified at high risk together with the number of stopping points throughout the catchment. The most common high risk categories identified were:

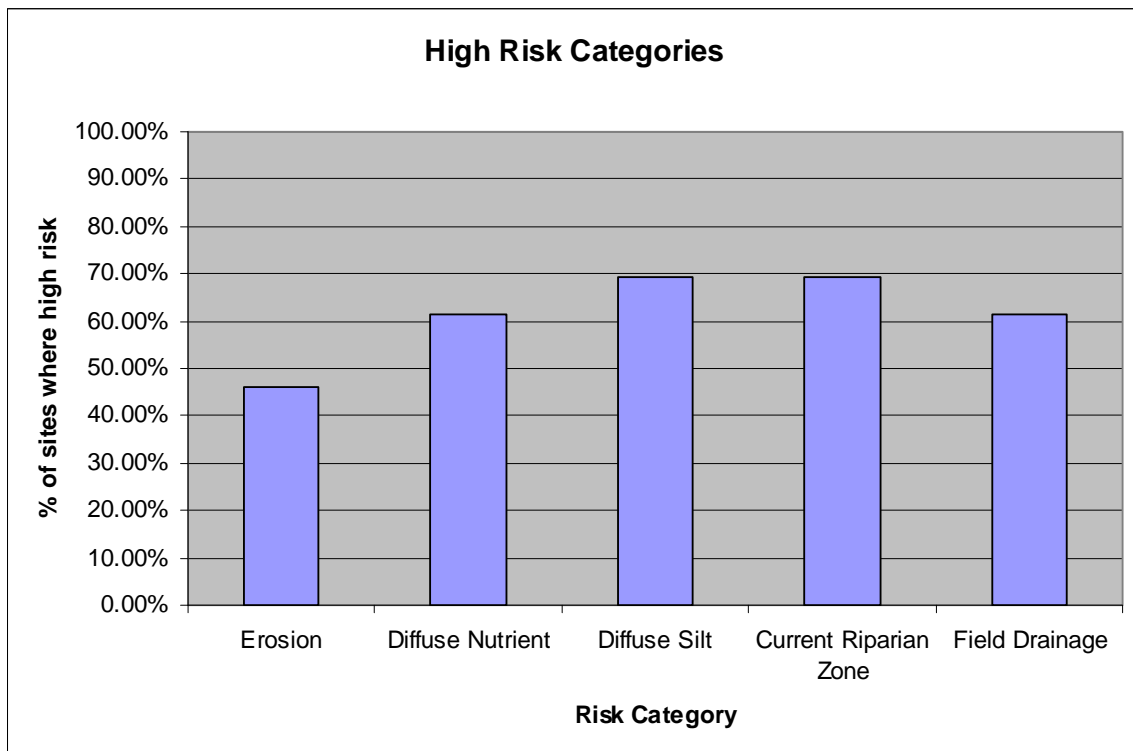
**Figure 3.4 Break-down of High Risk categories**

The break-down of pressure categories identified as high risk are outlined in Figure 3.4

It is evident that the current riparian zone category is also a major risk within this catchment, however this pressure generally relates to how a poor riparian zone can intensify other pressures e.g. increased erosion from animal trampling caused by poor fencing. Quantitative statistics do not successfully display the pressures created by a poor riparian buffer as they are linked with other pressure categories. The main issues identified within this catchment which lead to a high risk riparian zone were:

- An insufficient buffer or a tree-line at bank is a significant pressure within this catchment, the buffer or tree-line was insufficient at eight sites high risk for riparian buffer, the main risks were at banks used for improved grassland or housing. This has impacts including the intensification of existing erosion particularly that associated with animal trampling, increases impact of diffuse silt as there is no buffer to intercept and increases the impact of diffuse nutrient as nutrients from agricultural land, housing etc are more likely to be washed directly into the river channel.

- The condition of fencing on banks is a significant pressure within this catchment, there are areas where the fencing is not sufficiently set back from the channel and placed right at the bank and indeed areas where there is no fencing at all on agricultural grazing land. This has intensified the pressure of erosion from trampling on banks and poaching, increased nutrient enrichment from animals being within or very close to channel and increased silt within channel from exposed soil on banks;

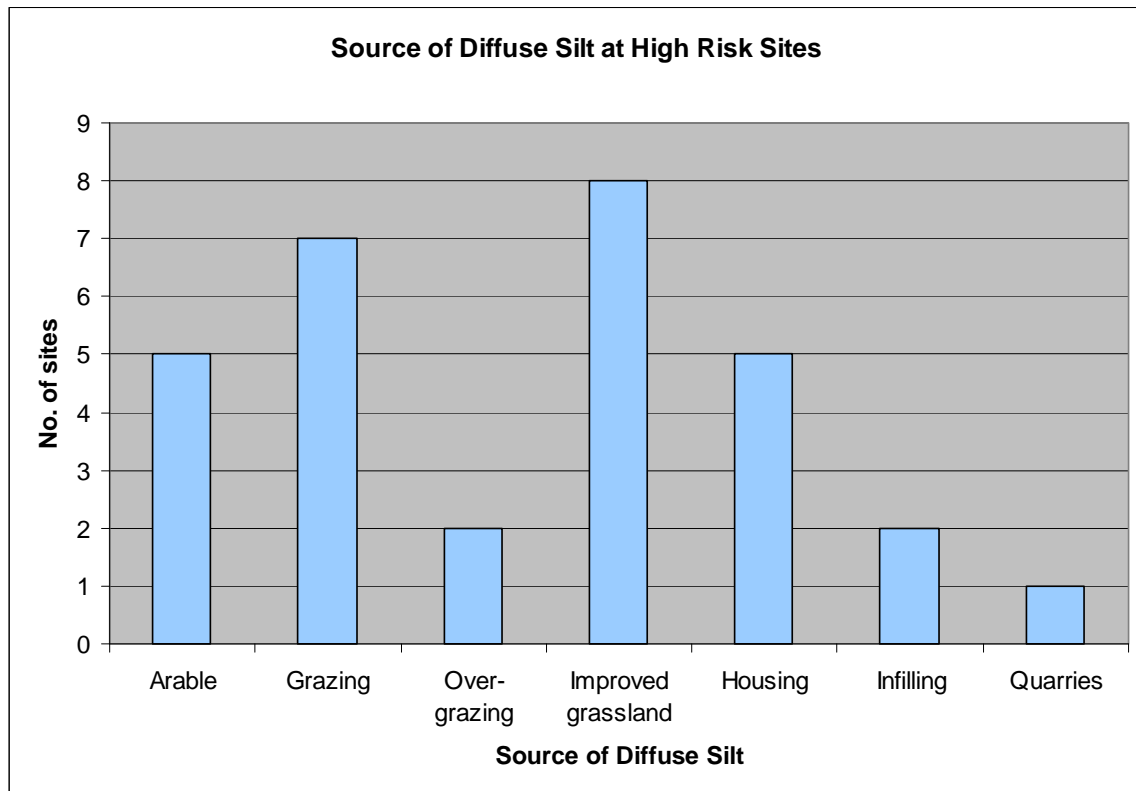
**Figure 3.5 Sources of Diffuse Silt at High Risk Sites**

The most common source of diffuse silt was improved grassland which was evident at eight high risk sites. A break-down of the individual sources of Diffuse Silt at high risk sites is given below:
