**NS 2 FRESHWATER PEARL MUSSEL SUB-BASIN  
MANAGEMENT PLANS**

**REPORT ON MORPHOLOGICAL MONITORING AND  
CATCHMENT WALKOVER RISK ASSESSMENTS IN THE  
OWENCARROW CATCHMENT**

**September 2009**

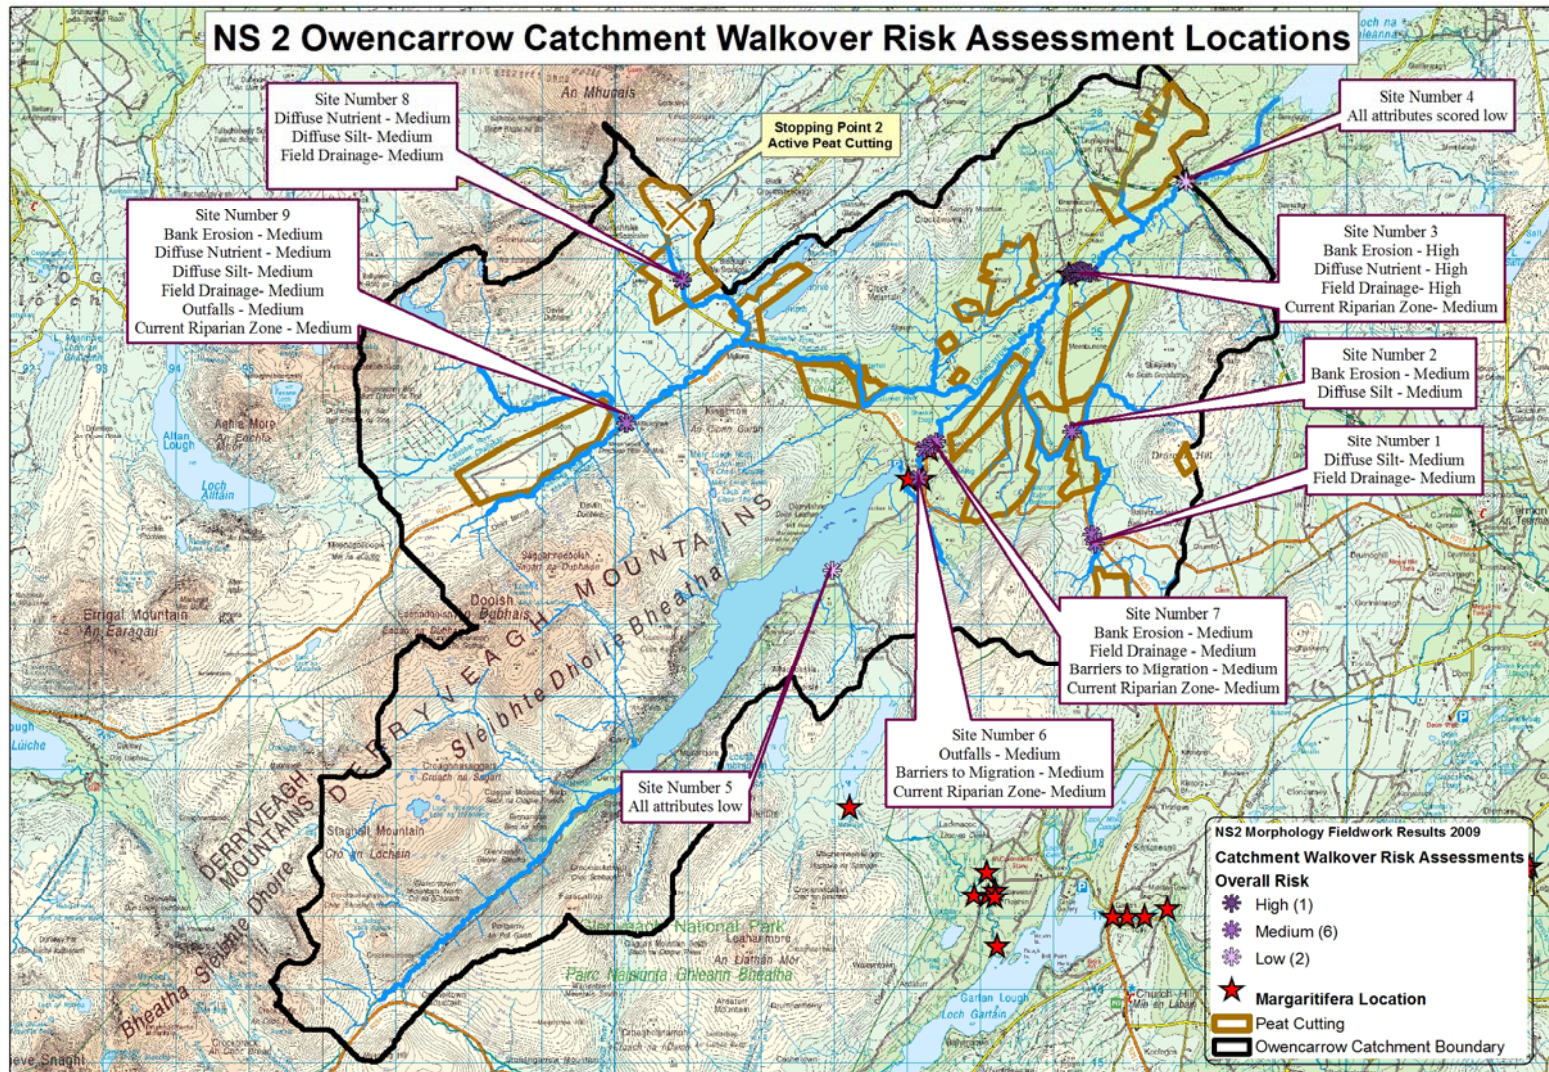
Figure 3.2 Location of Stopping points and Catchment Walkover Risk Assessments

A total of eleven sites were surveyed in the Owencarrow sub-basin catchment, with a risk assessment carried out at nine of these sites (two stopping points). **Figure 3.2** outlines the stopping point locations in addition to the High to Low Risk Assessment from the Catchment Walkover Risk Assessments. One high risk sites were recorded out of the nine that were assessed. Out of the remaining eight sites, six were recorded as medium risk and two as low risk. **Figure 3.3** outlines the percentage of sites classified at high, medium and low risk together with the number of stopping points throughout the catchment.

Only one high risk site was identified; the risk categories evident at this high risk site are outlined below:

- Erosion
- Field Drainage
- Diffuse Nutrient

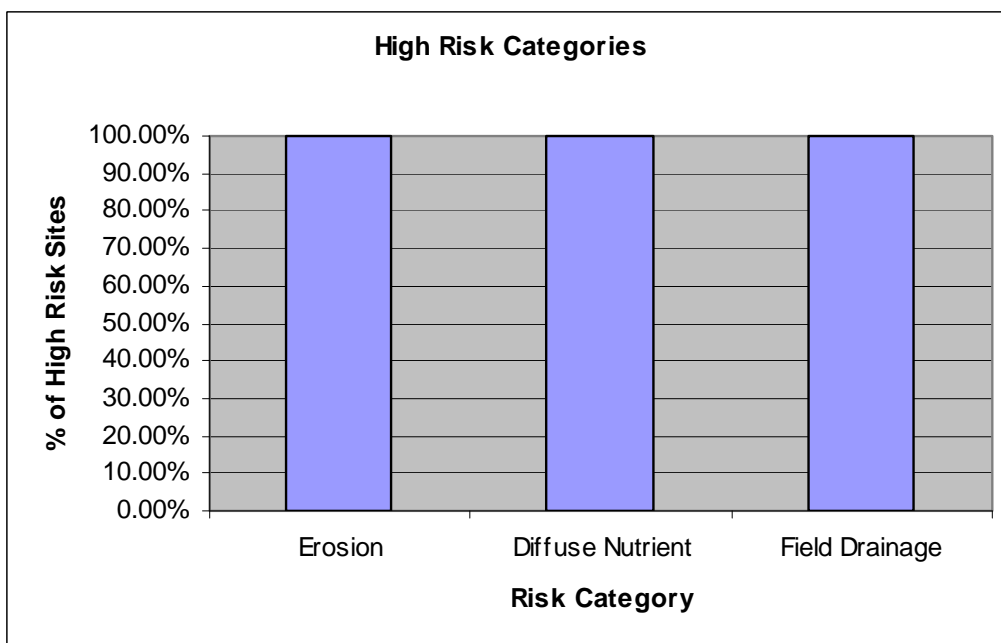
**Figure 3.4 Break-down of High Risk categories**

The break-down of pressure categories identified as high risk are outlined in **Figure 3.4**

The sources of bank erosion at the single high risk site were bank erosion, channel manipulation and hard bank protection measures. Field drainage was specified for high risk due to the presence of a managed ditch on a low slope which was observed entering the channel and contained significant macrophyte growth. Diffuse Nutrient was recorded as high risk due to the Improved Grassland on the river banks and the observed high growth rate of macrophytes.
