**NS 2 FRESHWATER PEARL MUSSEL SUB-BASIN
MANAGEMENT PLANS**

**REPORT ON MORPHOLOGICAL MONITORING AND
CATCHMENT WALKOVER RISK ASSESSMENTS IN THE
LICKY CATCHMENT**

September 2009

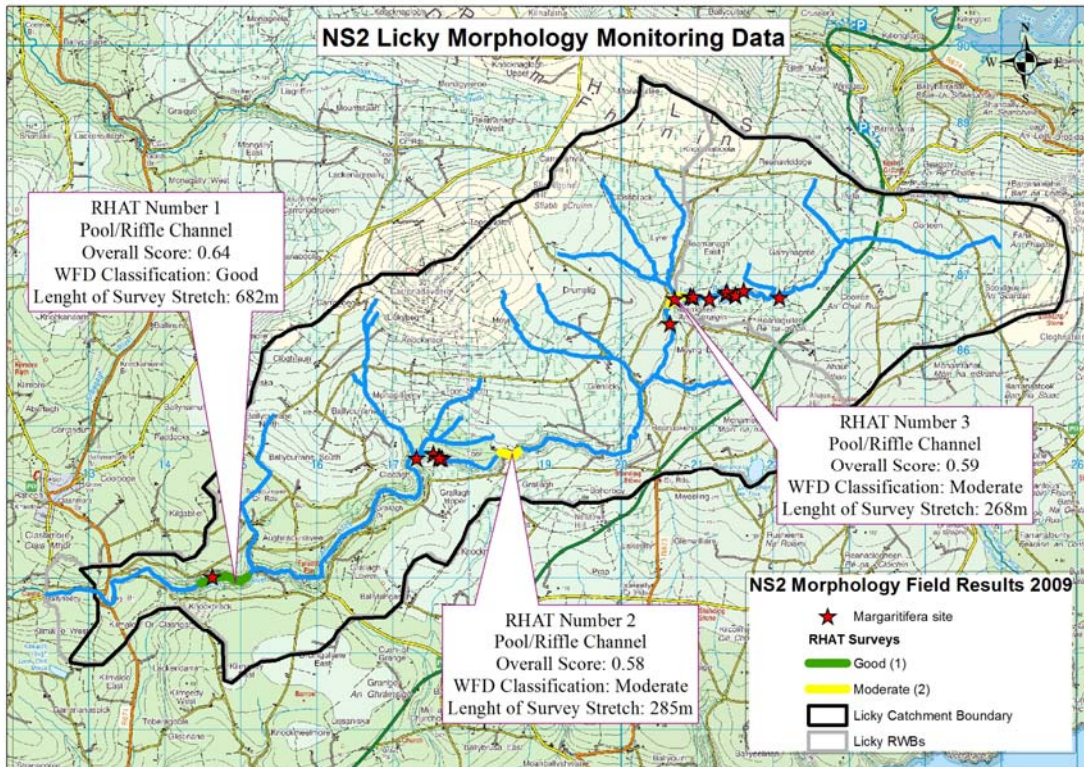
Figure 1 Morphology and Catchment Walkover Risk Assessment Locations

(The RHAT numbering system corresponds to the site code which may mean they are not sequential where a RHAT was not carried out at a particular site)

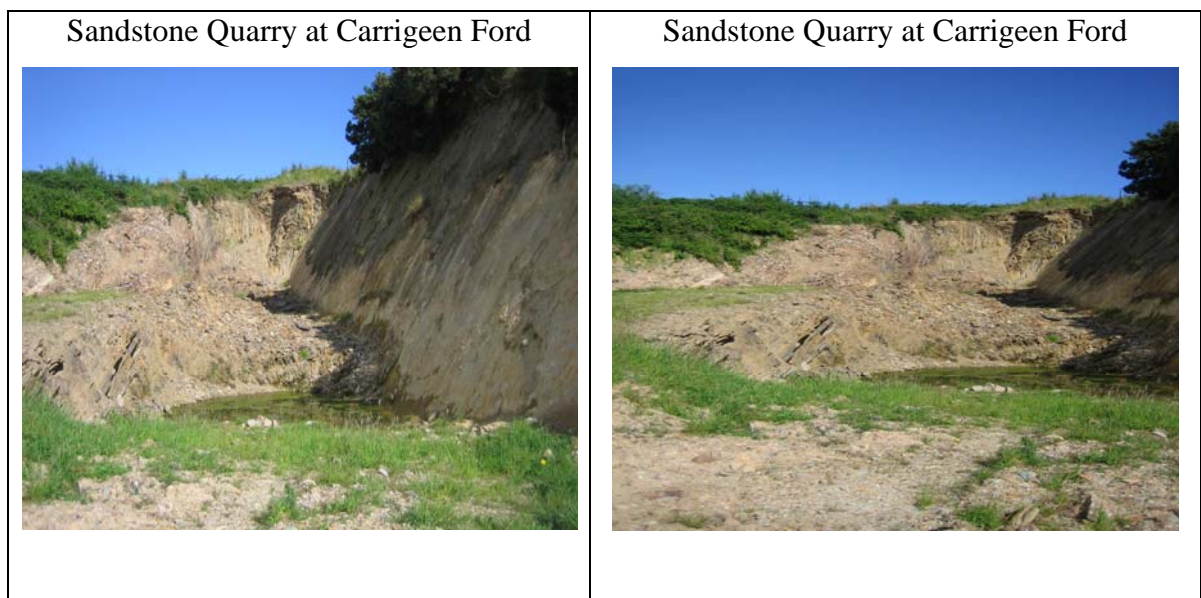
Figure 2 Location of Stopping points and Catchment Walkover Risk Assessments

A total of twelve sites were surveyed in the Licky Sub-basin catchment; with a risk assessment carried out at nine of these sites (three stopping points). **Figure 2** outlines the stopping point locations together with the High to Low Risk Assessment from the Catchment Walkover Risk Assessments. Eight out of the twelve sites were considered to be high risk with the remaining site classified as medium risk, meaning no sites surveyed were determined to be low risk. **Figure 3** outlines the percentage at high and medium risk together with the number of stopping points throughout the catchment. One quarry was found within the Licky catchment approximately 100m upstream of Carrigeen Ford on the left bank at 220789 86696. This is a small non-commercial sandstone quarry.

Where one or any of these aspects is found to be the cause of significant impact to the riparian zone, or the channel along the stretch then this category may be assigned a high risk score. Figure 2 outlines the percentage number of sites at High, Medium or Low risk. Locations where pressures were evident in the field which were not highlighted through the desk based assessment were also noted as stopping points. These points were not selected prior to fieldwork, they were opportunistic as the catchment drive through was taking place. The pie chart in Figure 2 indicates the percentage of stopping points also.
