**NS 2 FRESHWATER PEARL MUSSEL SUB-BASIN
MANAGEMENT PLANS**

**REPORT ON MORPHOLOGICAL MONITORING AND
CATCHMENT WALKOVER RISK ASSESSMENTS IN THE
MOUNTAIN CATCHMENT**

September 2009

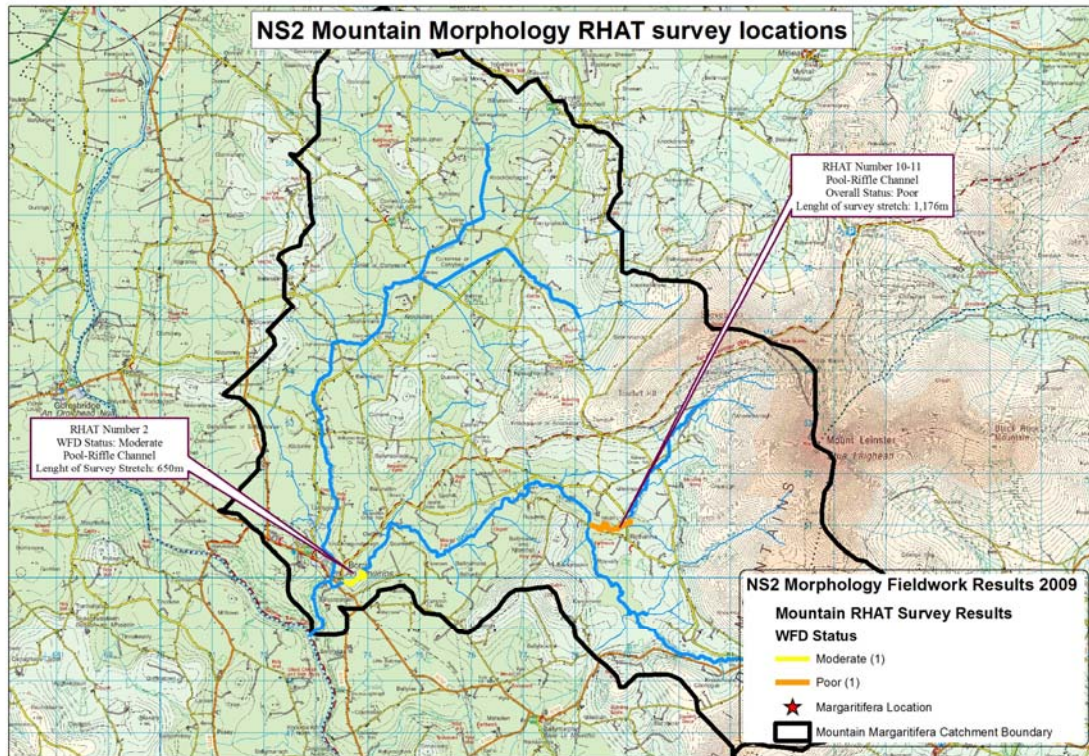
Figure 3.1 Morphology RHAT Assessment Locations

Two RHAT surveys were carried out throughout the Mountain catchment. The results of these surveys can be found in the electronic appendix. The first survey stretch commenced at the viaduct and moved upstream along a 650m survey stretch. The entire channel is subject to excessive bank erosion. The surrounding landuse is improved grassland with sheep grazing. This has led to a complete lack of buffer zone and direct access to the channel by the sheep which is causing erosion and leading to slumping and exposure of the bankside. An electric fence has been installed recently approximately 1 metre back from the bank however this is insufficient as it is not stock proof and too high for the sheep. Mid-channel bars, exposed tree roots and extensive sheep poaching was recorded throughout. The bank structure and stability, bank vegetation and riparian landcover all only scored one out of four. Overall this stretch was classified as moderate

status. While a number of salmonids were recorded along the survey stretch no live mussels were noted but a number of dead mussels were found. This stretch is in very poor condition with considerable pressure acting on the channel.

The second RHAT survey was carried out from site 10 to site 11. Resectioning, reinforcement and embankments were recorded on both the left and right banks. All attributes scored very low due to the many morphological alterations which have been carried out along the survey stretch. Bankside vegetation has been removed, animal poaching and direct vehicle access to the channel was recorded. The first section of the survey stretch contained extremely high levels of sand which has led to an almost choked channel. *Ranunculus* and *Apium sp.* were found across the entire width and in some parts altering the flow of the channel. Towards the end of the survey stretch the trees on the bankside have been totally removed and two ford crossings were recorded one of which has vehicular access and could cause additional silt to be released into the channel. Also towards the end of the survey stretch sheep were found to have access directly to the channel while fencing was in place it was insufficient to prevent direct animal access to the channel.

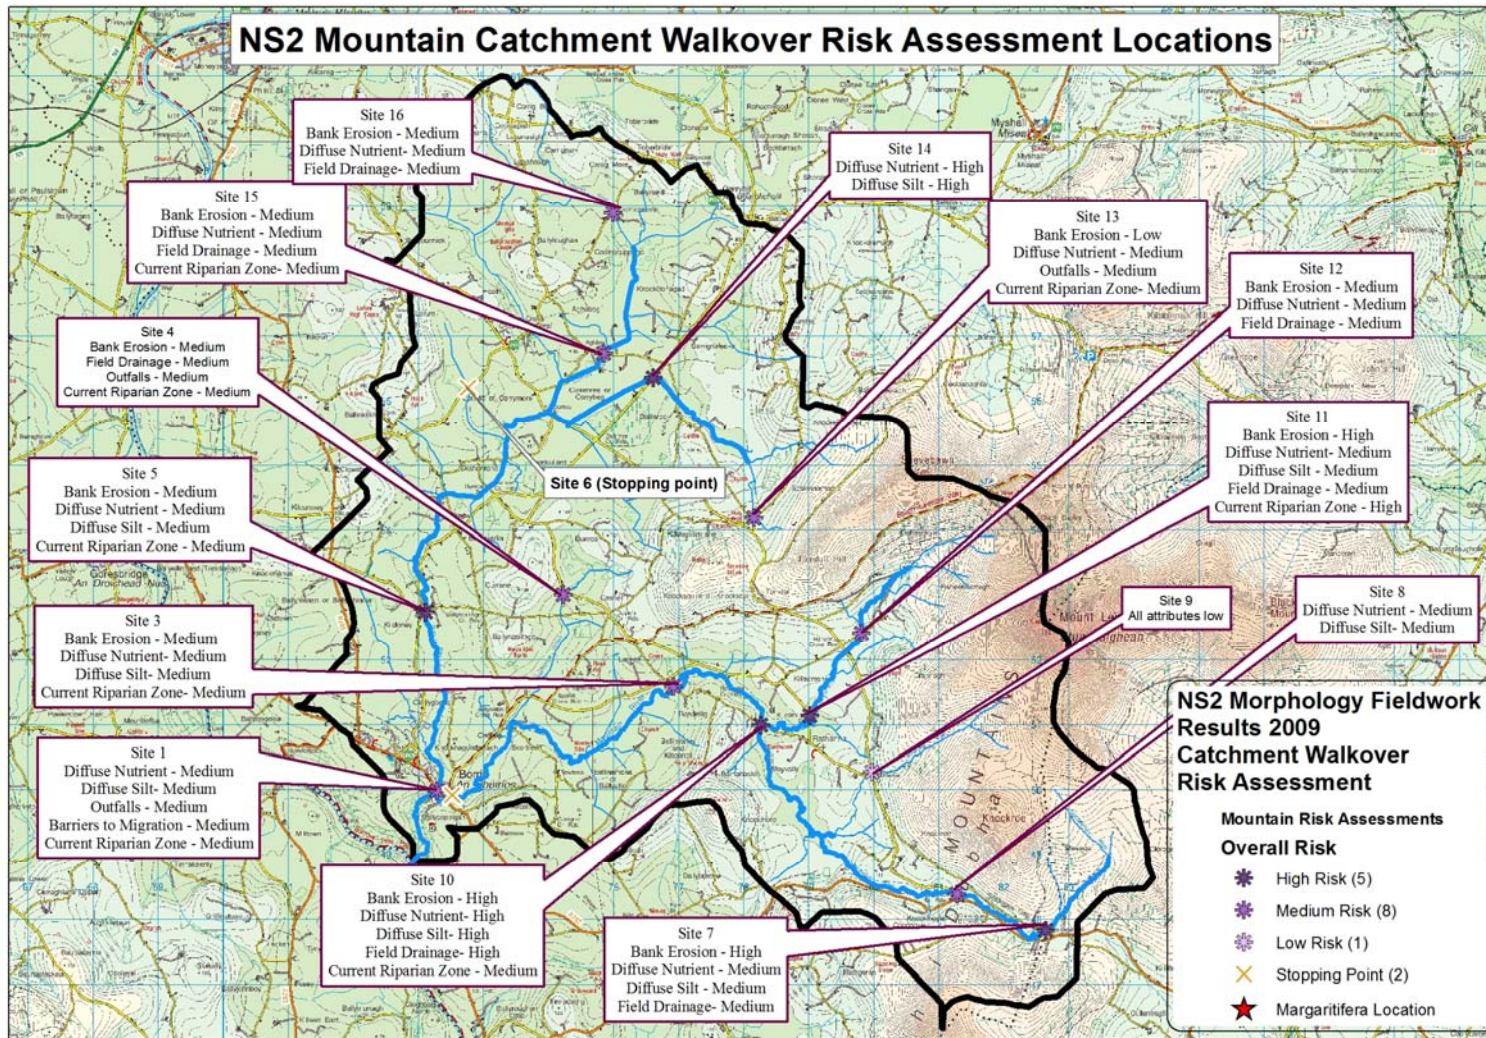
Figure 3.2 Location of Stopping points and Catchment Walkover Risk Assessments

A total of sixteen sites were surveyed in the Mountain sub-basin catchment, with a risk assessment carried out at fourteen of these sites (two stopping points). **Figure 3.2** outlines the stopping point locations in addition to the High to Low Risk Assessment from the Catchment Walkover Risk Assessments. Five high risk sites were recorded out of the four that were assessed. A further eight sites were recorded as medium risk, meaning only one low risk sites was recorded within this catchment. **Figure 3.3** outlines the percentage of sites classified at high, medium and low risk together with the number of stopping points throughout the catchment.

The intensive agriculture practised in some parts of the catchment coupled with the lack of a sufficient buffer strip and bank side removal works has led to increased levels of silt in the channel. This was particularly evident at site 7 (See **Figure 3.2**) in the upper reaches of the Aughnabrisky.

Three significant fords were observed within the catchment during the catchment walkover risk assessments. Both vehicular and animal, causing sediment loss from the vehicles/animals and the access roads, leading to excessive siltation in the river. These fords were located at site 6 and site 11 (See **Figure 3.2** above).

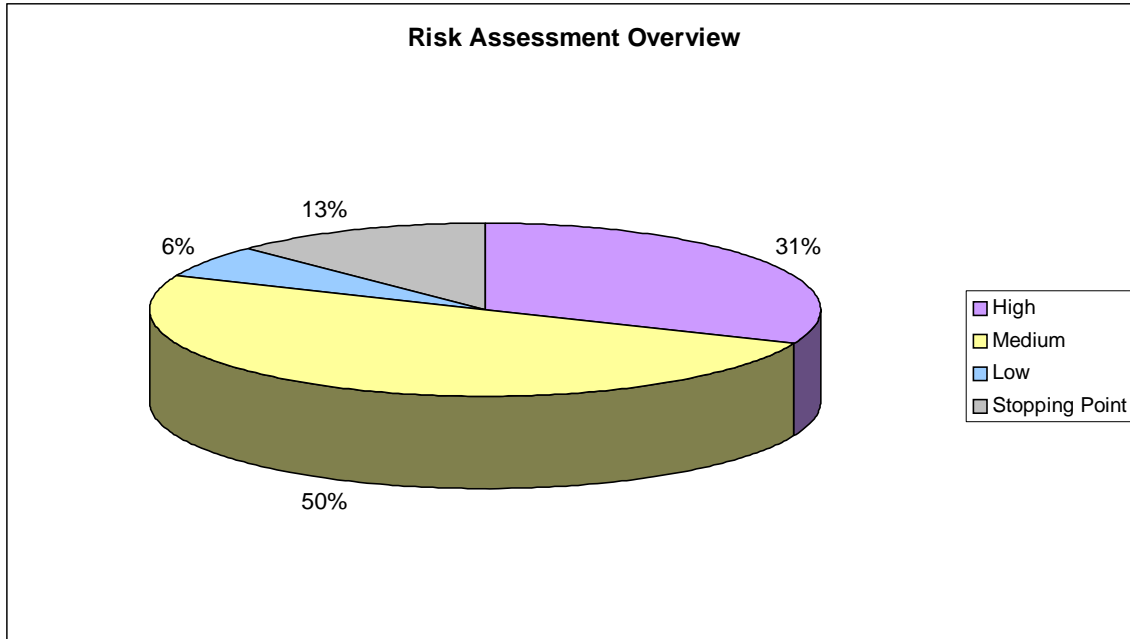
Figure 3.3 Risk Assessment Overview

Where one or any of these aspects is found to be the cause of significant impact to the riparian zone, or the channel along the stretch then this category may be assigned a high risk score. Locations where pressures were evident in the field which were not highlighted through the desk based assessment were also noted as stopping points. These points were not selected prior to fieldwork, they were opportunistic as the catchment drive through was taking place. The pie chart in **Figure 3.3** indicates the percentage of stopping points also.

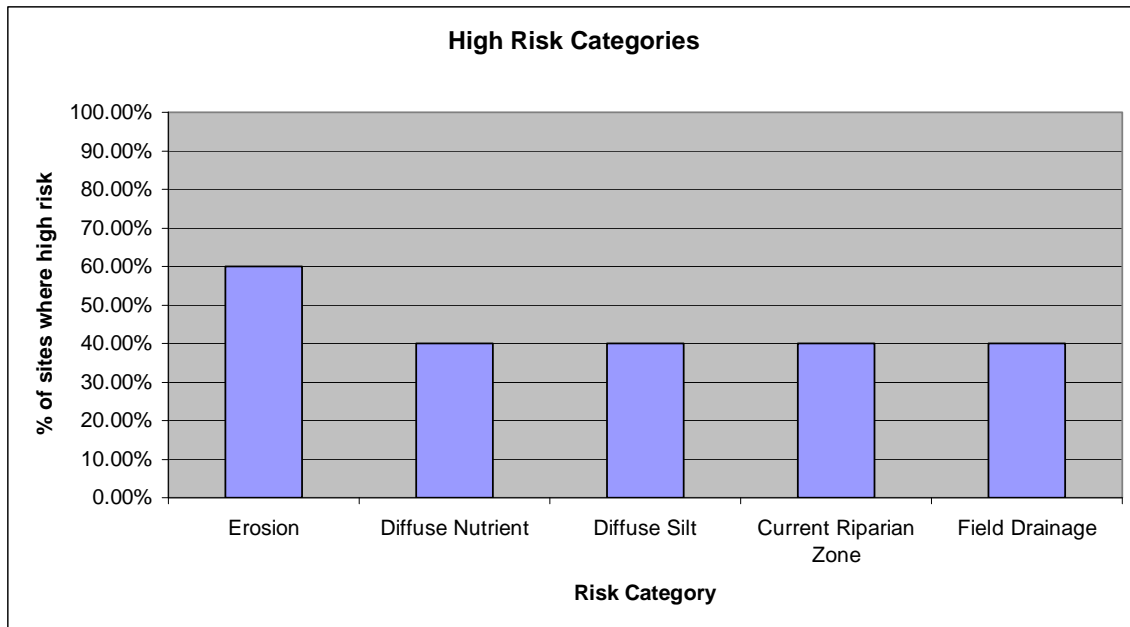
Figure 3.4 Breakdown of High Risk Categories

The break-down of pressure categories identified as high risk are outlined in **Figure 3.4**

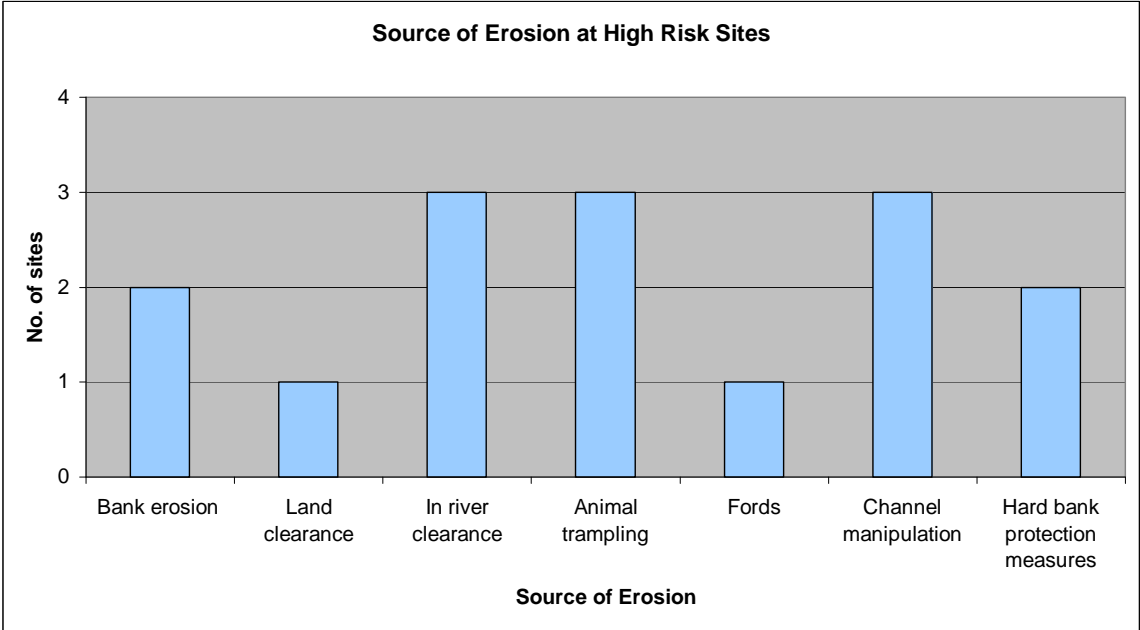
Figure 3.5 Sources of Erosion at High Risk Sites

The most common sources of erosion are in river clearance, animal trampling and hard bank protection measures. The remaining sources are shown below.
